# Experimental study into the overtopping and breaching of rockfill dams with erosion protection

Master's thesis in Hydropower Development

Norwegian University of Science and Technology  
Faculty of Engineering  
Department of Civil and Environmental Engineering

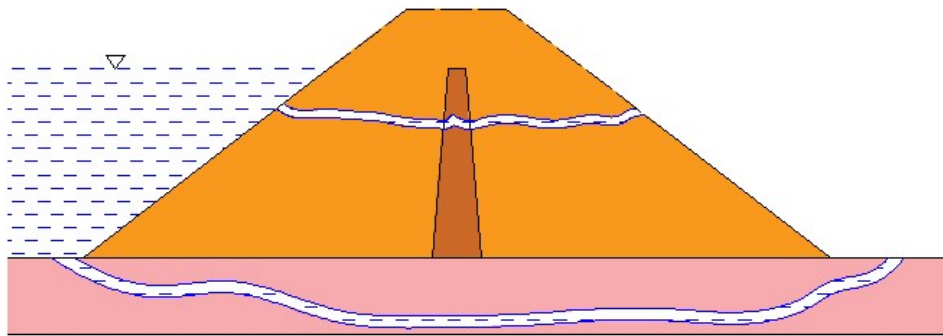
Internal erosion occurs when the water seeps through the dam and carries the soil particles away from the dam's filters, embankments, drains, foundations, or abutments. If the seepage through the downstream side of the dam approaches the reservoir, then catastrophic dam failure can occur. The process of internal erosion can be broadly divided into four phases initiation of erosion, continuation of erosion, progression to form a pipe and initiation of a breach. (Fell et al. 2005)

**Figure 2.2:** Internal Erosion and Piping in Embankment Dam

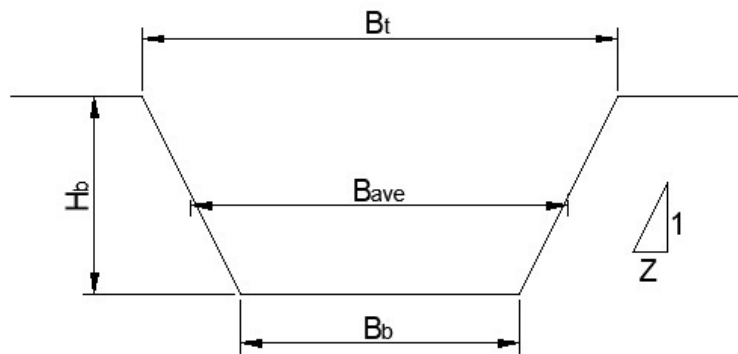
Dam breach parameters can be divided into two groups Geometric and Hydrographic Parameters. Dam breach often has a trapezoid shape, with the geometric parameters of breach depth ( $H_b$ ), breach top width ( $B_t$ ), average breach width ( $B_{ave}$ ), breach bottom width ( $B_b$ ) and breach side slope factor ( $Z$ ) as shown in figure 2.7 below. Any combination of three of five parameters determines the breach shape and size (Xu and Zhang 2009)

Figure 2.7: Geometric Parameters of Dam Breach

In figure 2.7 slope ratio can be taken as  $z = 1.4$  for overtopping failure and  $0.9$  for other types of failure. The failure time given by Froehlich (1995a)

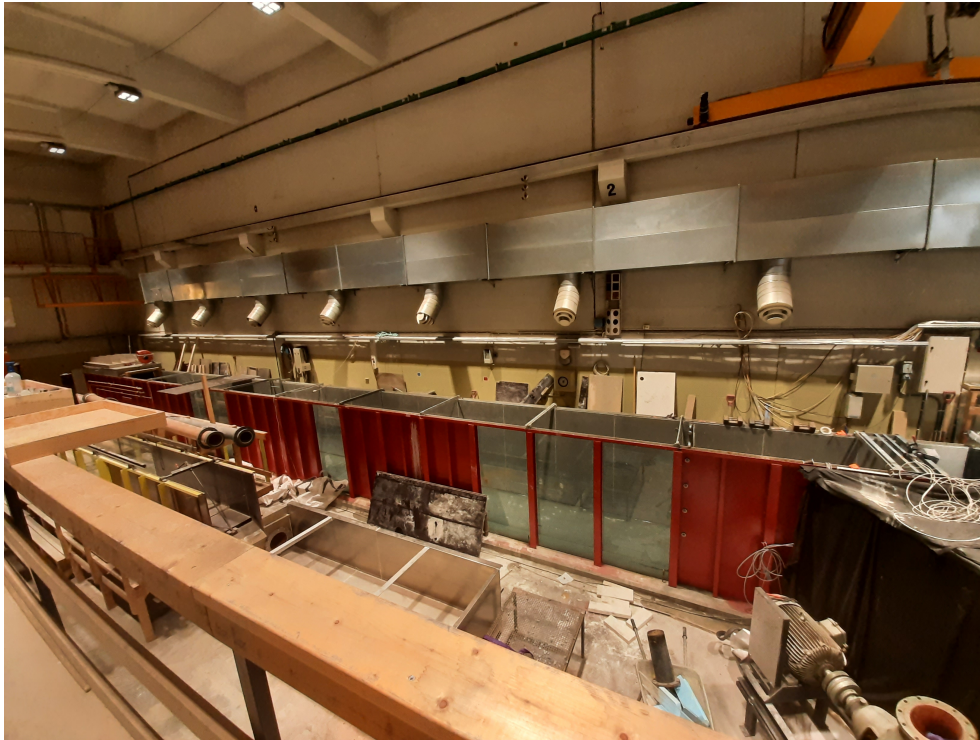
The physical model tests were conducted in a flume having the following dimensions 25 m in length, 1 m in breadth, and 2 m in height. This flume has four large glass panes on a testing side to capture the video during the experiment from the left bank side shown in figure 3.1 and figure 3.2. The flow was generated by two pumps having a combined maximum inflow capacity of  $0.5 \text{ m}^3/\text{s}$ . There are several holes in inflow pipes for better distribution of the large incoming volume of water, and his inflow water was collected in a reservoir(9) to prevent turbulent inflow water during the experiment. The aluminium platform (11) was constructed to support the model and to minimize the effect caused by the backwater effect on the downstream side of the dam. This aluminium platform was 0.35 m in height from the bottom of the flume; this was raised in a single vertical step on the upstream side of the dam and smooth slope on the downstream side of the model, stretching approximately 6.5 m in length. The geotextile fabric covered the elevated aluminum surface to prevent the artificial smooth surface, which can cause the unwanted and impractical sliding of material along the bottom surface. The (6) mark indicates the outlet for incoming discharge. On the upstream side, to control the incoming discharge and remove the water collected in 0.35 m vertical step, there was a bypass pipe indicated by the (7) mark. The experiment was captured by the (7) overhead camera indicated by (1) mark and the side camera

**Figure 3.2:** Model setup at NTNU Lab

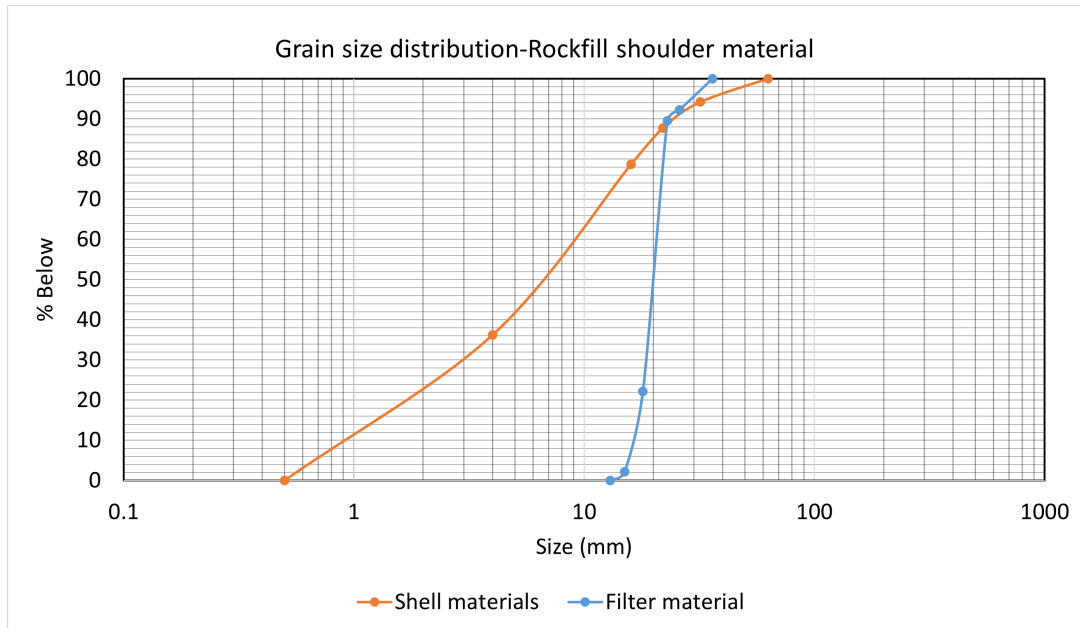
The material was not prepared during this thesis and used the same material prepared by (Senarathna 2021) during his master thesis. Grain size distribution for rock fill material was established based on existing rockfill dams in Norway by the (NVE 2012). The grain size curve was downscaled at a ratio of 1:10 for this test. However, there was a limitation for the finest material not smaller than 0.5mm. In the installed pump system, if the particle size was greater than 0.5 mm, it would settle in the reservoir. Due to this reason, the material gradation for this test lies on the coarse side of the range, which is shown in figure 3.4.

**Figure 3.4:** Gradation curves for shell material.

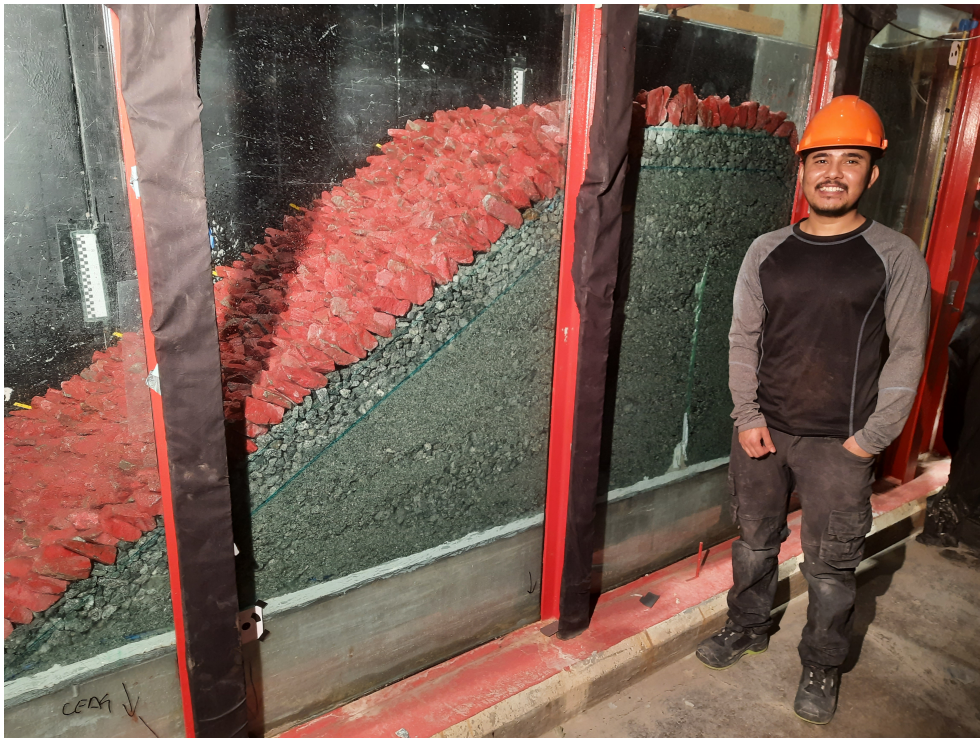
In figure 3.6, we can see that the filter material was placed on the top of the shell material and the top of the filter material placement of riprap. This is placed riprap in the given figure, the author of this thesis, was standing in front of the dam to visualize its scale.

**Figure 3.6:** Completion of Dam Construction

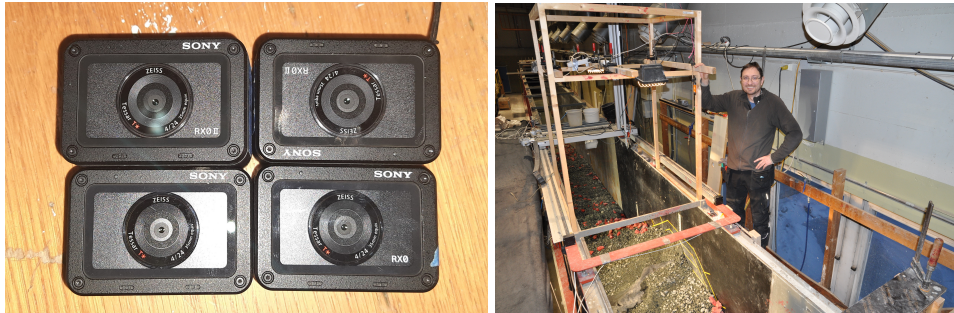
In tests M1, there were six cameras (Sony Cybershot RX0 / RX0 II shown in figure 3.7 installed to monitor the breaching process, one camera from the glass wall side, and the remaining five from the wooden frame placed on the top of the flume. In tests M2 and M3, there were nine cameras installed; one extra camera was set on the toe side from the glass side and two extra cameras on the wooden frame. At the start and end of the test number of images were taken from the DSLR camera to identify the changes in the dam before and after the test. The bypass valve on the downstream side was closed, then the opening of inflow pump, and the water in the reservoir was filled up to the core level(0.8 m from the bottom of the dam) to see whether the leakage was significant in the structure. Then the cameras were switched on to record the test; these cameras were synchronized with the help of a stopwatch. Usually, the pump filling rate started from 10-15 l/s and increased the discharge by 5 l/s every 30-minute interval.

**Figure 3.7:** Sony Camera RX0/ROXOII on the left and wooden frame for camera stand on right

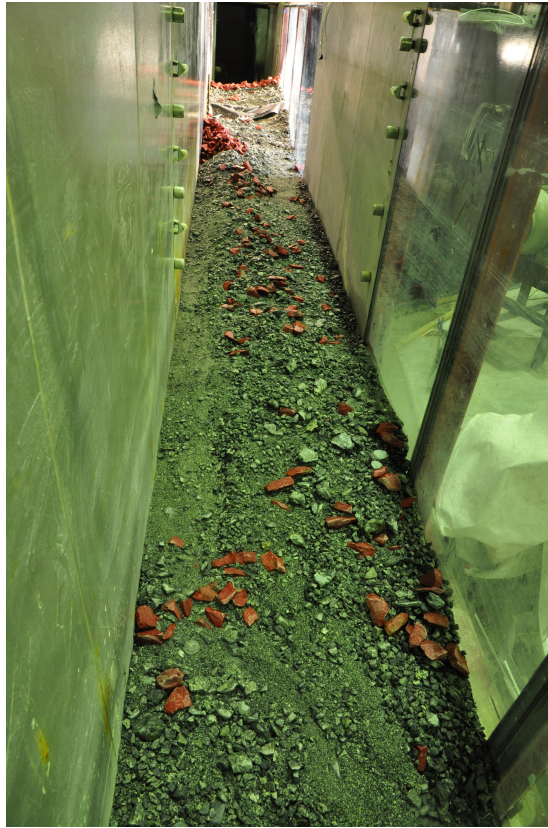
When the dam failure process was completed, the inflow pump was closed; then bypass valve was opened to drain the water in the upstream reservoir. Then the photos of the breached dam were again taken by DSLR camera. Some geometric measurements were also done manually at a distance of 0.5 m space along the length flume and at a distance of 0.25 m along the width of the dam. At this time, all the material riprap, filter, and shoulder were completely mixed and sprayed along the flume. First, these riprap materials were collected and separated by hand. In our case, we have to separate filter material around 50 small buckets (capacity of 10 l) from shoulder material. This separation process was done in the sieving bed as shown in the figure 3.8 below.

**Figure 3.8:** Riprap, shell, and filter material mixed after dam breach

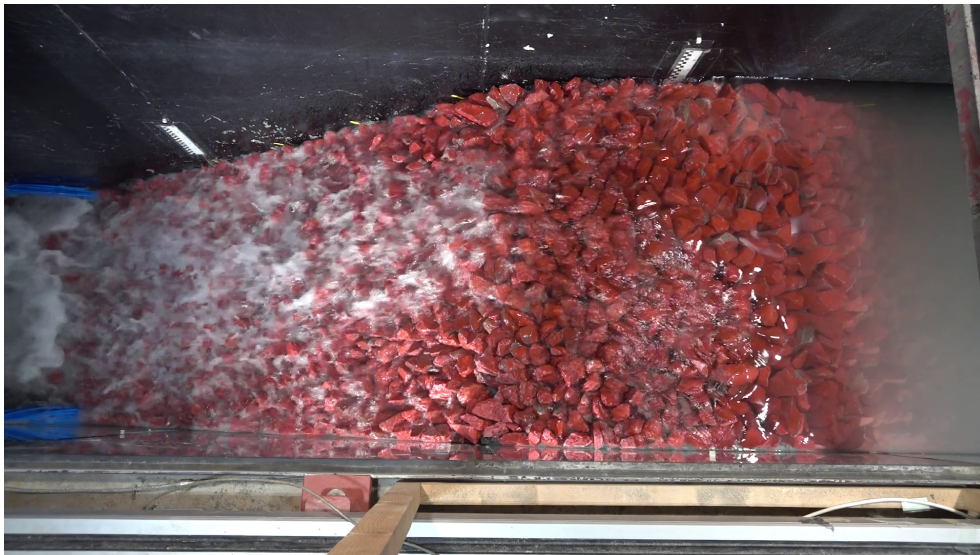
The experiment M3 was captured from 9 cameras, and through the very fine time step (8 images per second), it was observed that the failure started on the downstream edge of the crest where aeration was absent, which is very much in agreement with (Hiller 2017). Ongoing through the video footage taken during the experiment, the overtopping discharge created extra force on the downstream toe of the dam. At a certain point, the toe was not able to take more force from the overtopping discharge, and the developing gap was observed on the downstream edge of the crest. This developing gap was observed due to compaction of riprap material, and exposure of the filter material resulted in the sliding of the riprap on the downstream side shown in figure 4.2, which is similar to the failure mechanism described by (Siebel 2007).

**Figure 4.1:** Placed riprap exposed to overtopping before sliding,  $t=20$  s

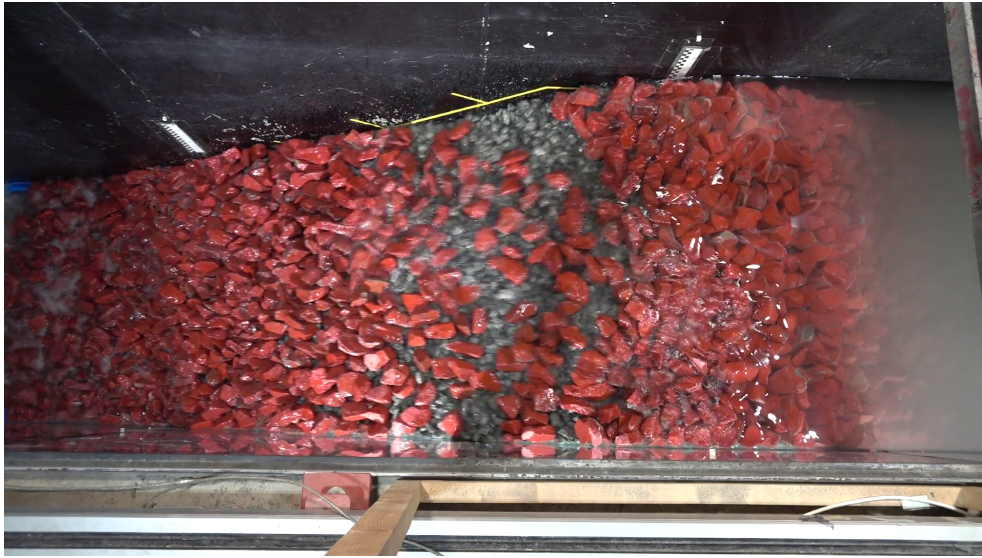
Figure 4.2: Sliding in placed riprap due to overtopping,  $t=25$  s

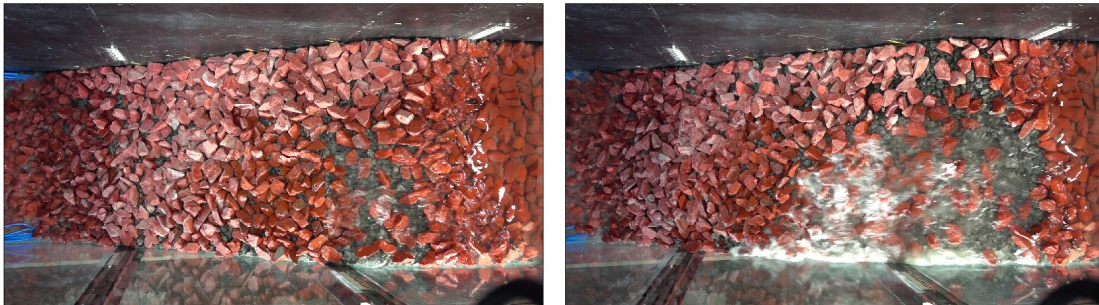
**Figure 4.7:** Single layer dumped riprap exposed to overtopping during sliding(left,t=5 S) and after sliding(right, t= 10s)

Six cameras captured the dam model M1 (dumped double layer) while nine captured model M2 (dumped single layer). In model M2, there was one extra camera on the toe of the dam and two more cameras for the top view. Similar to placed riprap, both single and double layers breached just downstream side of the crest; however, there is no such aeration like in placed riprap just before breach shown in figure 4.7 and 4.8. Ongoing through the video footage for both single and double layer riprap dams in small time intervals, it was found that initial breach starts, and minor sliding occurs. This sliding stabilizes for the certain period; in our case, the major continuous sliding starts after 5-10 seconds. In placed riprap, the riprap behaves as a single unit, and when sliding occurs, all the riprap material gets deposited in the toe of the dam shown in figure 4.5 while for the case of dumped riprap, it was found that there was no such deposition of riprap at the end.

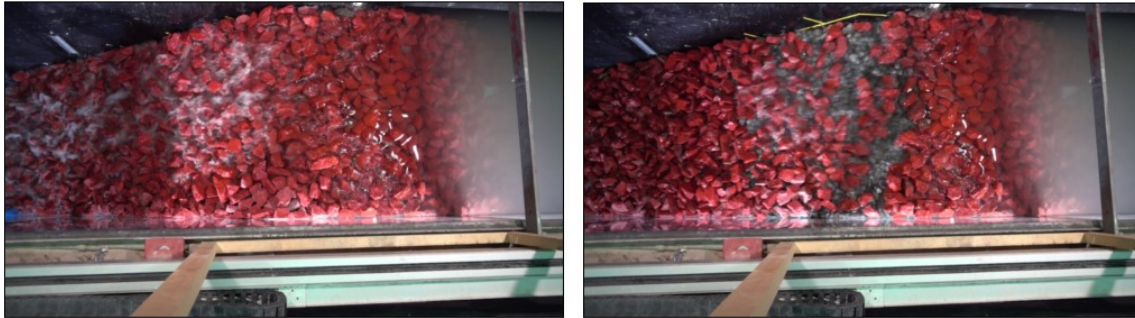
**Figure 4.8:** Double layer dumped riprap exposed to overtopping before sliding(left,t= 0 s) and during sliding(right,t= 10 s)

The breaching discharge for single layer and double dumped riprap was 20 l/s and 30 l/s, respectively. It indicates that the double layer dumped riprap has a much higher breaching discharge capacity than the single-layer dumped riprap. The placement of placed riprap is time-consuming and requires technical skills. If riprap can be easily found from the quarry site, then double layer riprap may be the solution for a similar kind of breaching discharge as placed riprap.

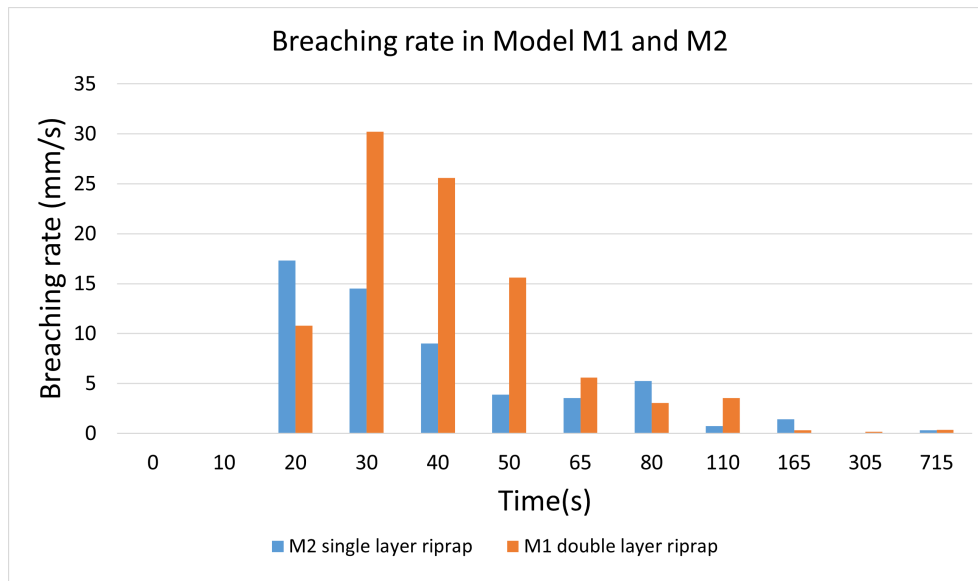
**Figure 4.13:** Vertical Breaching rate in dumped riprap

Similar to mention in placed riprap, the TIF images generated from R programming were imported to Qgis, and failure surfaces were drawn. Taking reference to 0 s and at a crest position, the erosion rate was determined. Referring to the figure 4.13 and table 4.3, we can see that the erosion rate in single layer riprap was higher in the 20 s time interval; it was due to failure in single riprap started earlier. In time the 30 s the breaching rate in double-layer riprap was much higher; it is almost double the highest breaching rate in single-layer riprap. From time 165s, the erosion rate decreased significantly, and after 715 s, the erosion rate ceased almost in both dams, which are shown in figure 4.13.

It was found that the breaching rate and peak discharge are relatable higher the peak discharge higher the breaching rate, and vice versa refer to figure 4.13 and 4.6 . In higher breach discharge, it was revealed that more dam materials get eroded than the dam breach with lower discharge.

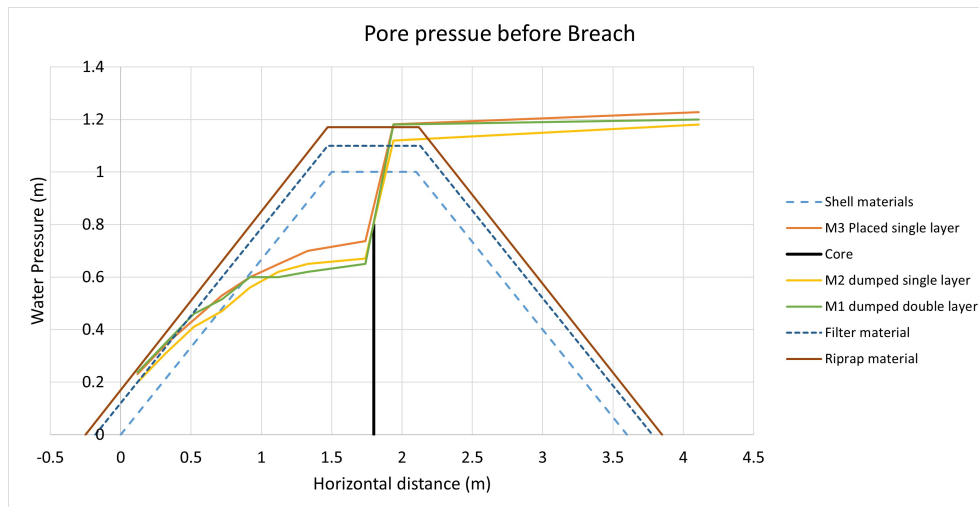
Figure 4.14 describes graphically the pore pressure developed at the bottom of the dam just before the breach. There are outlines for the shell material, riprap materials, and filter material for better visualization of the dam body.

**Figure 4.14:** Pore pressure at bottom of dam before breach

In this thesis, only the comparison of pressure measurement just before the breach and just after the breach is done refer to figure 4.14 and 4.15. Before the breach, we can observe that all the pressure lines downstream side of the core are inside the dam. After the breach, the pressure lines are outside the dam due to overtopping action. When the water overtops during breaching, more water is on the downstream side creating higher pressure. Comparing the pore pressure graph, we can observe that there is similar pressure on the upstream side of the core, but on the downstream side of the core, there is a significant change in pressure. From these experiments, it was observed that the pressure development inside the dam doesn't play an important role during the failure due to overtopping; it's due to surface erosion during overtopping.

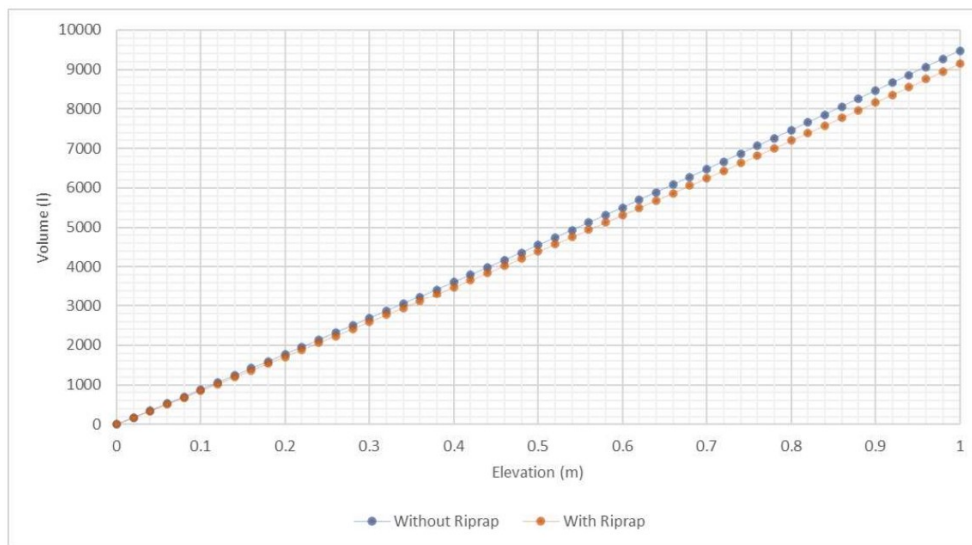
**Figure 4.20:** Reservoir volume versus elevation without riprap layer and filter layer and with these two layers

The breach discharge was measured indirectly; to calculate it, we need to find the stage versus water stored volume in the reservoir. Senarathna (2021) and I had experimented on the same setup at NTNU Lab. He measured the cross-sectional area of the reservoir, incremental increase in volume, and further took into account the water stored in the upstream section of the dam. The porosity of the shell material was measured by filling the material in the known volume of the container and then measuring the water required for the complete saturation of the sample. In the figure 4.20 we can see that there is a marginal difference between a dam without a riprap and filter layer and a dam with these two layers.

During the breach, water elevation on the upstream side of the reservoir was measured by pressure sensors. These pressure sensor data were converted to readable meter reading by R programming language as described in previous sections 3.4 and 4.3. In figure 4.20, we can see that elevation and volume have linear relations. The best-fitting line was plotted, and its equation 4.1 was determined; now, the water level at different periods can be converted to stored water volume in the reservoir. By using a simple water balance equation, we know the difference in water volume in a given time interval; dividing the change in water volume by time interval gives the outflow discharge.

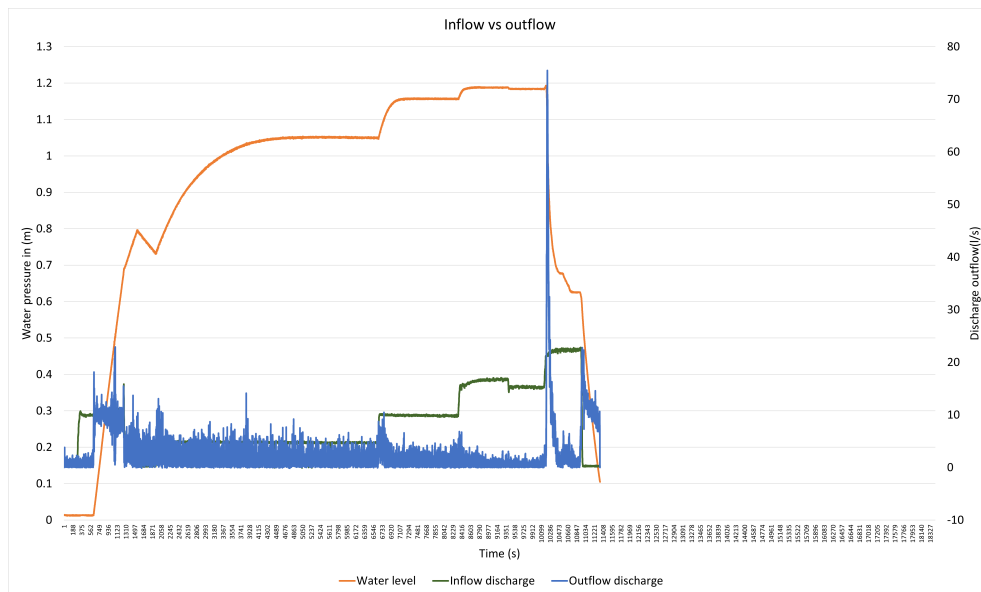
Figure 4.23: Outflow discharge in dumped single layer riprap at dam failure

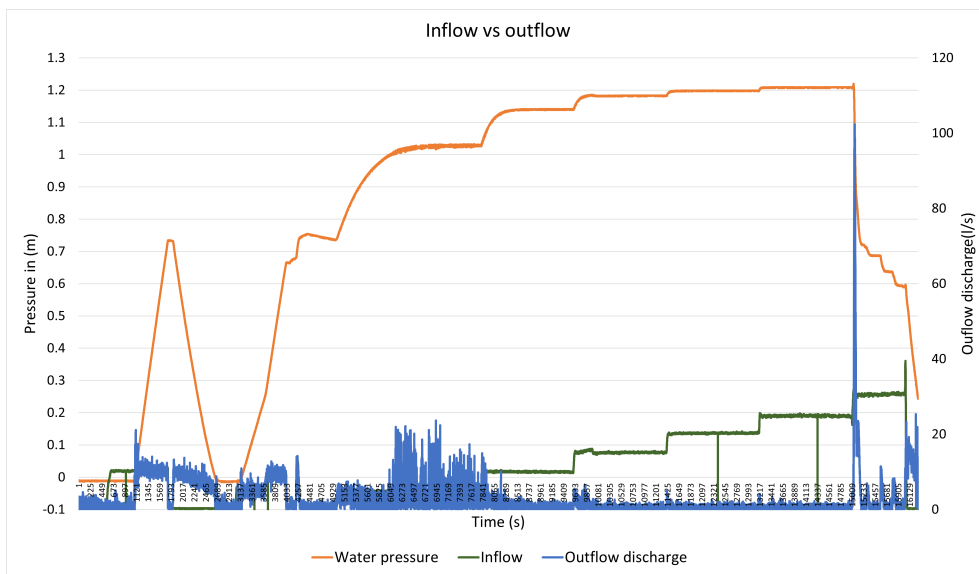
Figure 4.24: Outflow discharge in dumped double layer riprap at dam failure

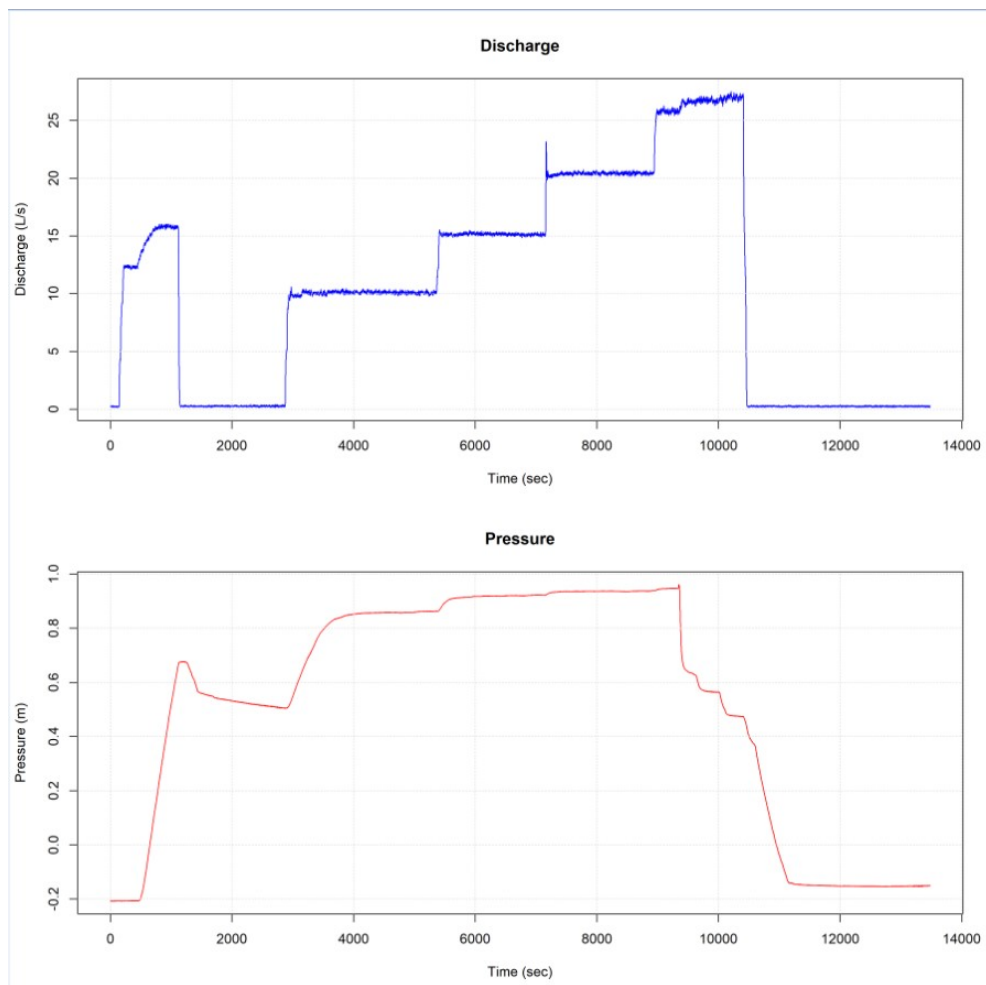
Figure A.4: Inflow discharge and reservoir water level Placed riprap
