# Non-Destructive Inspection of Polymer Composite Pipelines

Master's thesis in Mechanical Engineering  
Supervisor: Andreas Echetermeyer  
July 2022

Norwegian University of Science and Technology  
Faculty of Engineering  
Department of Mechanical and Industrial Engineering

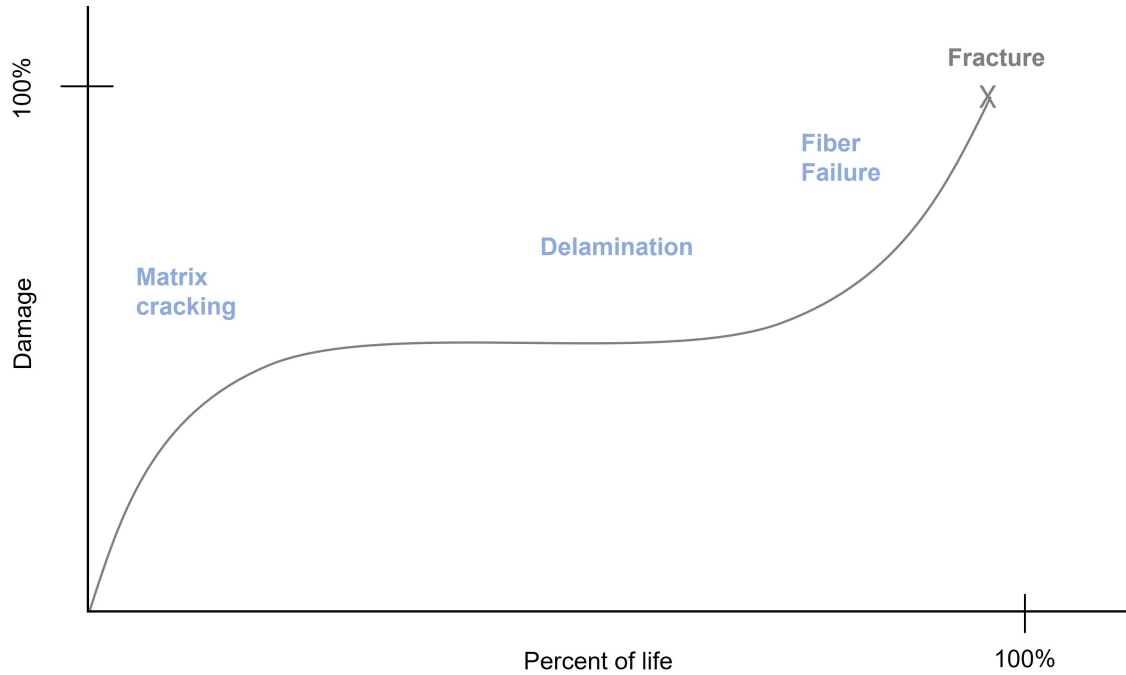
Figure 2.1 shows a conceptual description of fatigue damage evolution in polymer composite materials, beginning with matrix cracking, leading to delamination, and finally, fibre failure occurs; after this, ultimate failure takes place quickly. [13].

Figure 2.1: Fatigue damage evolution in polymer composites

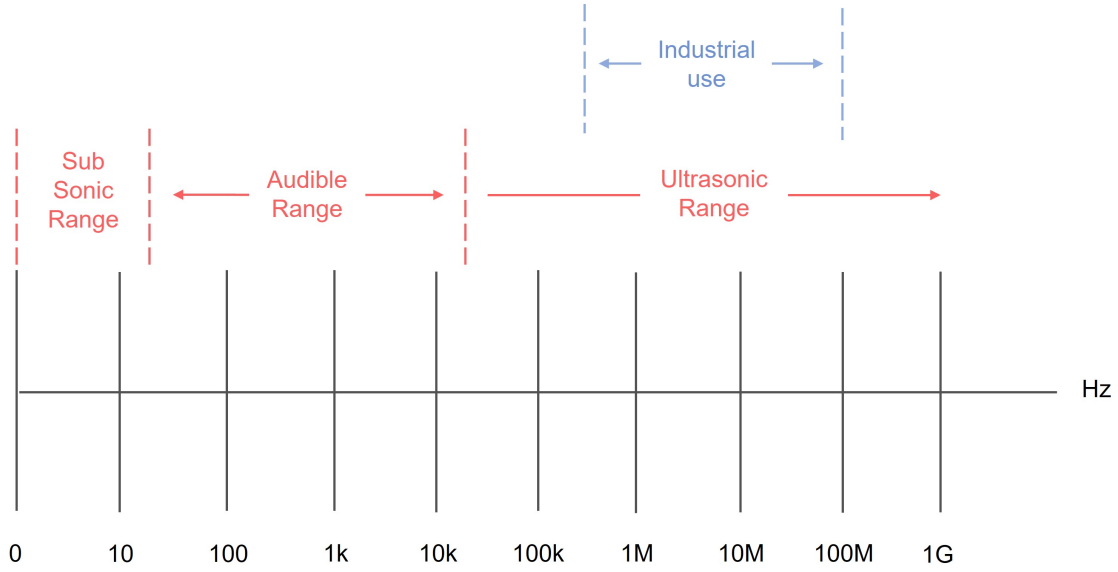
The acoustic spectrum can be divided into a sub-sonic-, audible- and ultrasonic range. These are depicted, with the corresponding frequency range, in Figure 2.4.

Figure 2.4: The acoustic spectrum

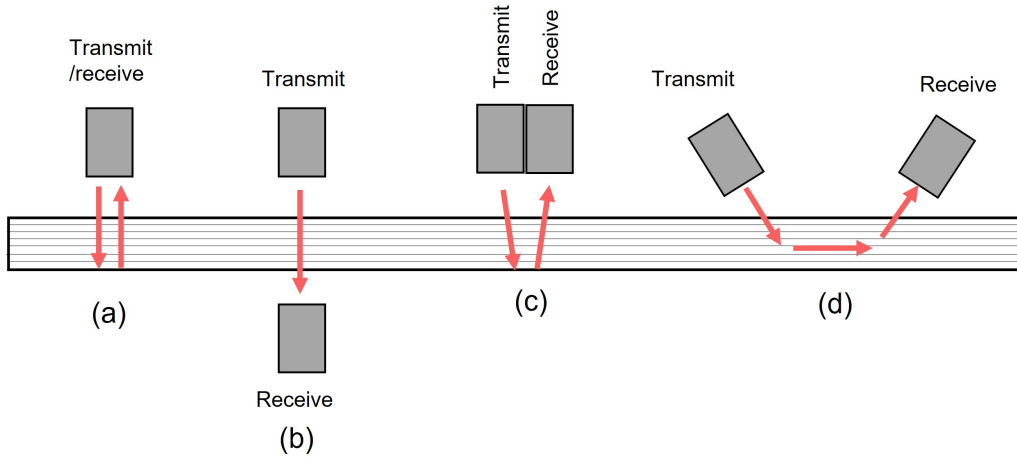
Other methods include **pitch-catch** where two transducers are placed closely together on the same side of the material, and **guided waves** where the transducers are placed relatively far away from each other, and the wave is sent at an angle [6].

Figure 2.5: Common ultrasonic inspection techniques: (a) Pulse-echo, (b) Through-transmission, (c) Pitch-catch, (d) Guided waves

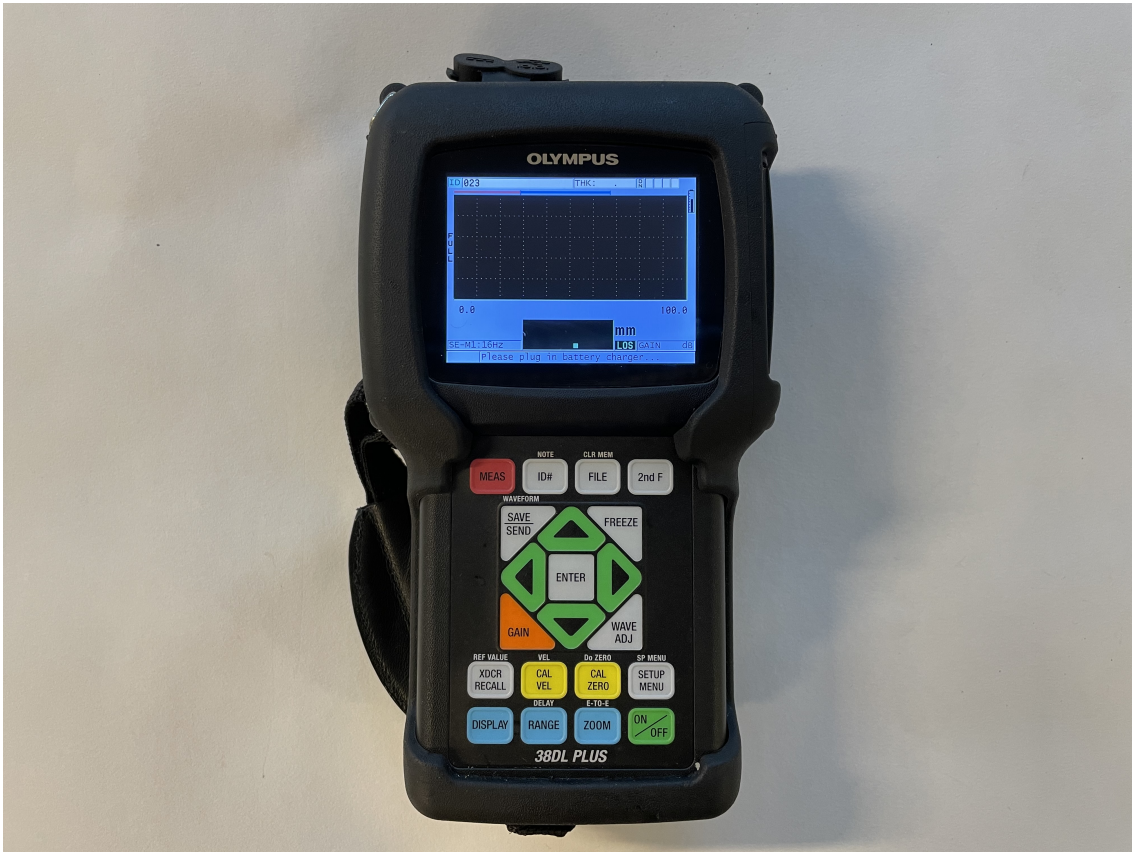
Ultrasonic measurements are taken using a 38DL PLUS Ultrasonic thickness gauge from Olympus, shown in Figure 4.4 used for pulse-echo testing. The thickness gauge is used for pulse-echo testing and can measure parameters such as thickness, sound velocity and time of flight and offers an A-scan view. Only inspection mode 1, which measures the time of transit of the first returning echo, is available.

Further, the standard resolution of the thickness measurements is 0.01 mm, and a high penetration software option is available for inspecting attenuating materials such as glass fibre composites.

Figure 4.4: Ultrasonic thickness gauge

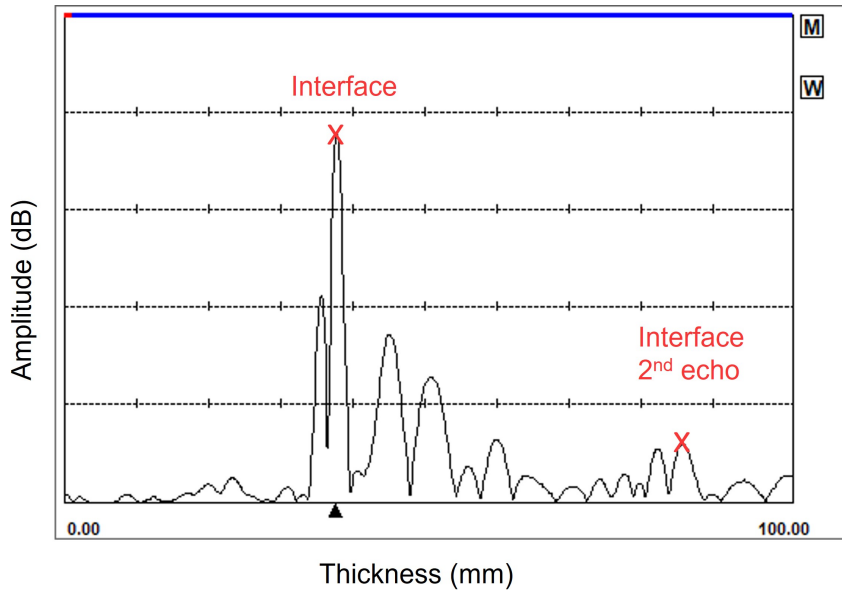
Figure 4.8 shows a measurement of a non-defected area using a contoured wedge. The first peak indicated is the wedge-test piece interface, and the second peak is the second echo of the interface. The valid inspection area is the area between these two echoes.

Figure 4.8: A-scan of measurement with wedge

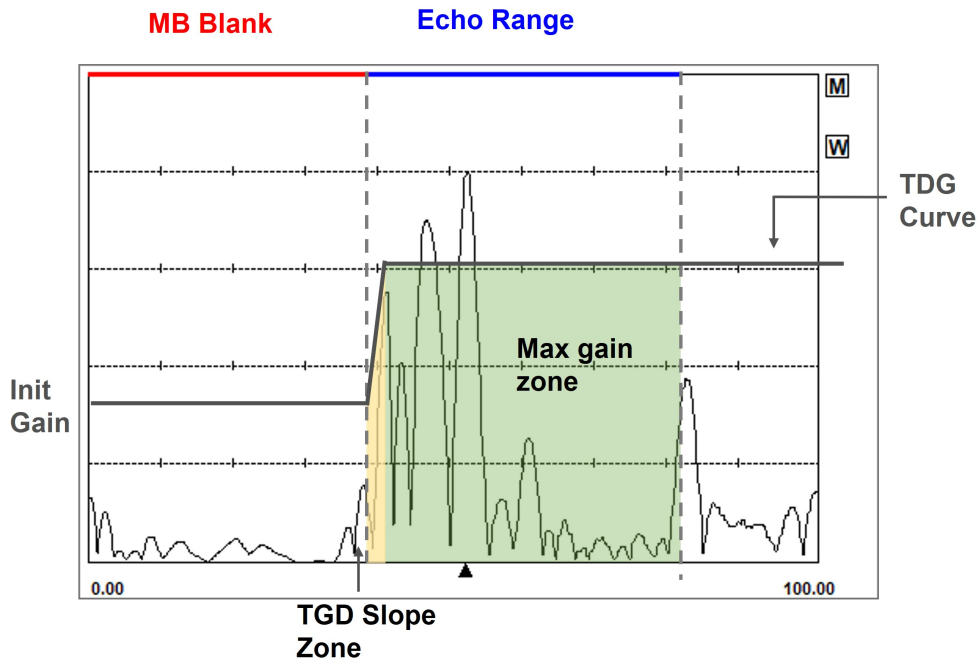
Figure 4.9: Inspection interval and TDG curve for contact testing with wedge

Moreover, the time-dependant gain (TDG) slope, which controls the rate at which the receiver gain increases from initial gain to maximum gain, is increased so that the near surface resolution is optimized. Together, these three parameters create the TDG curve.

Figure 4.9 illustrates the inspection interval and TDG curve set for the measurements taken with the contoured wedge. The interval in which echoes can be detected is underneath the blue line representing the echo range and is also illustrated by the maximum gain zone and the TDG slope zone.

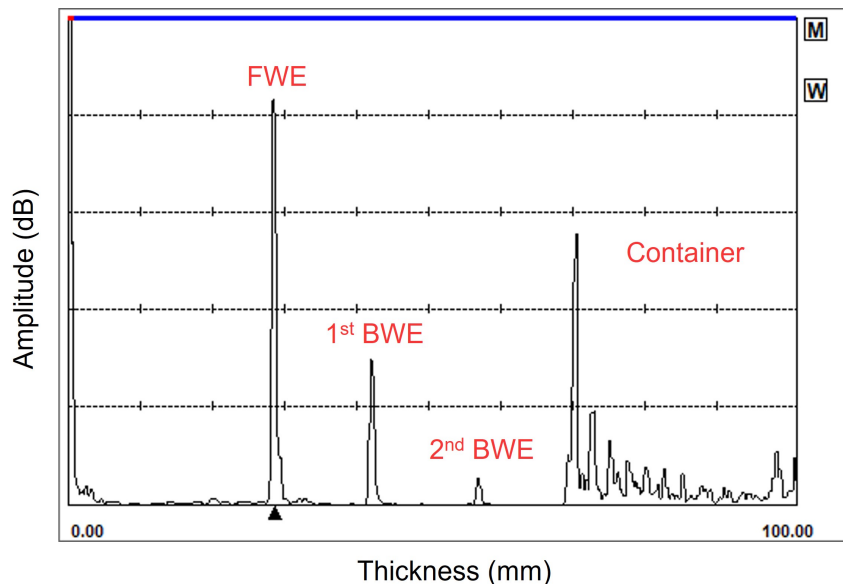
Figure 4.10: A-scan of measurement taken with immersion technique

Figure 4.10 shows an A-scan of a measurement taken with immersion technique of an area without defect. The high peak to the left is the reflected signal from the front wall of the test piece, while the multiple peaks to the right are reflections from the glass container. Between these are the test piece's first and second BWE.

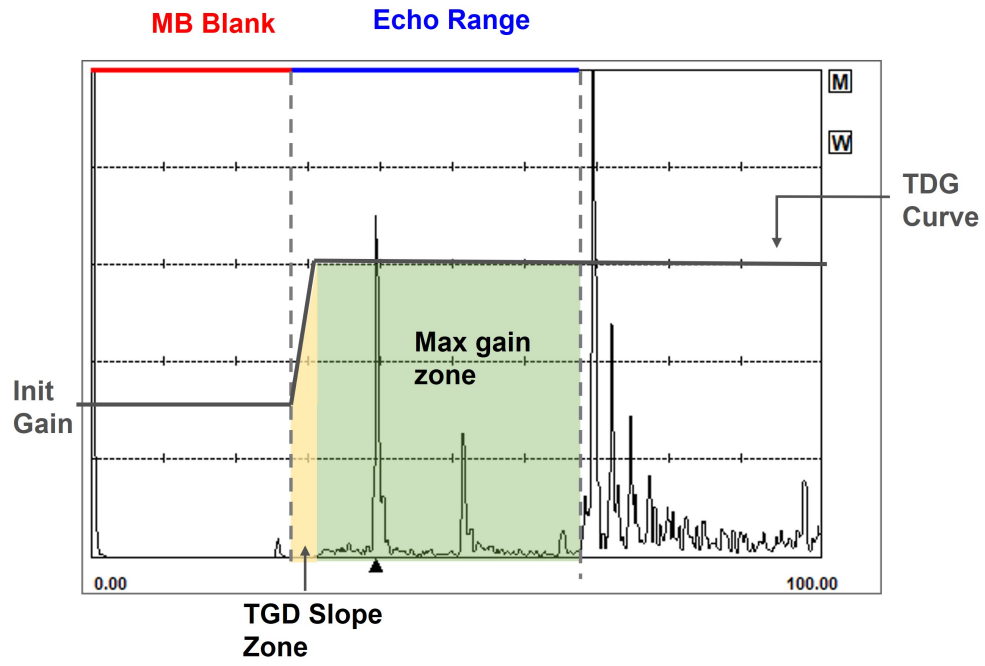
The MB blank is set to include the front wall echo (FWE) and the echo range to stop before the water-container interface so that these echoes are not detected. Further, the TDG slope is increased to obtain high near-surface resolution. In Figure 4.11 the transducer parameters affecting the inspection interval and TDG curve is illustrated.

Figure 4.11: Inspection interval and TDG curve for immersion testing

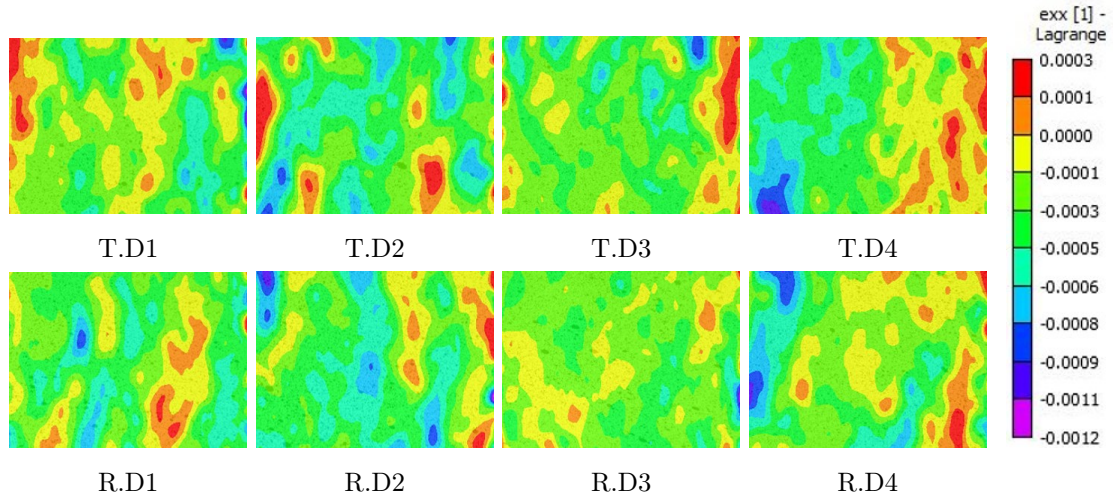
strates no consistent strain values out of the ordinary, indicating detectable damage. Transverse strain fields scaled at an interval of  $\epsilon_{xx} = -0.0012$  to  $\epsilon_{xx} = 0.0003$  are presented in Figure 5.7.

Figure 5.7: Comparison of transverse strain fields for specimens with fabricated delaminations at  $\epsilon_{yy} = 0.4\%$

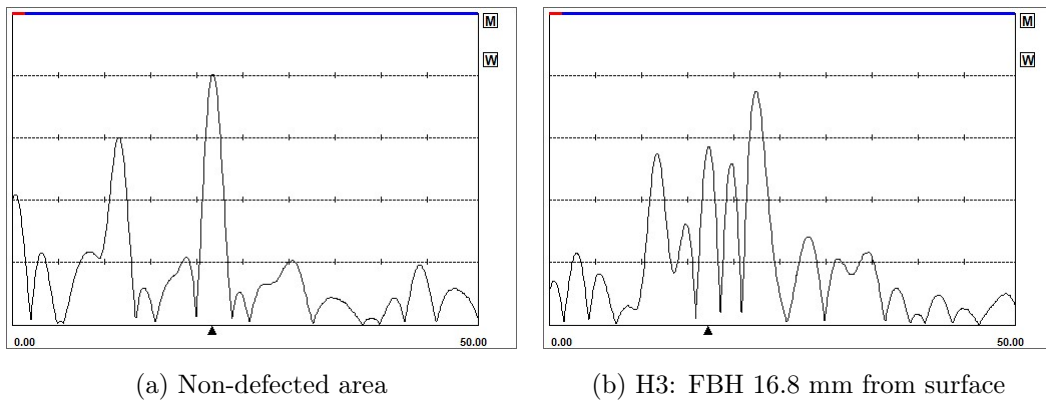
All three transducers could detect all the FBHs, and their depth could be measured. The figures below compare measurements from an intact area to an area with a FBH 16.8 mm from the inspected surface in specimen H3. Figure 5.10 show A-scans taken with 5 MHz frequency, Figure 5.11 with 2.25 MHz and Figure 5.12 with 0.5 MHz frequency, all with a thickness range on the x-axis from 0 to 50 mm

Figure 5.12: A-scan of non-defected area (a) and FBH (b) with 0.5 Mhz transducer

Inspection using the lowest frequency of 0.5 MHz gave a visibly lower level of detail in the ultrasonic A-scans due to the lower resolution of the measurements. The measured depth of the defects also deviated slightly from the actual defects position, compared to the two other transducers. Still, all defects could be located. While using 2.25 MHz gave accurate measurements with both high resolution and low amplification of the receiver signal.

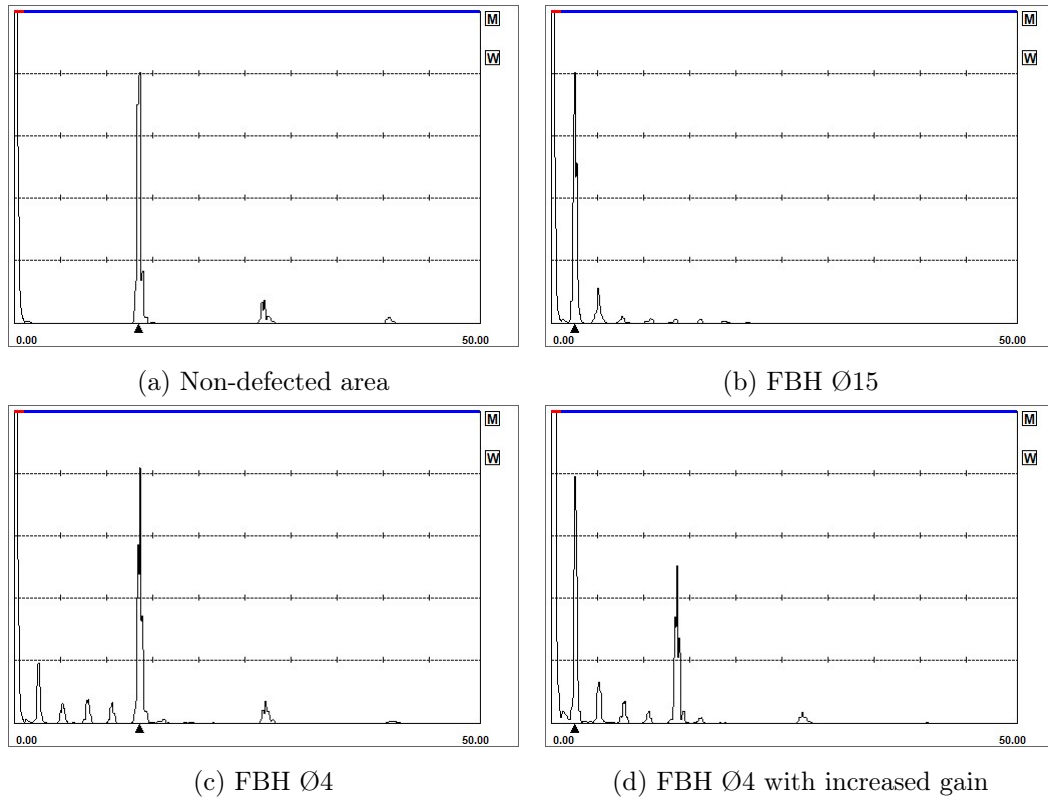
Figure 5.16 displays ultrasonic A-scans of measurements taken of the PE pipe samples using the 5 MHz transducer. The thickness range of the x-axis is 0 to 50 mm. Figure 5.16a shows an area without defects. The three peaks in the scan represent the 1<sup>st</sup>, 2<sup>nd</sup>, and 3<sup>rd</sup> echo reflected from the back wall of the specimen. The position of the first peak along the x-axis corresponds to the thickness of the specimen, while the 2<sup>nd</sup> and 3<sup>rd</sup> echo corresponds to two times and three times the specimen thickness. Figure 5.16b and 5.16c shows an area with a 15 mm and 4 mm wide FBH respectively. In 5.16c the FBH can be seen as the small peaks appearing to the left for the back wall echo of the specimen. By adjusting the initial gain of the acoustic signal, measuring the through-thickness location of the FBH is possible, shown in 5.16d.

Figure 5.16: Contact testing of PE specimens with 5 MHz transducer frequency

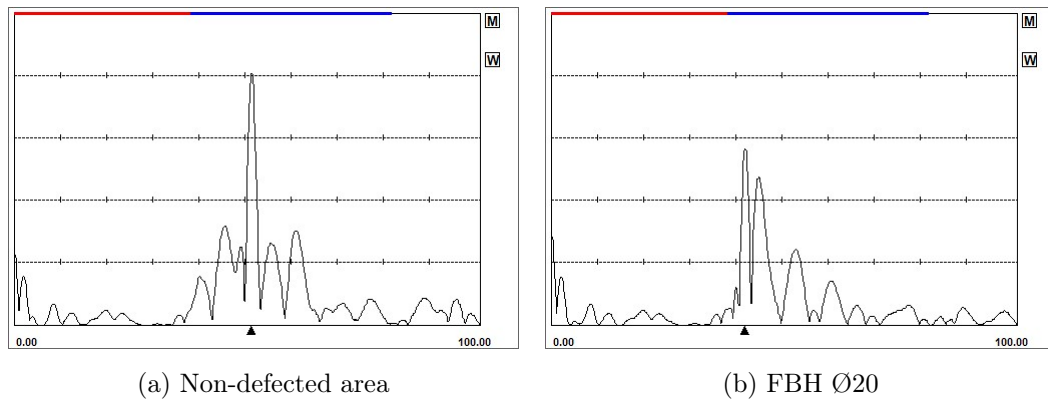
Figure 5.17a and 5.17b shows the A-scan of an area without defect and with a 20 mm wide FBH, respectively. Note that the thickness output indicated by the triangle below the x-axis of the scan equals the measured thickness of the wedge and the measured thickness of the specimen added together. The thickness range is 0 to 100 mm.

Figure 5.17: Contact testing with contoured of PE specimens with 0.5 MHz transducer frequency

A contoured wedge was applied when performing contact testing with the 0.5 MHz transducer. Proper coupling between the transducer and the specimens was obtained using the wedge and thickness measurements of the specimens with a consistent signal as possible. The largest FBHs, at Ø20 mm and Ø15 mm, could be detected with thickness measurement, while for the smaller FBHs, at Ø4 mm and Ø7 mm, no notable changes could be observed in the ultrasonic A-scan.

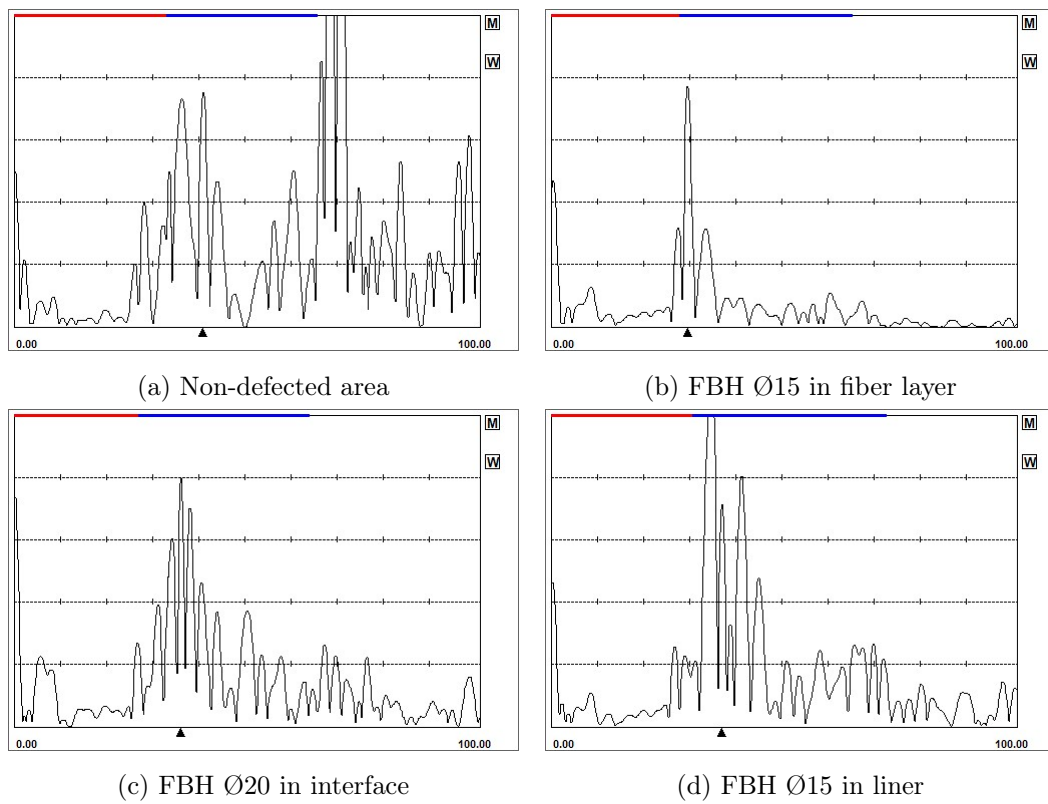
Figure 5.22 shows measurements taken performing immersion testing with 2.25 MHz transducer frequency. Figure 5.22a shows an intact area, while Figures 5.22b, 5.22c, and 5.22d, shows measurements taken at FBHs in the fiber laminte, interface, and liner respectively. Further, Figure 5.23a-5.23d show measurements from the same areas with transducer frequency 0.5 MHz. Both in Figure 5.22 and Figure 5.23 have x-axis ranging from 0 to 100 mm.

Figure 5.23: Immersion testing of GFRP specimens with 0.5 MHz transducer frequency

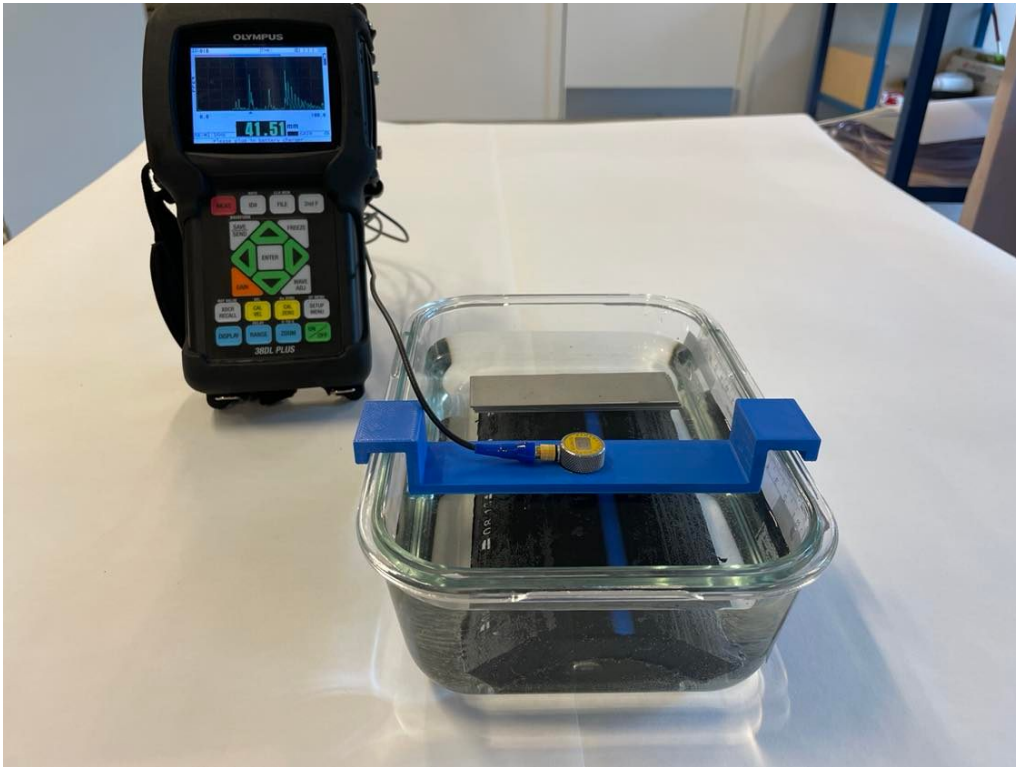
Figure 7: Test setup for immersion testing of PE pipe sample with 2.25 MHz transducer

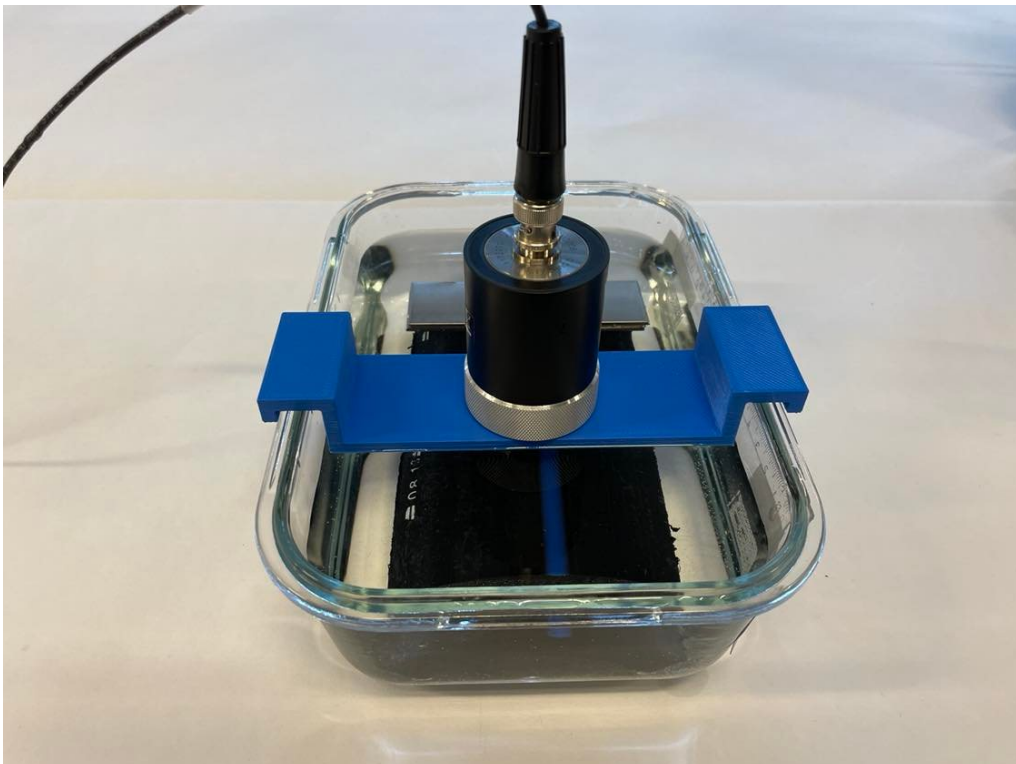
Figure 8: Test setup for immersion testing of PE pipe sample with 0.5 MHz transducer

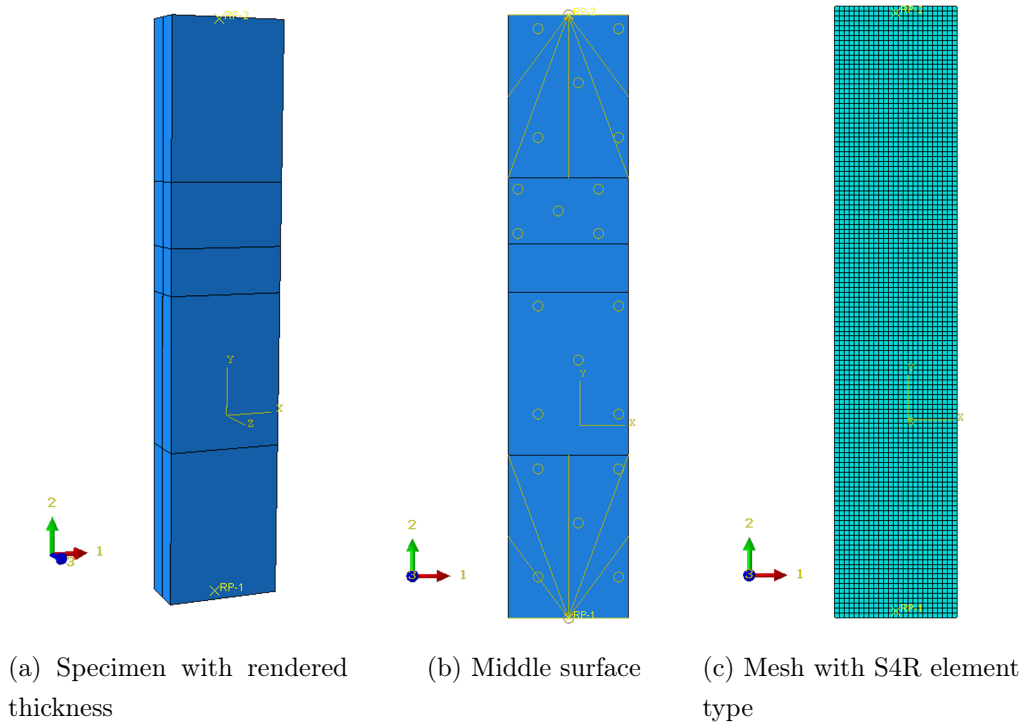
Figure 11: The specimens with delaminations are made of two shell parts connected with tie constraint expect at delaminated area.
