Effect of Air Storage on Stress Corrosion Cracking of ZK60 Alloy Induced by Preliminary Immersion in NaCl-Based Corrosion Solution

Abstract: The preliminary exposure of Mg alloys to corrosion solutions can cause their embrittlement. The phenomenon is referred to as pre-exposure stress corrosion cracking (PESCC). It has been reported that relatively long storage in air after pre-exposure to the corrosion solution is capable of eliminating PESCC. This effect was attributed to the egress of diffusible hydrogen that accumulated in the metal during pre-exposure. However, recent findings challenged this viewpoint and suggested that the corrosion solution retained within the side surface layer of corrosion products could be responsible for PESCC. The present study is aimed at the clarification of the role of hydrogen and the corrosion solution sealed within the corrosion products in the “healing” effect caused by post-exposure storage in air. Using the slow strain rate tensile (SSRT) testing in air and detailed fractographic analysis of the ZK60 specimens subjected to the liquid corrosion followed by storage in air, we found that PESCC was gradually reduced and finally suppressed with th

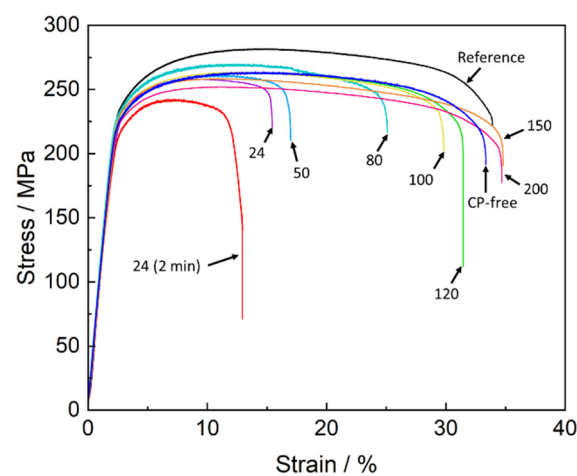
Figure 1. Stress–strain diagrams corresponding to the specimens of the ZK60 alloy which were SSRT tested in the reference and CP-free state as well as after pre-exposure to the corrosion solution followed by storage in air. Temperatures of air storage (in °C) are provided at the arrows. The duration of storage in air was 24 h, if not marked otherwise.

The mechanical testing showed that the specimens which were SSRT tested in air within a few minutes after pre-exposure to the corrosion solution demonstrated a substantial loss in strength and ductility compared to the reference specimens (Figures 1 and 2). This is typical behaviour for ZK60 embrittled by PESCC. In harmony with our previous reports [6,20,23], the removal of corrosion products resulted in complete recovery of ductility and partial recovery of strength in all specimens tested. The apparent irreversible loss of strength, which remains after the removal of corrosion products, is not related to embrittlement but rather is due to the reduction in the specimens' cross-section caused by irreversible corrosion damage [20]. It was found that similarly to the removal of corrosion products, post-exposure air storage inhibits PESCC. The efficiency of this recovery process, however, depends on the time and temperature of the storage of specimens in air. As can be seen in Figures 1 and 2, both ultimate tensile strength (UTS) and elongation to failure (EF) of the pre-exposed specimens after air storage at 24 °C for 24 h are significantly higher than those after 2 min of air storage at the same temperature. Nevertheless, even after 24 h of storage at room temperature, the pre-exposed specimens show roughly 50% loss of EF and approximately 25 MPa smaller UTS in comparison with their reference counterparts. It was found that the recovery of mechanical properties can be substantially enhanced by storage of the specimens in air at elevated temperatures. Figure 2a demonstrates that the increased temperature of air storage results in the increase in EF. The improvement in the EF value is non-monotonic and is most pronounced in the temperature range from 50 to 100 °C. After storage in air at 100 °C, the ductility loss of the pre-exposed specimens does not exceed 20%. However, at a chosen post-exposure storage time, the complete recovery of ductility can be achieved only at 150–200 °C. After such treatment, the measured EF values were the same as those of the reference specimens and the specimens with the removed corrosion product layer (referred to hereafter as CP-free specimens).

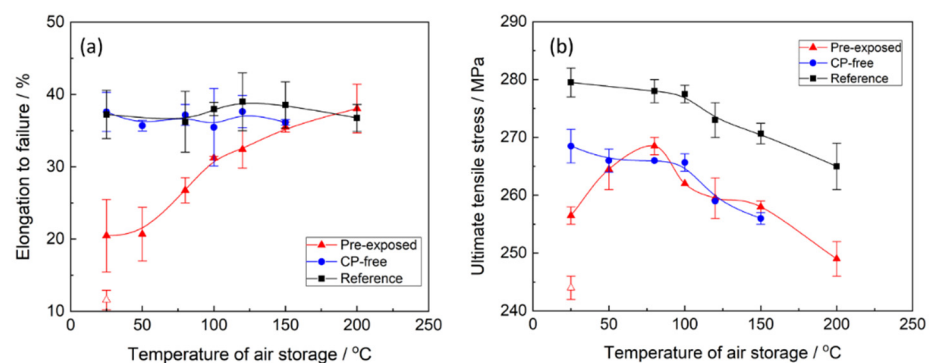
Figure 2. The effect of temperature of air storage on elongation to failure (a) and ultimate tensile strength (b) of the reference, CP-free, and pre-exposed specimens of the ZK60 alloy. The open and filled symbols indicate the pre-exposed specimens after air storage for 2 min and 24 h, respectively.

The effect of storage temperature on the strength of the pre-exposed specimens is more complex than on ductility. It can be seen from Figure 2b that UTS of the specimens monotonically grows when the storage temperature increases from 25 to 80 °C, while the further temperature increase up to 200 °C results in the non-monotonic decrease in UTS with a short plateau around 120–150 °C. To clarify whether the observed complex behaviour of strength and ductility is associated with temperature-induced microstructural changes or if it is attributed specifically to PESCC, the effect of annealing temperature on mechanical properties of the reference and CP-free specimens was investigated. One can see (Figure 2b) that the UTS of these specimens is almost unaffected by low-temperature annealing below 100 °C, while at higher temperatures, the strength decreases monotonically with temperature. Apparently, some ageing-related microstructural changes affecting the strength occur in the alloy at temperatures above 100 °C. Therefore, these changes are likely to take some part in the observed deterioration of UTS in the pre-exposed specimens subjected to air storage above 100 °C. However, the opposite trend, i.e., the increase in UTS, in the pre-exposed specimens stored in air in the temperature range below 80 °C, cannot be explained by any microstructural changes in the metallic matrix. Furthermore, the decrease

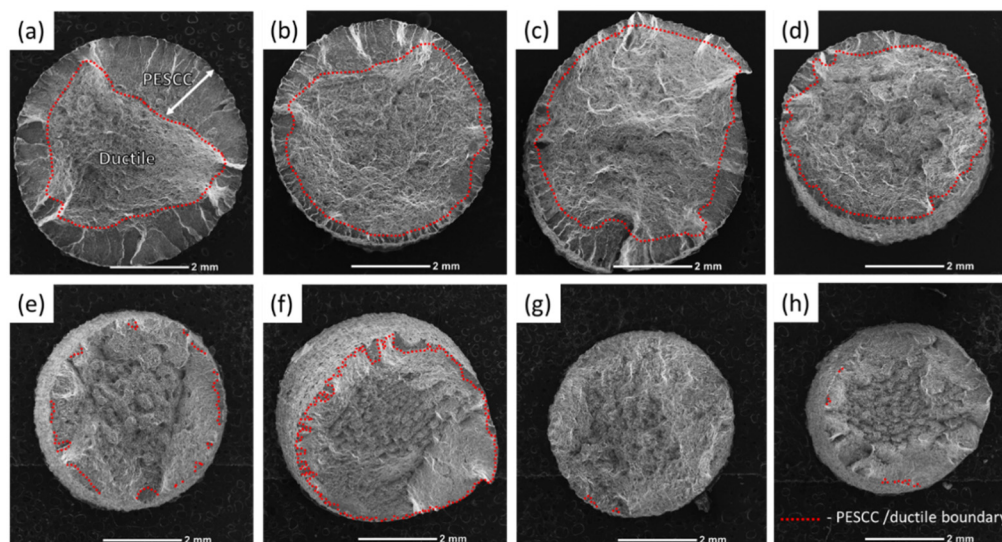
Figure 3. Whole views of the fracture surfaces of the specimens SSRT tested after pre-exposure followed by storage in air at 24 °C for 2 min (a) and by 24 h, at 24 °C (b), 50 °C (c), 80 °C (d), 100 °C (e), 120 °C (f), 150 °C (g), and 200 °C (h).

general, the increase in the time and temperature of post-exposure storage in air results in the significant reduction in both the total area of the fracture surface and the area of the PESCC zone (as well as its areal fraction with respect to the total area of the fracture surface) (c.f., Figures 3 and 4a). It also follows from Figure 3f–h that when the temperature of air storage exceeds 80 °C, the PESCC zone becomes discontinuous and is represented by several small isolated “islands” with a brittle-like morphology at the edge of the fracture surface. After post-exposure storage at 150–200 °C, the PESCC zone is almost completely absent. However, some specimens occasionally exhibited a few tiny areas with the brittle topology (e.g., Figure 3g,h) even after storage at 150–200 °C. Despite the generally increasing apparent ductility of the fracture surface with the temperature of post-exposure storage, one can notice the anomalous increase in the fraction of the brittle relief on the fracture surface after storage at 120 °C (Figure 4a). As was shown above, the decrease in strength was supposedly associated with the microstructural changes occurring at the same temperature in the reference specimens.

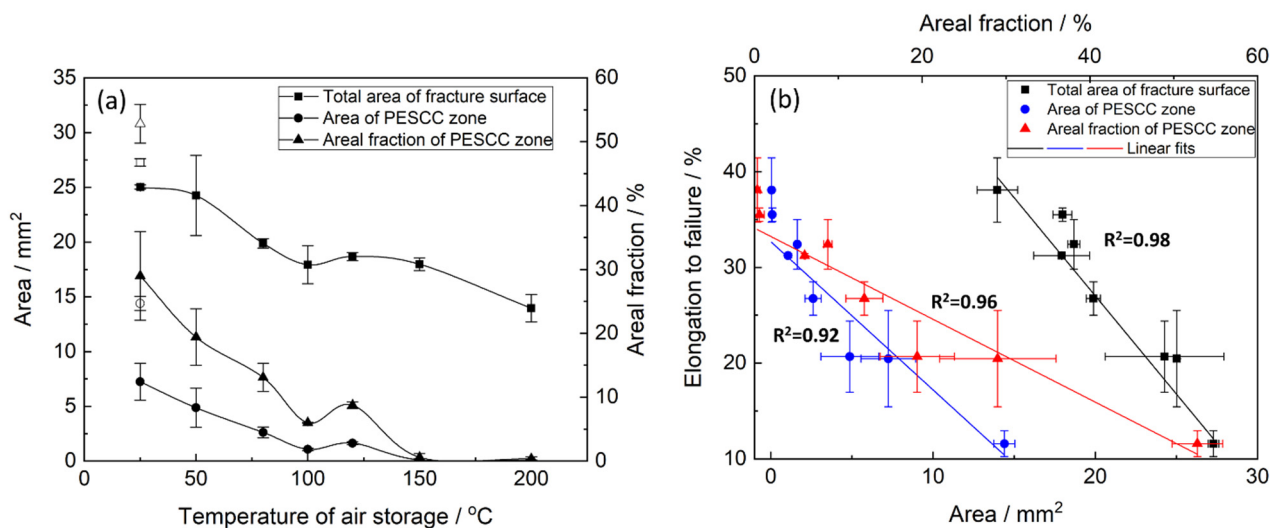
Figure 4. The effect of temperature of post-exposure storage on the areal fractographic characteristics of the ZK60 specimens tested after pre-exposure followed by air storage (a) and the correlation between these characteristics and the elongation to failure of the specimens (b). The open and filled symbols correspond to the pre-exposed samples subjected to air storage for 2 min and 24 h, respectively.

The fractographic observations corroborate well with the results of mechanical testing showing the increasing ductility of the pre-exposed specimens due to the suppression of PESCC by post-exposure storage in air. The confident linear correlation with Pearson’s $R^2 > 0.91$ is found between EF and the total area of their fracture surface as well as the area of the PESCC zone and its areal fraction (Figure 4b), thus confirming the link between the propagation of PESCC and the material’s embrittlement unveiled by SSRT testing in ambient conditions.

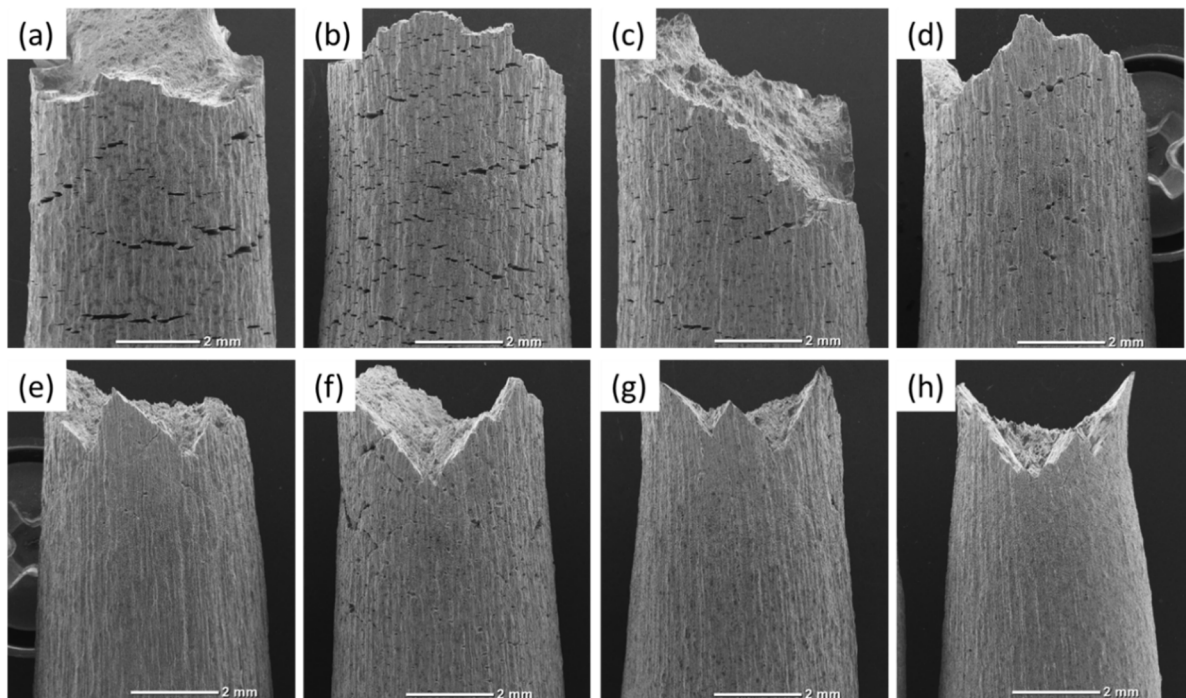
Figure 5. SEM images of side surfaces of the specimens SSRT tested after pre-exposure followed by air storage at 24 °C for 2 min (a), and by 24 h at 24 °C (b), 50 °C (c), 80 °C (d), 100 °C (e), 120 °C (f), 150 °C (g), and 200 °C (h).

The side surface observations in combination with the fractographic analysis show that the PESCC zone is formed due to the propagation of multiple cracks nucleating at the side surface along the whole gauge part of the specimens (c.f., Figures 5 and 6). These cracks coalesce during their propagation towards the specimen’s centre as well as in the transverse direction. The coalescence of the cracks occurs in a stepwise manner by mutual axial shearing of the two halves of the fracture surface. The location of the cracks’ nucleation sites on the peripheral part of the fracture surface corresponds to relatively flat regions separated from each other by the axial shearing steps. As an example, the shearing steps and the crack initiation sites between them are indicated by the inclined red and vertical white arrows, respectively, in Figures 7a and 8a. As is seen in the SEM side surface images in Figures 5 and 6, the number and size of the side surface cracks decrease considerably with the temperature of post-exposure storage. This visual observation is testified by the results of the quantitative fractographic analysis provided in Figure 9a. According to these results, the number of cracks’ nucleation sites on the fracture surface increases considerably along with the storage temperature. Furthermore, as the temperature increases, the side surface cracks become shorter in the transverse direction and acquire a more ductile appearance, as is indicated by their less sharp and more round geometry (c.f., Figure 6). It follows from Figure 5a,b and Figure 9a that the increase in the time of post-exposure storage in air at 24 °C from 2 min to 24 h results in the remarkable growth in the number of side surface cracks and the cracks’ nucleation sites on the fracture surface. Thus, the number of cracks decreases with temperature and increases with the time of air storage. It is worth noting that, similarly to the area of the PESCC zone, the number of the cracks’ nucleation sites exhibits a sharp increase after air storage at 120 °C (Figure 9a), whereas just a few cracks can be found in the specimens subjected to holding in air at 150–200 °C.

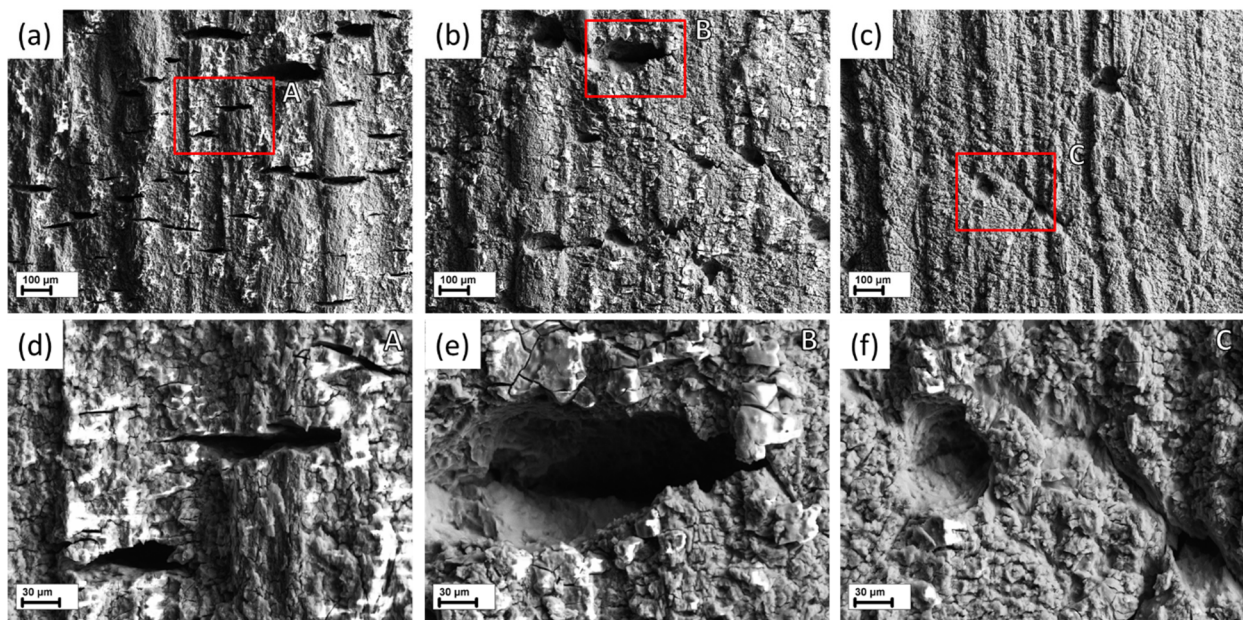
Figure 6. The appearance of the side surface cracks in the specimens SSRT tested after pre-exposure followed by 24 h of air storage at: 24 °C (a,d), 80 °C (b,e), and 100 °C (c,f). The magnified SEM images of the regions outlined by the frames A–C in (a–c) are represented in (d–f) to show the microscopic characteristics of side surface cracks.

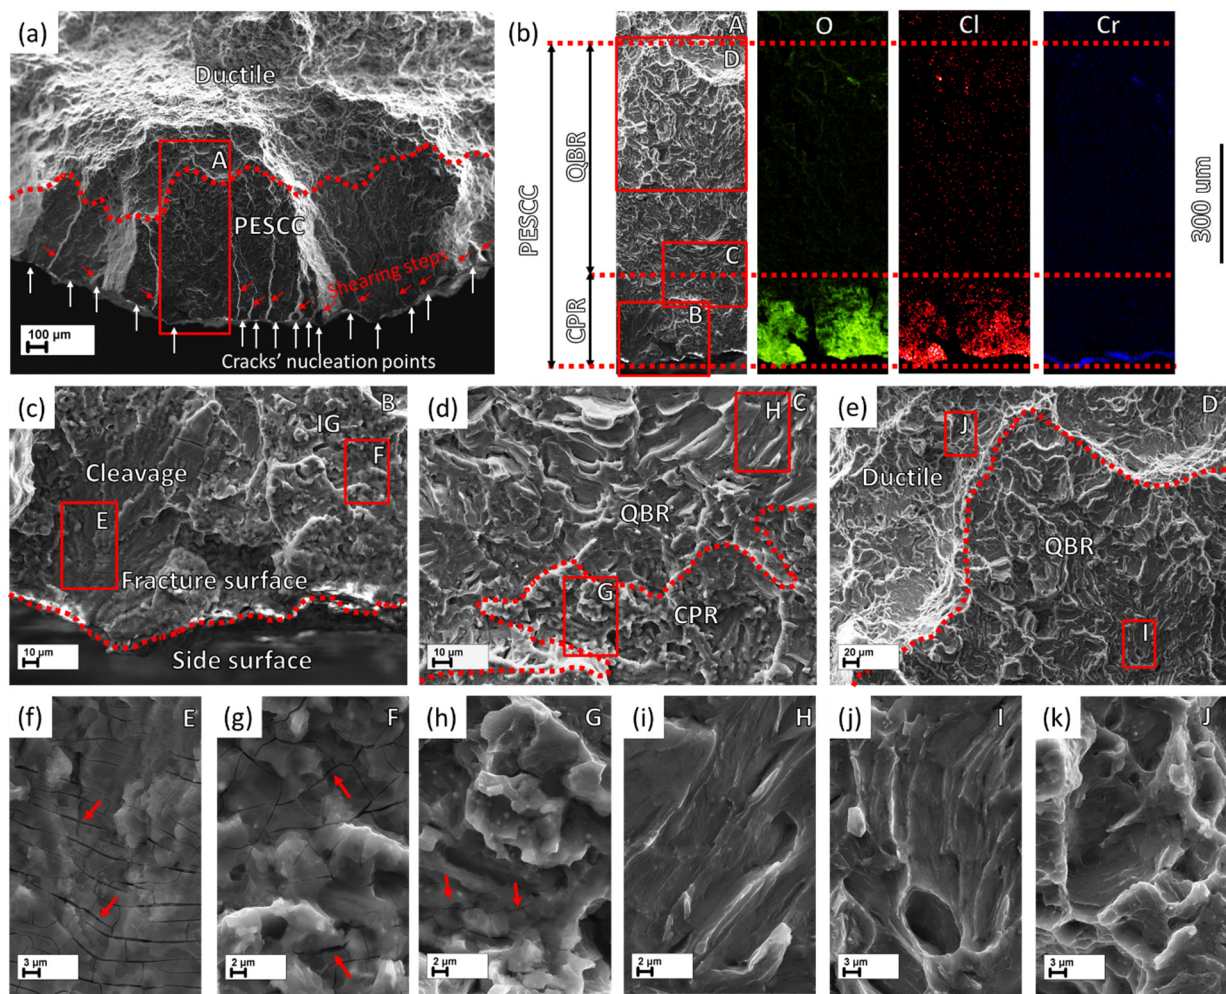
Figure 7. The fractographic features of the specimen SSRT tested after pre-exposure followed by 24 h of air storage at 24 °C: (a) the peripheral region of the fracture surface with PESCC zone delimited from the ductile region by the dotted curve. The vertical white and inclined red arrows indicate the nucleation points of the multiple cracks and the shearing ligaments between them, respectively; (b) the magnified SEM image with elemental EDS maps of the region outlined by the frame A in (a) showing the boundaries of the specific regions; (c) the magnified SEM image of the region outlined by the frame B in (b) showing the crack's nucleation part of the corrosion product region (CPR) characterised by cleavage and intergranular facets and corrosion products; (d) the magnified SEM image of the region outlined by the frame C in (b) showing the transition region between CPR and the quasi-brittle region (QBR); (e) the magnified SEM image of the region outlined by the frame D in (b) showing the transition region between QBR and the ductile region; (f–k) the magnified SEM images of the regions outlined by the frames E–J in (c–e) showing the characteristic morphologies of the specific regions.

The PESCC zone in all pre-exposed specimens is composed of two distinct regions referred to as the corrosion product region (CPR) and the quasi-brittle region (QBR), which are seen one after the other from the edge of the specimen to the centre (Figures 7 and 8). The corrosion product region starts to develop immediately at the edge of the fracture surface and is covered by the cracked crust of corrosion products (Figure 7b,c,f–h and Figure 8b,c,f,g). It has been shown recently that the intergranular cracking assisted by the corrosion solution sealed in the side surface layer of corrosion products can be responsible for the formation of the corrosion product region on the fracture surface [6]. Thus, the specific “melted” relief, which is observed within this region under the crust of corrosion products (Figure 7g,h and Figure 8f,g), is probably composed of fine intergranular facets attacked by corrosion. In addition, the large transgranular cleavage facets exhibiting corrosion damage can also be occasionally distinguished within the corrosion product

region on the fracture surface (Figure 7c,f). The thickness of the corrosion product layer on the fracture surface decreases with the distance from the edge of the fracture surface towards the following quasi-brittle region, as is firmly evidenced by the EDX analysis (Figures 7b and 8b). Additionally, the EDX elemental map obtained for the PESCC zone undeniably shows that this layer is strongly enriched with oxygen and chlorine. It should be stressed that the concentration of these elements decreases progressively along the crack path within the corrosion product region; however, it drops down abruptly to the negligible level at the boundary between the corrosion products and quasi-brittle regions. Thereby, the latter region is always completely free of traces of aggressive elements. Alternatively, the CPR–QBR boundary can be reliably distinguished by the morphological features in the SEM images with no aid from the EDX. The characteristic microcracks, such as those indicated by the arrows in Figures 7f–h and 8f,g, are found to be indispensable attributes of the crust of corrosion products. As such, they serve as independent markers of corrosion products on the fracture surface. The size and density of these microcracks are gradually reduced with the thickness of the corrosion product layer throughout the respective region (see Figures 7f–h and 8f,g). However, the cracks cease to appear in the quasi-brittle region beyond the CPR–QBR boundary (c.f., Figures 7i–k and 8h–j). Moreover, in contrast to the region that has been covered by corrosion products, the morphology of the quasi-brittle region is distinctively characterised by various tear ridges, small dimples, and fluted facets (Figure 7j,i and Figure 8h,i). These features indicate the appreciable contribution of plastic deformation to the crack growth mechanism.

Notably, the CPR–QBR boundary recognised by the topological features on SEM images matches precisely with that distinguished by the EDX analysis (Figures 7b and 8b). Thus, both methods can be used to characterise and identify two morphologically distinct regions. Apparently, the secondary electron imaging is less laborious in comparison with the EDX mapping. That is why the former was prioritised for further measurements. The length of the corrosion product zone, l_{CPR} , as well as the length of the quasi-brittle region, l_{QBR} , and the PESCC zone, l_{PESCC} , were measured for each crack within the PESCC zone, as is schematically shown in Figures 7b and 8b. The average values of these characteristics were calculated for the specimens tested under specific experimental conditions. The effect of air storage temperature and time on the measured fractographic properties is

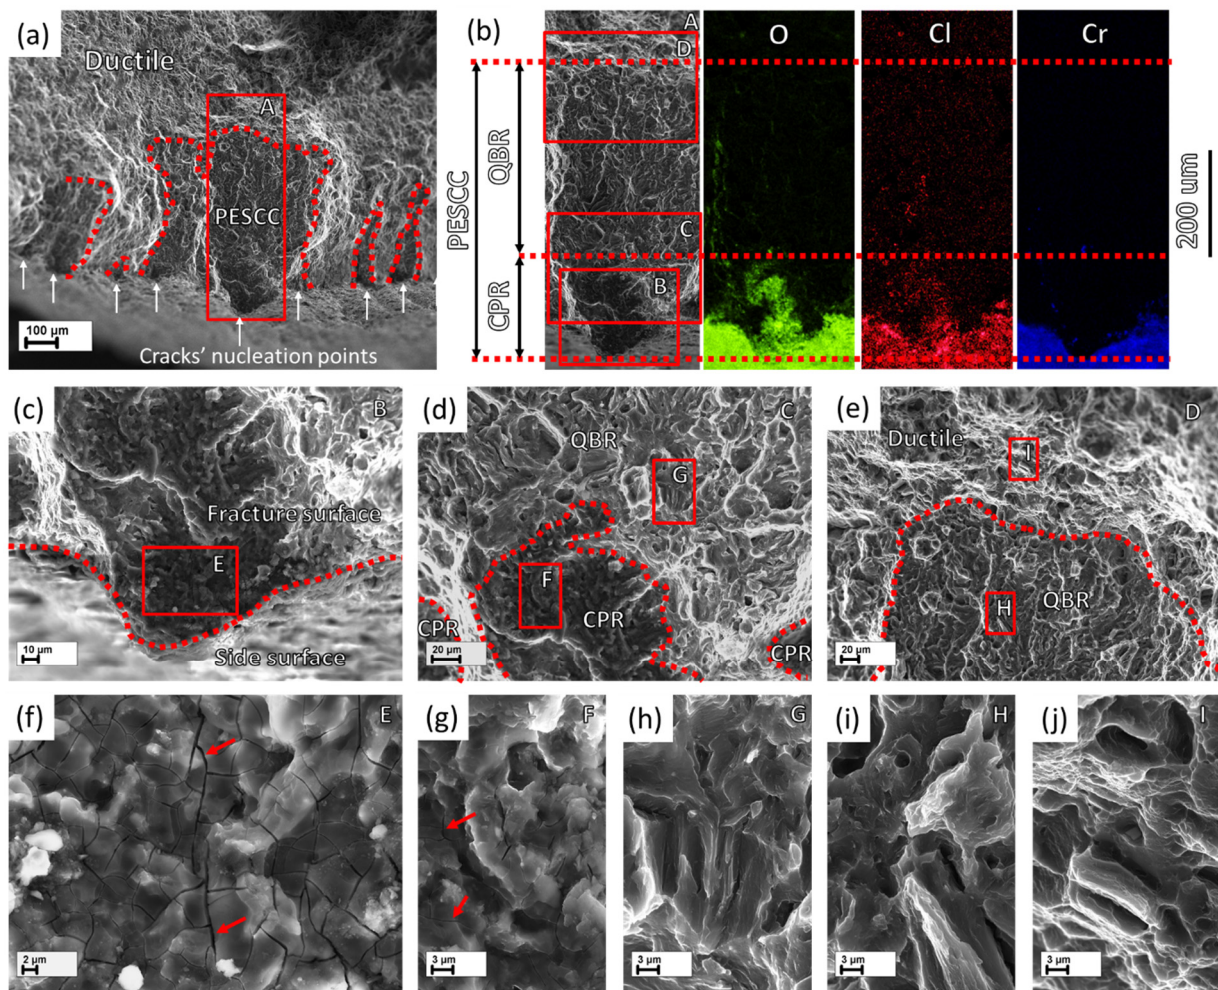
Figure 8. The fractographic features of the specimen SSRT tested after pre-exposure followed by 24 h of air storage at 80 °C: (a) the peripheral region of the fracture surface with isolated islands of PESCC zone delimited from the ductile region by the dotted curve. The vertical white arrows indicate the nucleation points of the multiple cracks; (b) the magnified SEM image with elemental EDX maps of the region outlined by the frame A in (a) showing the boundaries of the specific regions; (c) the magnified SEM image of the region outlined by the frame B in (b) showing the crack's nucleation part of CPR; (d) the magnified SEM image of the region outlined by the frame C in (b) showing the transition region between CPR and QBR; (e) the magnified SEM image of the region outlined by the frame D in (b) showing the transition region between QBR and ductile region; (f–j) the magnified SEM images of the regions outlined by the frames E–I in (c–e) showing the morphologies characteristic of the specific regions.

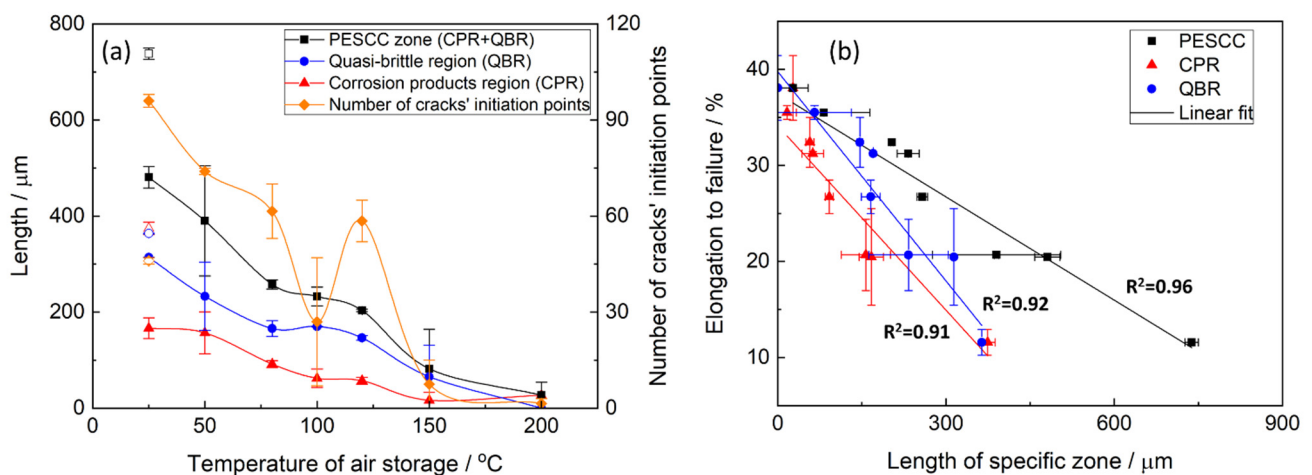
Figure 9. The effect of temperature of post-exposure storage on the linear fractographic characteristics of the ZK60 specimens tested after pre-exposure followed by air storage (a) and the correlation between these characteristics and the elongation to failure of the specimens (b). The open and filled symbols correspond to the pre-exposed samples subjected to air storage for 2 min and 24 h, respectively. CPR—the region covered by the crust of corrosion products, QBR—the quasi-brittle region free of corrosion products.

illustrated in Figure 9a: the lengths of all specific zones, including the corrosion product region, decrease significantly with temperature and time. In particular, the corresponding reduction in l_{CPR} is also evidently illustrated by the EDX oxygen maps shown in Figure 10. The obtained results corroborate the conclusions made in the previous study that the corrosion products on the fracture surface are produced during the SSRT testing. Indeed, if the corrosion product region was formed during pre-exposure, the size of this region would not be affected by subsequent air storage. It is worth noting that reduction in l_{CPR} becomes notable at the temperatures of air storage higher than 50 °C, while the l_{QBR} considerably decreases after storage at a lower temperature. In the temperature range of 100–120 °C, the plateau followed by the further decay up to near complete vanishing at higher temperatures of air storage is seen on the l_{CPR} , l_{QBR} , and l_{PESCC} curves in Figure 9a. It is established that the lengths of all three characteristic regions, including the corrosion product region, correlate well with the elongation to failure of the specimens embrittled by pre-exposure to the aggressive environment (Figure 9b). This finding suggests the crucially active role of the corrosion solution sealed/stored within the side surface layer of corrosion products in the mechanism of PESCC.

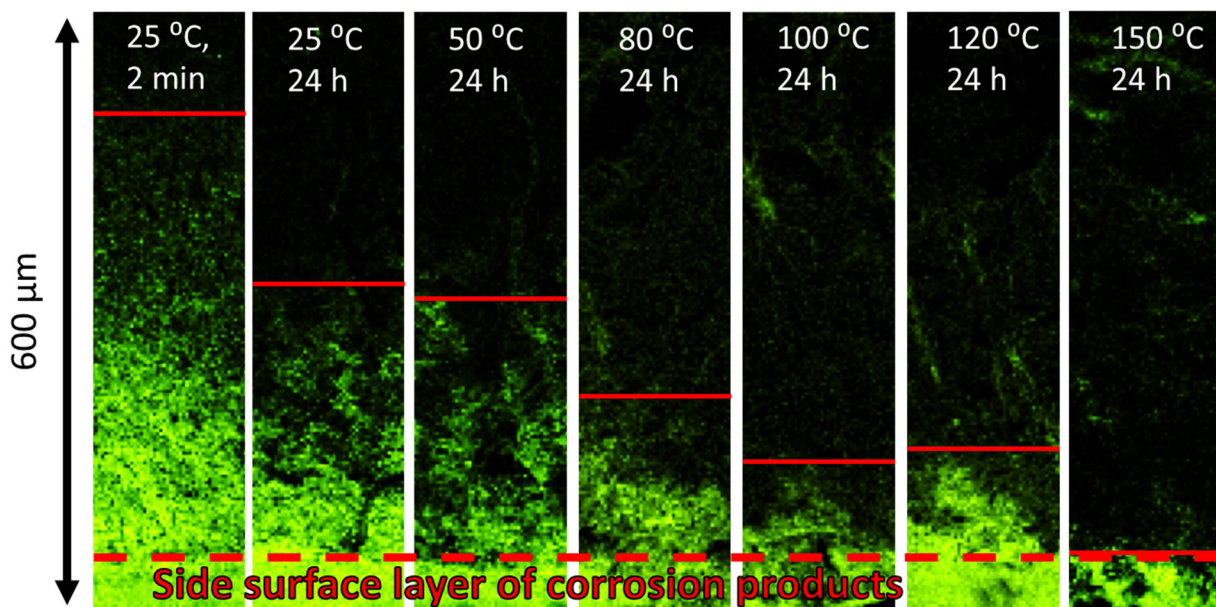
Figure 10. The distribution of oxygen on the peripheral part of the fracture surface for the specimens SSRT tested after pre-exposure followed by storage in air at different temperatures and durations. The red solid horizontal lines show the boundary between the CPR and QBR. The dashed line indicates the boundary between the side and fracture surfaces.

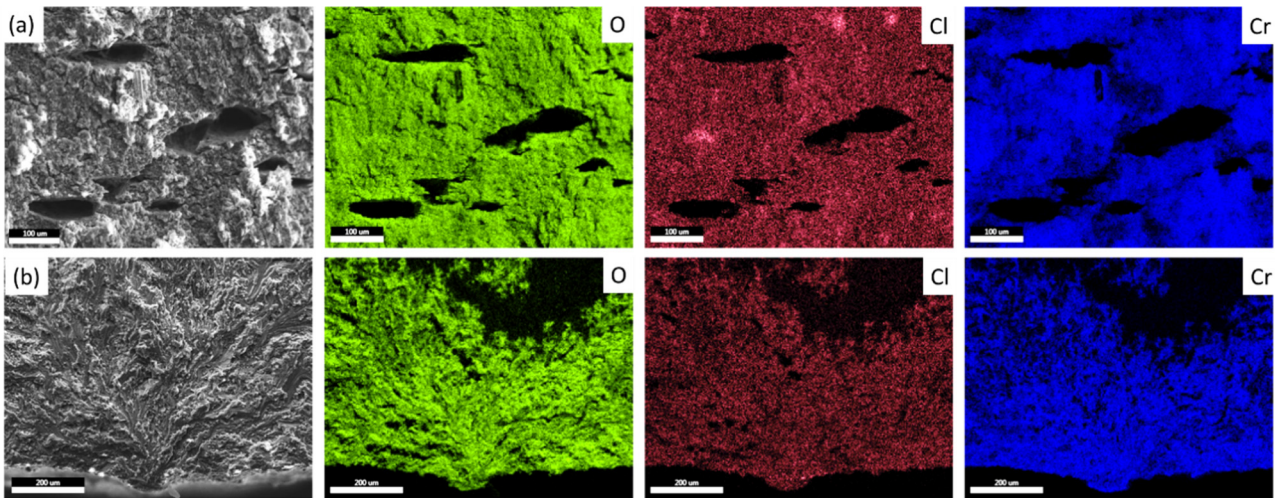
Figure 11. The SEM images and elemental maps obtained by EDX from the side surface of the specimen SSRT tested after pre-exposure in the 4% NaCl + 4% $K_2Cr_2O_7$ corrosion solution (a) and from the fracture surface of the specimen SSRT tested in the same corrosion solution (b).

As has been mentioned, the corrosion products on the fracture surface can be associated with the corrosion solution, which is likely sealed within the corrosion product layer on the side surface. In conjunction with this suggestion, it is important to note that according to the results of EDX analysis, the corrosion product region on the fracture surface almost does not contain chromium (Figures 7b and 8b), which is, however, abundantly present in the side surface layer of corrosion products (Figure 11a). This feature of the corrosion product region also drastically differs the fracture surface of the tensile tested pre-exposed specimens from that of the specimens which have been SSRT tested right in the corrosive solution containing chromates. The EDX maps obtained from the fracture surface of the specimen SSRT tested in the 4% NaCl + 4% K₂Cr₂O₇ solution in the previous study [19] are provided in Figure 11b. It is clear that the fracture surface of this specimen demonstrates high concentrations of Cl, O, and Cr. This finding implies that the corrosion solution responsible for the formation of corrosion products on the fracture surface of the
