# Influence of Hot-Dip Galvanization on the Fatigue Performance of High-Strength Bolted Connections

In the present work, the influence of hot-dip galvanization (HDG) on the fatigue behaviour of high-strength bolted details is investigated through a set of 15 constant-amplitude tests. Cyclic behaviour of coated specimens is hence compared against results for unprotected samples drawn from literature, i.e., both with reference to neutral and aggressive exposure conditions. Namely, while behaviour of coated samples is moderately inferior as respect to uncoated ones in dry air (−6% in terms of characteristic fatigue strength, probability of failure  $P_F = 5\%$ , confidence interval  $CI = 75\%$ ), their performance still complies with European normative requirements for double covered joints, and galvanization proves to be highly effective when corrosion is likely to occur (with a characteristic strength increase of [+12%; +52%]). Finally, fractography analyses on both uncoated and coated specimens were performed, suggesting that hydrogen embrittlement may play a role in reducing fatigue strength of coated joints, that is, especially within the high-cycle fatigue regime.

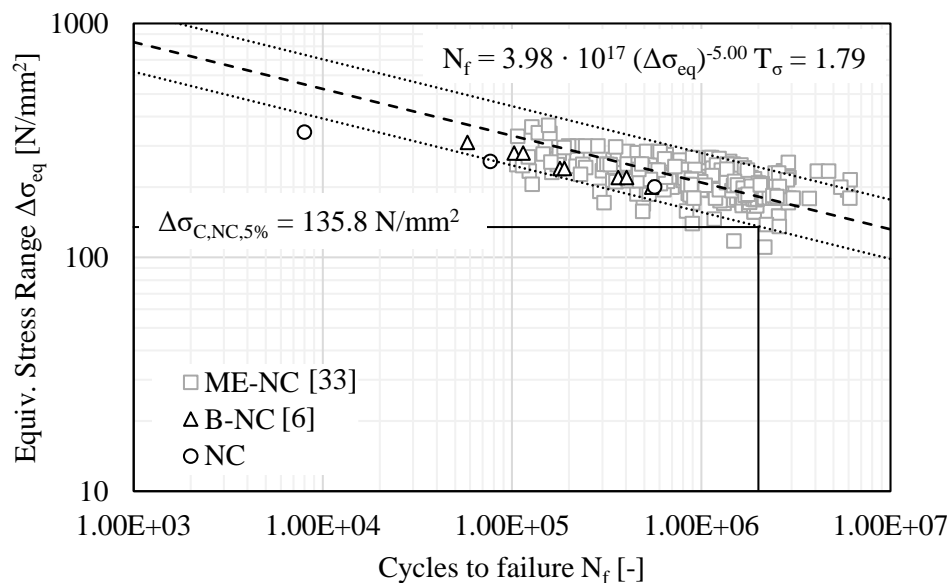
Figure 4 – Summary of experimental and literature results for uncoated specimens (NC: experimental tests; B-NC: Berto et al. [6]; ME-NC: Maljaars & Euler [33]).

Literature results are summarized in Figures 4-5 and Table 3 in terms of Wöhler curves and statistical assessment of experimental outcomes ( $\Delta\sigma_{C,PF}$ ,  $m$ , SR). For the sake of comparison, results of experimental tests illustrated in Section 2.2 are reported as well.

As noticeable in Figure 4, experimental outcomes (see Section 2.2) and results from Berto et al. [6] for uncoated samples can be ascribed to the same scatter band identified by data reported in Maljaars & Euler [29], i.e., with the only exception of NC02 ( $\Delta\sigma = \Delta\sigma_{eq} = 250$  N/mm<sup>2</sup>,  $N_f = 7996$ ), which slightly falls outside the 5% lower bound. This plausibly descends from non-negligible plasticity phenomena, as  $\Delta\sigma > f_y$  for NC02. Remarkably, in spite of the multiple configurations considered (i.e., lap-shear and butt-joints, featuring 1 ÷ 11 bolts and 3 ÷ 5 plates having variable thickness –  $t = 8.5 \div 15$  mm – and steel grade [6, 33, 42-49]), the scatter ratio for NC fatigue data is reasonably low ( $T_{\sigma,NC} = 1.79$ ).

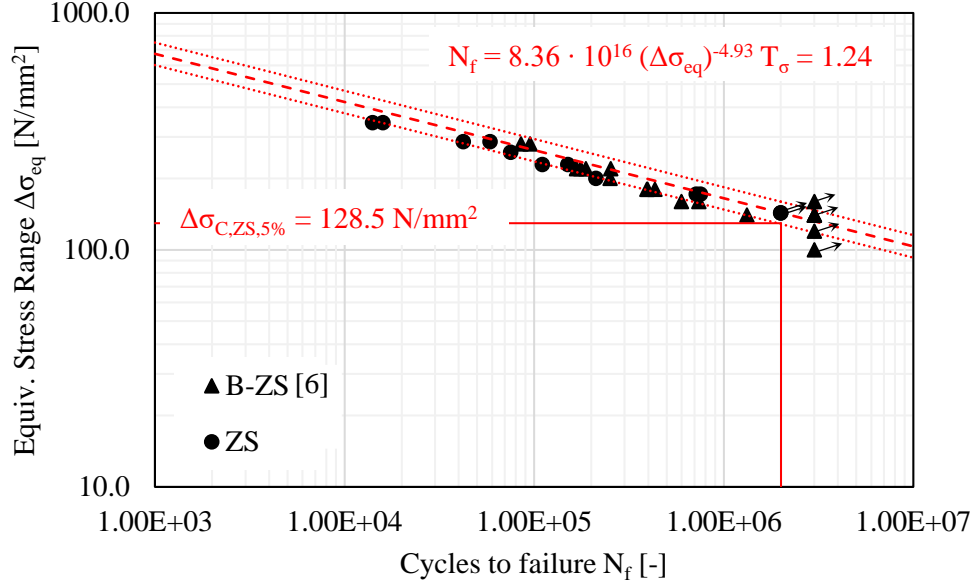
Figure 5 – Summary of experimental and literature results for coated & blasted specimens (ZS: experimental tests; B-ZS: Berto et al. [6]).

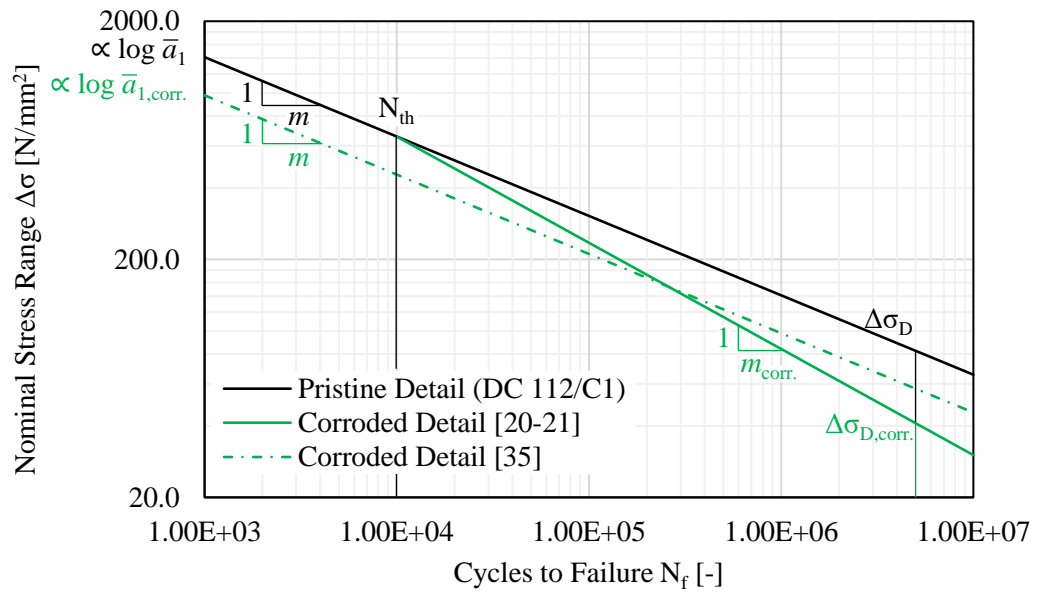
Figure 6 – Corrosion-depending corrections for Wöhler curves according to Adasooriya et al. [20-21] and DNVGL-RP-C203 [35].

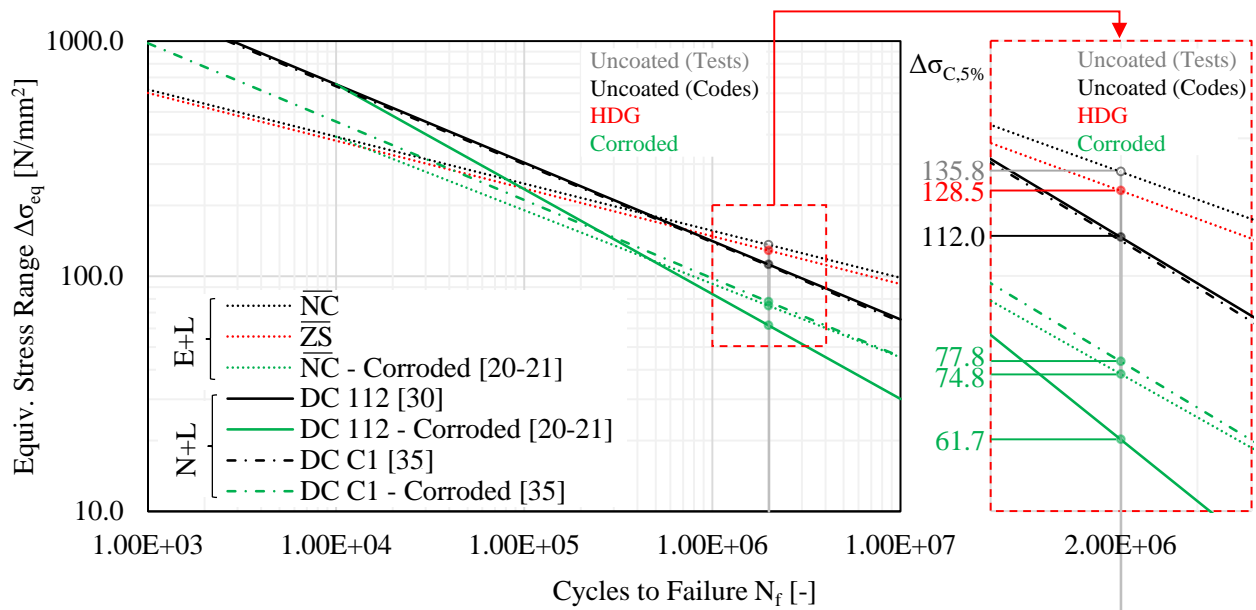
Figure 7 – Corrosion-depending corrections for Wöhler curves according to Adasooriya et al. [20-21] and DNVGL-RPC203 [35] (E+L: Experimental tests + Literature corrections; N+L: Normative provisions + Literature corrections; for the sake of simplicity, slope variation for  $N_f \geq 5 \cdot 10^6$  is omitted).

Figure 7 depicts the comparison of fatigue performance of uncoated, coated & blasted and corroded high-strength bolted details in terms of relevant characteristic Wöhler curves ( $CI = 75\%$ ,  $P_F = 5\%$ ). For the sake of clarity, Wöhler curves related to all considered uncoated (NC + ME-NC + B-NC) and coated & blasted (ZS + B-ZS) specimens are hence referred as  $\overline{NC}$  and  $\overline{ZS}$ , respectively.

In order to account for the detrimental effect of corrosion on unprotected specimens, three alternative strategies were assumed, namely: *i*) correction of the  $\overline{NC}$  curve [33] by means of expressions proposed by Adasooriya et al. [20-21] (Figure 7, green dotted curve,  $\Delta\sigma_{C,5} = 74.8 \text{ N/mm}^2$ ), *ii*) correction of normative curves (DC 112/C1 [30-31]) according to Adasooriya et al. [20-21] (Figure 7, green solid line,  $\Delta\sigma_{C,5} = 61.7 \text{ N/mm}^2$ ), *iii*) introduction of the corrosion-affected curve for DC C1 according to DNVGL-RP-C203 [35] recommendations (Figure 7, green dash-dotted line,  $\Delta\sigma_{C,5} = 77.8 \text{ N/mm}^2$ ).

Interestingly, while  $\overline{ZS}$  and  $\overline{NC}$  curves are almost parallel to each other, the corrected  $\overline{NC}$  curve is significantly steeper ( $m = 5.00, 4.93$  and  $3.20$ , respectively, see Table 4); hence, fatigue performance of ZS specimens can be deemed as superior as respect to corroded samples within the entire range of applicable stress ranges. While the slope of other corrected curves significantly differs from the  $\overline{ZS}$  regression line ( $m = 2.24 \div 3.20$ ), fatigue strength of coated & blasted bolted joints still exceeds the resistance of corroded details in high-cycle fatigue (HCF) conditions ( $\approx N_f > 10^5$ , see Figure 7), i.e., the most relevant regime for practical civil engineering purposes [2, 41, 54].
