# Effect of heat treatment and defects on the tensile behavior of a hot work tool steel manufactured by laser powder bed fusion

defects, heat treatment, laser powder bed fusion, mechanical properties, tool steel

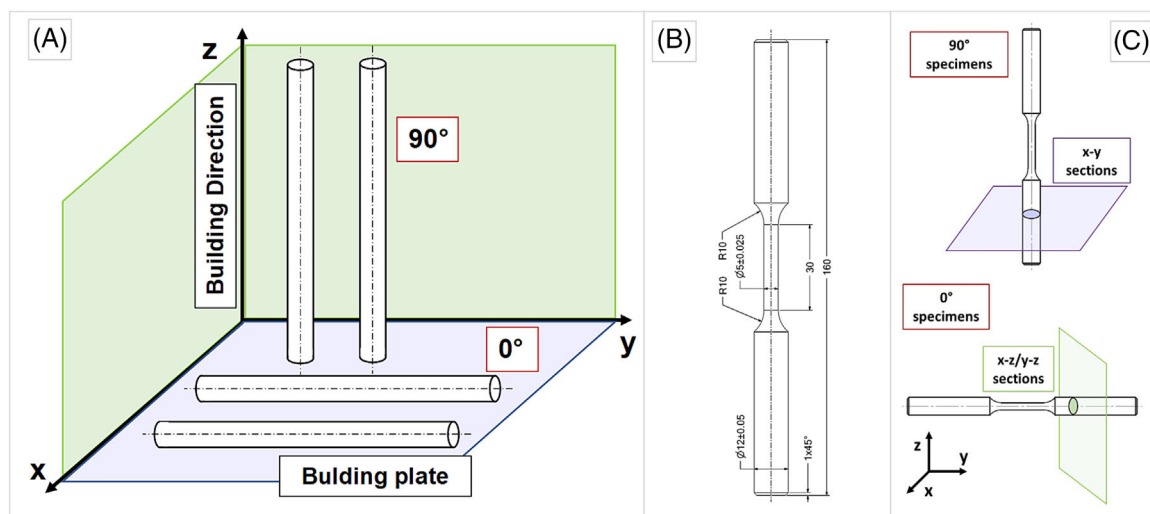
**FIGURE 1** Schematic representation of bars orientation during the LPBF process (A); geometry (dimensions in mm) of tensile specimens machined from the annealed LPBF bars (B); orientation of metallographic sections extracted from 90° and 0° specimens (C). [Colour figure can be viewed at [wileyonlinelibrary.com](https://onlinelibrary.wiley.com/doi/10.1111/ffe.14025)]

analyses were performed on cross-sections extracted in the transverse direction respect to the specimen axis. Note that, as clarified in Figure 1C, the sections extracted from 90° specimens are parallel to the x–y plane of LPBF laser scanning/building plate, while the ones extracted from 0° specimens are normal to the x–y plane (parallel to x–z/y–z planes). Samples for metallographic analysis were prepared following the standard procedure defined in the ASTM E3–11 standard composed of hot mounting, grinding with abrasive papers up to 1,200 grit and polishing with diamond suspensions (9 µm, 3 µm, 1 µm). Low magnification images of polished sections were acquired using a Zeiss Axio Imager A.1M optical microscope (OM) and processed using the ImageJ v. 1.52a open-source software to analyze defects. Phase identification was performed using the Pananalytical X'Pert HighScore

Vickers hardness (HV) indentations were performed according to ISO 6507-1:2018 using a 30 Kg load on the same specimens used for metallographic analyses. Tensile tests were performed according to the ISO 6892-1:2019 standard using a servo-hydraulic testing machine, on the specimens shown in Figure 1B, for the determination of Young's modulus (E), 0.2% proof strength ( $R_{p0.2}$ ), ultimate tensile strength (UTS), elongation after fracture (A%), and reduction of area after fracture (Z%). Three specimens were tested for each condition defined in Table 2. The strain hardening exponent (n) was calculated according to ISO 10275. Analysis of variance (ANOVA) tests with  $\alpha = 0.05$  were performed on density, hardness, and tensile data using the MS Excel software to assess the effect of the investigated conditions, in terms of heat treatment and building direction, from a statistical standpoint. Fracture surfaces of tensile

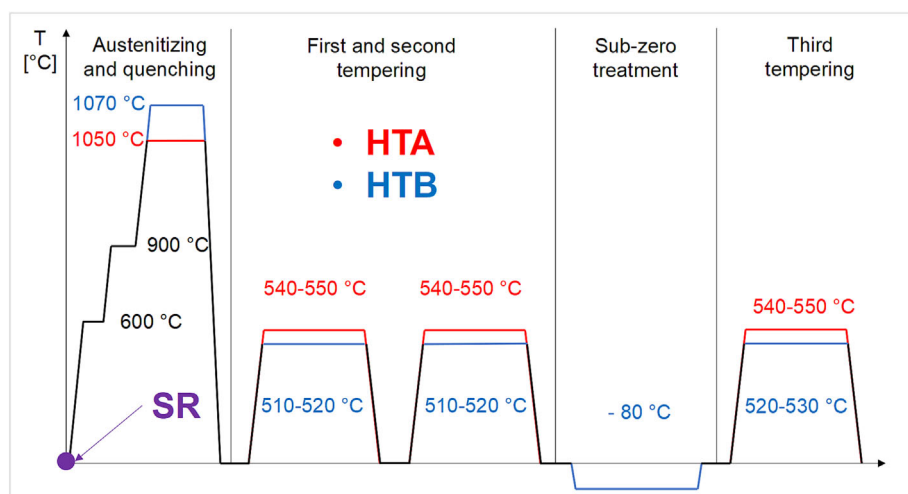
**FIGURE 2** Schematic representation of heat treatments HTA and HTB. [Colour figure can be viewed at [wileyonlinelibrary.com](https://onlinelibrary.wiley.com/doi/10.1111/ffe.14025)]

HTA and HTB treatments are schematically depicted in Figure 2. HTA included: (i) austenitizing at 1050°C in vacuum (after a double preheating at 600°C and 900°C), (ii) quenching in nitrogen gas, and (iii) triple tempering at 540–550°C. Heat treatment HTB, instead, consisted of: (i) austenitizing at 1070°C in vacuum (after the same double preheating), (ii) quenching in nitrogen gas, (iii) double tempering at 510–520°C, (iv) a sub-zero treatment at –80°C, and (v) final tempering at 520–530°C. HTA represents the standard quenching and multiple tempering treatment performed on the ESR-produced counterpart of the steel, with identical composition, previously investigated by the authors in ref.<sup>11</sup> Instead, the HTB treatment was designed following previous research activities performed by the authors, published in Morri et al.,<sup>44</sup> which indicated higher hardness, tensile strength and ductility, toughness, and fatigue strength for a PM-produced cold work tool steel subjected to a heat treatment featuring higher austenitizing temperature, lower tempering temperatures, and a –80°C sub-zero step compared to the one subjected to the typical quenching and multiple tempering treatment.

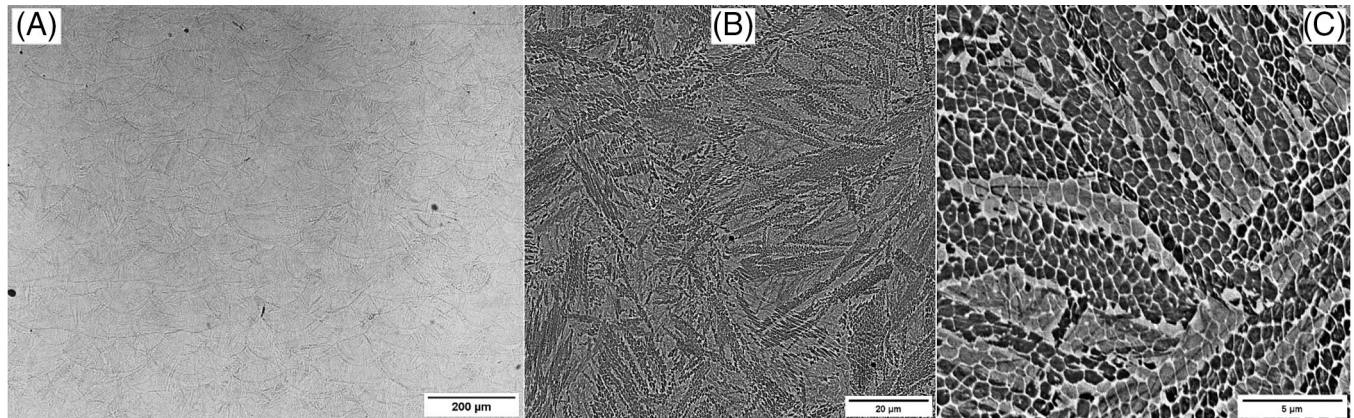
**FIGURE 4** Microstructure in the SR condition: low magnification OM images (A) and back-scattered SEM images at different magnifications (B,C). [Colour figure can be viewed at [wileyonlinelibrary.com](http://wileyonlinelibrary.com)]

Figure 4 shows the microstructure in the SR condition, i.e., prior to the application of HTA or HTB heat treatments. As can be noted, in the SR condition, the steel exhibited the typical *hierarchical* structure of LPBF manufactured tool steels,<sup>16,20,31–33</sup> featuring melt pool borders (Figure 4A), and a cellular sub-structure resulting from alloying segregation during the rapid solidification (Figure 4C). At intermediate magnifications (Figure 4B), the microstructure appeared fully bainitic, in agreement with the prolonged isothermal exposure at 400°C during the LPBF process. In fact, as reported in Huber et al.,<sup>45</sup> the use of a platform pre-heating temperature higher than  $M_s$  suppresses martensite formation and promotes the isothermal transformation in bainite during the manufacturing of subsequent layers. XRD analyses (Figure 5) indicated  $\alpha$ -ferrite as the only phase in the SR condition, with no  $\gamma$ -austenite nor alloying carbides resulting from the LPBF process or SR annealing.

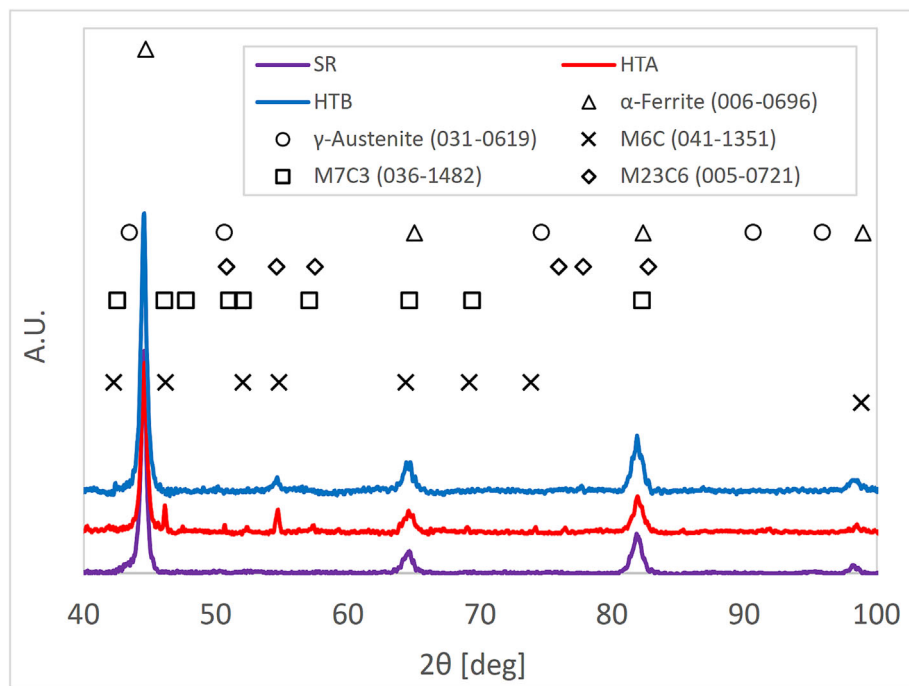
**FIGURE 5** XRD patterns of specimens in the SR condition (in purple) and subjected to heat treatments HTA (in red) and HTB (in blue). [Colour figure can be viewed at [wileyonlinelibrary.com](http://wileyonlinelibrary.com)]

For both HTA and HTB treated samples, XRD analyses indicated  $\alpha$ -ferrite as the main phase, with negligible amounts of retained austenite below the instrumental

detection limit (2%). Moreover, minor diffraction peaks were observed, possibly related to  $M_6C$  and  $M_{23}C_6$  carbides, in particular for the HTA sample.  $M_6C$  and  $M_{23}C_6$

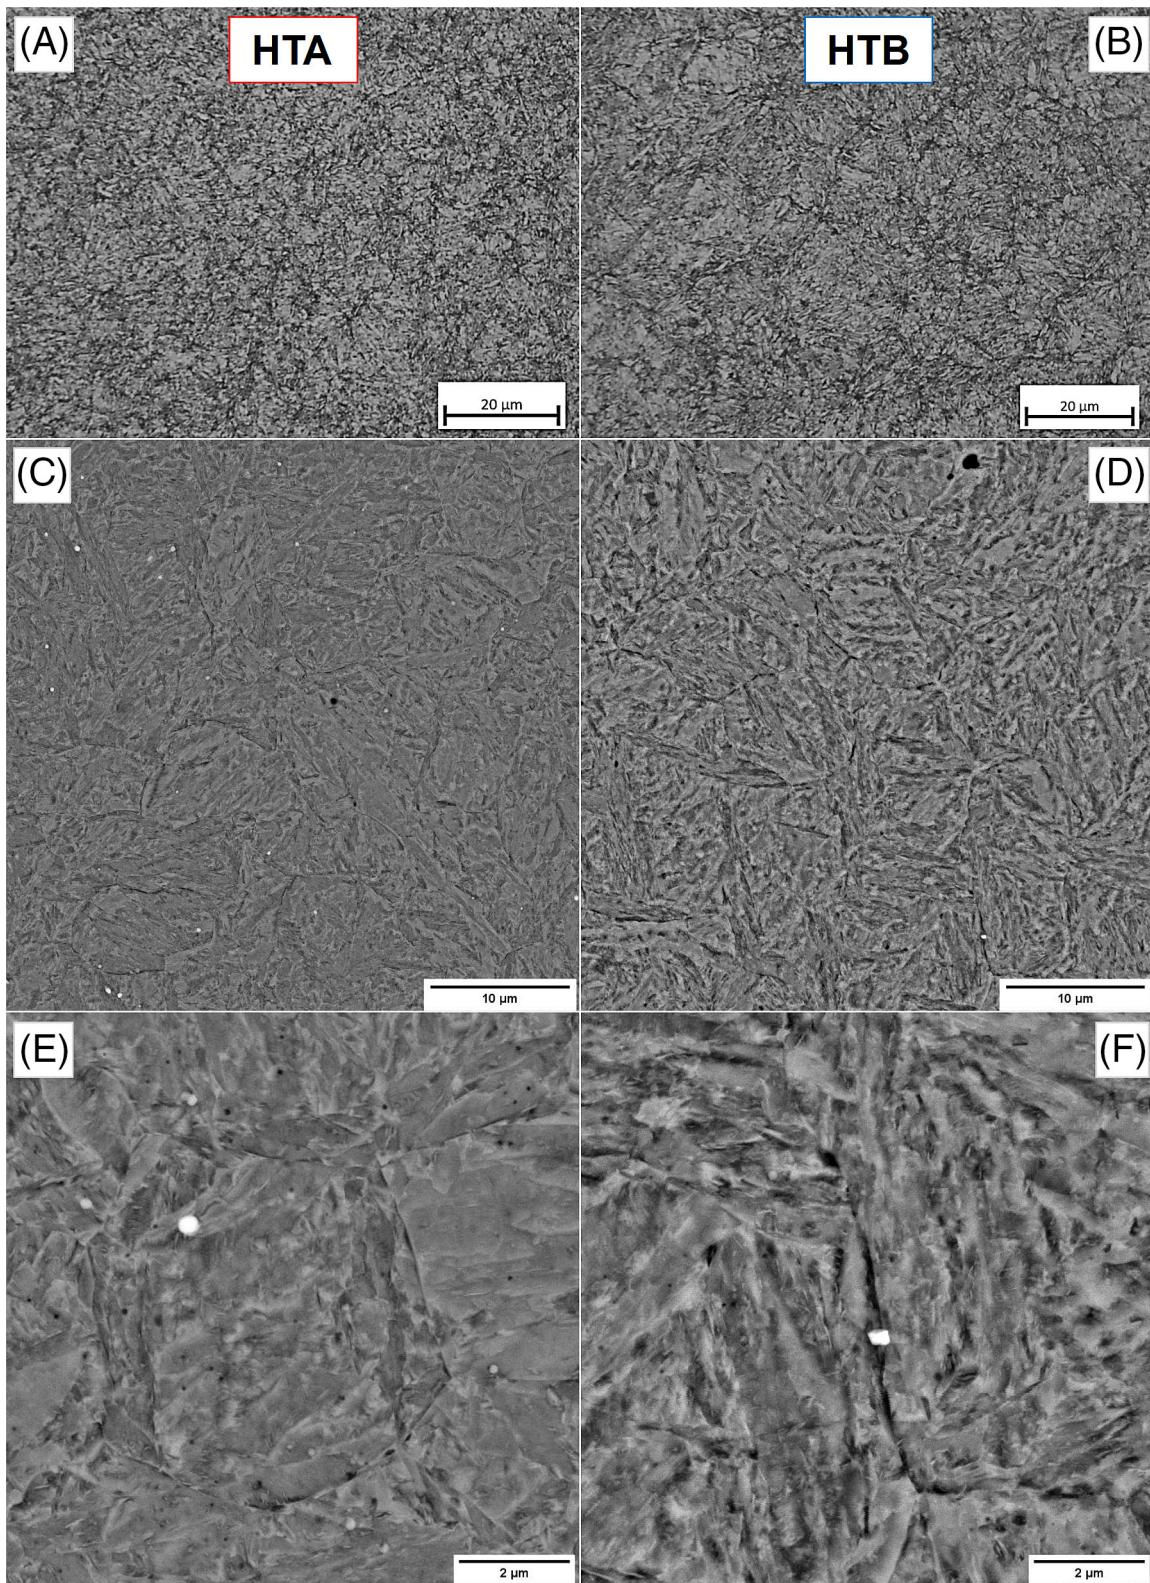
**FIGURE 6** Microstructure of specimens subjected to HTA (A,C,E) and HTB (D,D,F) observed using OM (A,B) and SEM (C,D,E,F). [Colour figure can be viewed at [wileyonlinelibrary.com](https://onlinelibrary.wiley.com/doi/10.1111/ffe.14025)]

Figure 6 shows the microstructure of HTA and HTB specimens observed using OM and SEM in back-scattered electrons imaging (BSE). Both specimens exhibited a homogeneous tempered martensite structure, featuring equiaxed prior austenite grains with a size between 5 and 10  $\mu\text{m}$ . None of the typical features of LPBF components (melt pool/scan track borders, columnar grain, cellular solidification sub-structure), still present in the SR condition, were observed, as well as differences between 90° (x-y sections) and 0° (x-z/y-z sections) specimens. High magnification SEM images (Figure 6E,F) revealed the presence of fine particles dispersed within the martensite matrix, mainly in the HTA specimens, with various appearance: i) bright particles with a size of hundreds of nm and ii) gray particles, with similar contrast to the surrounding martensite matrix and smaller than the formers. SEM-EDS analyses (Figure 7) revealed a high Mo content in bright particles, suggesting their matching with the  $\text{M}_6\text{C}$  Mo-rich carbides indicated by XRD analyses. The assessment of chemical composition of grey particles via SEM-EDS was not possible due to the size of the interaction volume between the electron beam and the sample. However, considering the atomic number contrast of BSE imaging, it is reasonable to assume that gray particles contain elements with atomic number similar to Fe ( $Z = 24$ ), and thus probably Cr ( $Z = 26$ ). This assumption would explain the diffraction peaks related to Cr-rich carbides from XRD patterns.

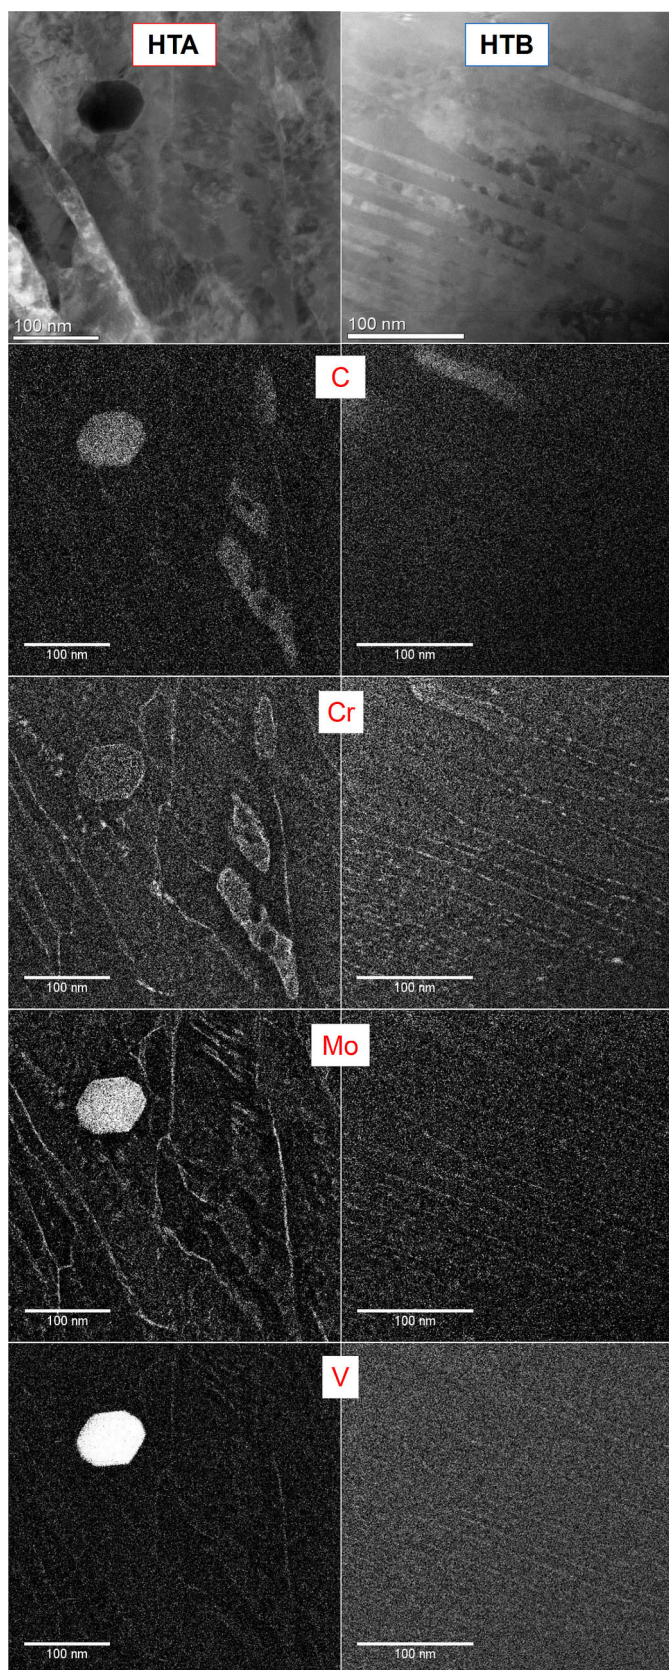
**FIGURE 8** Representative TEM bright field micrographs and element maps obtained with EDS and EELS in STEM mode for HTA (left column) and HTB (right column) samples. [Colour figure can be viewed at [wileyonlinelibrary.com](https://onlinelibrary.wiley.com/doi/10.1111/ffe.14025)]

Figure 8 shows representative bright-field TEM micrographs of HTA and HTB samples and the C, Cr, Mo, and V maps of the same regions obtained via STEM-EDS and EELS. TEM analyses confirmed the presence of alloying carbides, especially in HTA samples, as indicated

by the local enrichment in Mo, V, Cr, and C at the particle observed in the HTA sample. Two types of carbides were observed: Fe-based and V-based ones, also containing Mo and Cr. Both types of carbides are present, but at lower densities, in the HTB sample. Furthermore, for both types, a significant enrichment of Cr at the interface between the carbide and the steel matrix was observed. The number of carbides did not appear sufficiently high to induce an appreciable strengthening effect, neither in HTA nor in HTB samples. Considering the absence of carbides in SR samples from XRD and SEM-EDS analyses (Figures 4 and 5), it can be reasonably inferred that the ones observed in HTA and HTB samples were originated during the subsequent heat treatment, and in particular during the tempering step. For this reason, they are generally referred to as *secondary* or *tempering* carbides, in opposition to *primary* or *solidification* ones originated during steel solidification.<sup>2</sup> TEM analyses also indicated a segregation of Cr, Mo, and V toward the martensite laths boundaries. As for carbides, this alloying segregation appeared more pronounced in HTA samples than in HTB ones, which exhibited a more homogeneous composition.

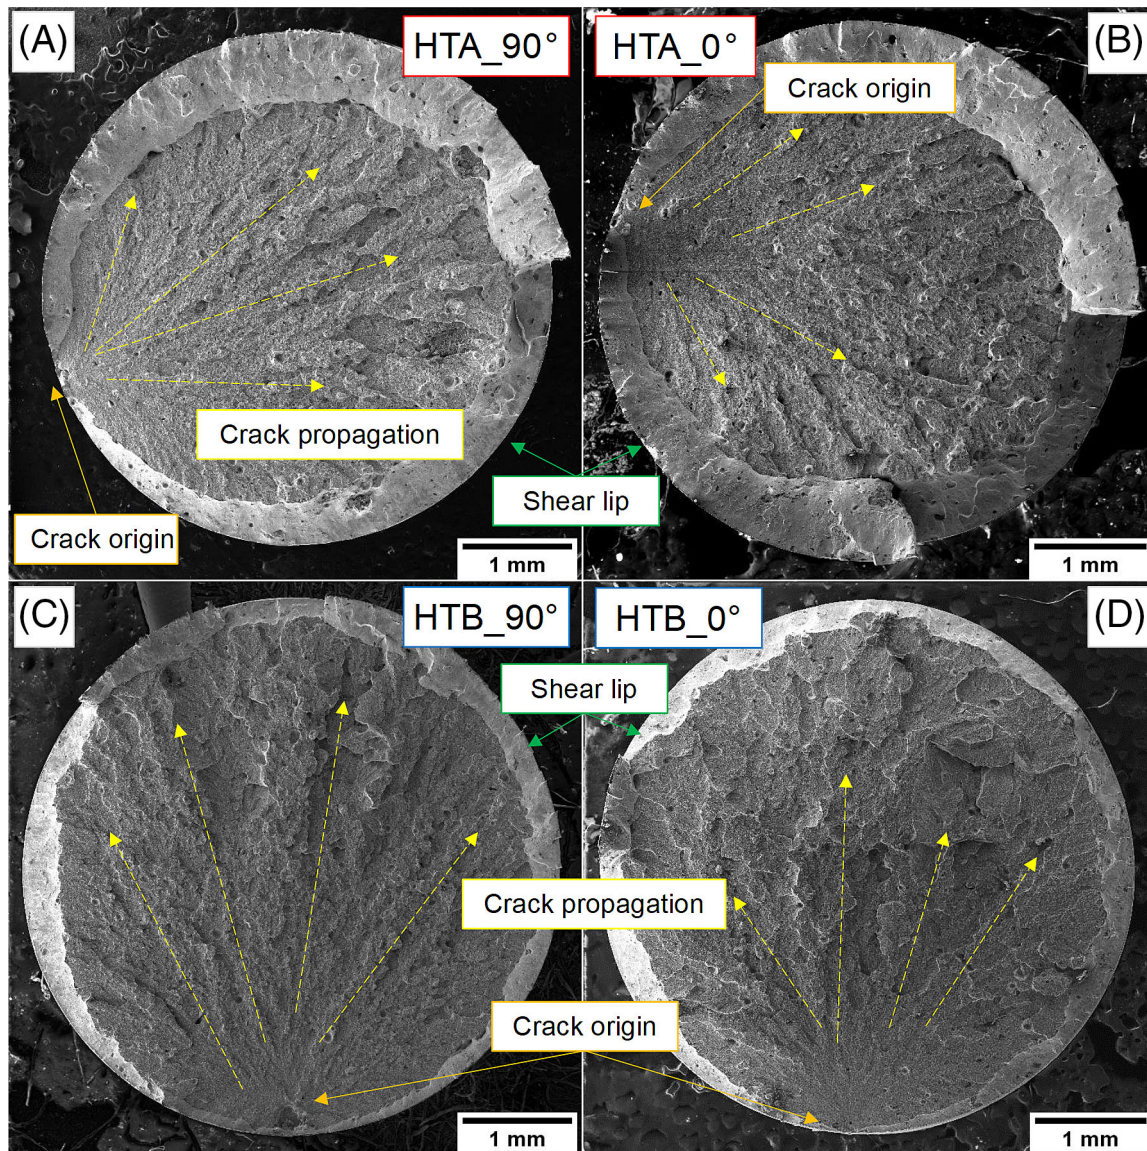
**FIGURE 9** Representative low magnification SEM images of fracture surfaces of tensile specimens: HTA\_90° (A), HTA\_0° (B), HTB\_90° (C), and HTB\_0° (D). [Colour figure can be viewed at [wileyonlinelibrary.com](https://onlinelibrary.wiley.com/doi/10.1111/ffe.14025)]

Figure 9 shows representative low magnification SEM images of the fracture surfaces of tensile specimens. The large part of tensile specimens showed a fracture morphology indicating a mechanism of unstable crack propagation initiated from a large discontinuity, which is quite unusual for ductile material subjected to tensile loading since they generally fail via *micro-voids formation and coalescence*, responsible of dimples formation and the resulting *cup-cone* fracture morphology.<sup>48,49</sup> The fracture was found to originate and propagate from large LPBF defects, mainly LoFs, showing an irregular morphology and large size (in the range 50–250  $\mu\text{m}$ ). Figure 10A shows the largest *lack of fusion* defect observed at a fracture initiation site. Besides LoFs, also gas pores or clusters of gas pores, with smaller size (approximately in the range 40–150  $\mu\text{m}$ ) and spherical morphology, were observed at crack origins, as shown in Figure 10B. It is worth noting that the size of defects observed at the crack initiation site widely exceeded the maximum size observed on metallographic sections (roughly 100  $\mu\text{m}$ ). Furthermore, many other LPBF defects randomly distributed on the fracture surfaces, mainly gas pores, were found in all the investigated specimens, consistently with metallographic observations on polished cross-sections. The fracture morphology indicated a strong influence of defects resulting from the LPBF process on the tensile mechanism and thus on tensile properties, as will be discussed in section 4. It is worth noting from Figure 9 that HTB specimens exhibited a *shear lip* considerably less wide than HTA ones. In fact, since *shear lip* is formed during

an existing crack, defect or flaw reaches a critical value known as *fracture toughness* ( $K_{IC}$ ).<sup>56</sup> For each specimen showing the fracture morphology reported in Figure 9, the area and position of the killer defect were measured via image analysis on the SEM images of fracture surfaces.  $\sigma_0$  was calculated by dividing the maximum force applied during the tensile test to the area of the minimum cross-section after fracture, in order to correct the Ultimate Tensile Strength UTS, reported in Table 3, accounting for the effect of the little necking. The calculated values of  $K_I$  lies in the range 18–41 MPa·m<sup>0.5</sup> with average and standard deviation equal to  $21 \pm 5$  MPa·m<sup>0.5</sup> for HTA and  $28 \pm 9$  MPa·m<sup>0.5</sup> for HTB specimens. The overall average and standard deviation of  $K_I$  calculated at killer defects were equal to  $26 \pm 7.7$  MPa·m<sup>0.5</sup> which, despite the large scatter, appeared reasonably comparable to the fracture toughness  $K_{IC}$  ( $33 \pm 1.1$  MPa·m<sup>0.5</sup>) reported in ref.<sup>11</sup> for the ESR-produced version of the steel investigated in the present work, subjected to a heat treatment consistent with HTA and possessing a similar hardness (648–676 HV), evaluated according to the ASTM E399 standard. The authors are well aware that the  $K_I$  values calculated at LPBF killer defects from fracture surfaces analyses via the procedure described above suffer from several inaccuracies and that the precise measurement of the fracture toughness  $K_{IC}$  on dedicated samples following a standard test method would be required, as performed in ref.<sup>11</sup> However, the similarity of  $K_I$  values calculated at *killer* defects in LPBF specimens in the present work to the fracture toughness  $K_{IC}$  calculated according to the ASTM E399 standard in ref.<sup>11</sup> together with the fracture appearances reported in Figures 9, 10, and 11, supports the idea that the tensile fracture of the investigated LPBF-manufactured steel occurred by unstable crack propagation from a pre-existing LPBF defect at the fulfillment of the critical condition  $K_I = K_{IC}$ , and thus it can be considered a *defect-controlled* phenomenon. Hence, the  $K_I$  values calculated at *killer* defects can represent a rough estimate of the fracture toughness  $K_{IC}$  of the investigated steel.

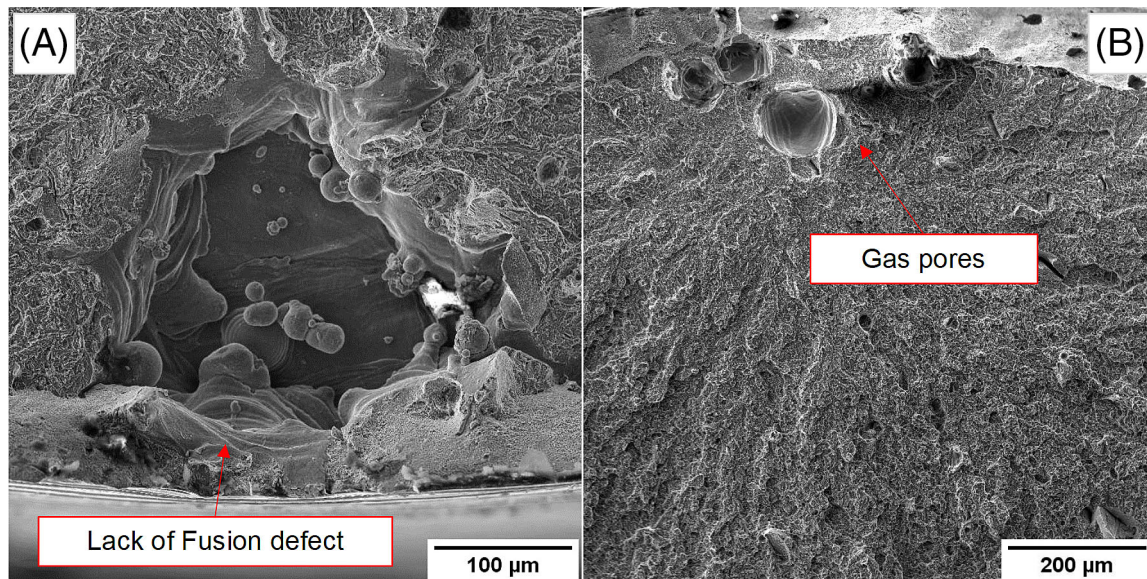
FIGURE 10 Examples of defects resulting from the LPBF process found at the crack origin of tensile specimens: (A) lack of fusion defect; (B) cluster of gas pores. [Colour figure can be viewed at [wileyonlinelibrary.com](https://onlinelibrary.wiley.com/doi/10.1111/ffe.14025)]

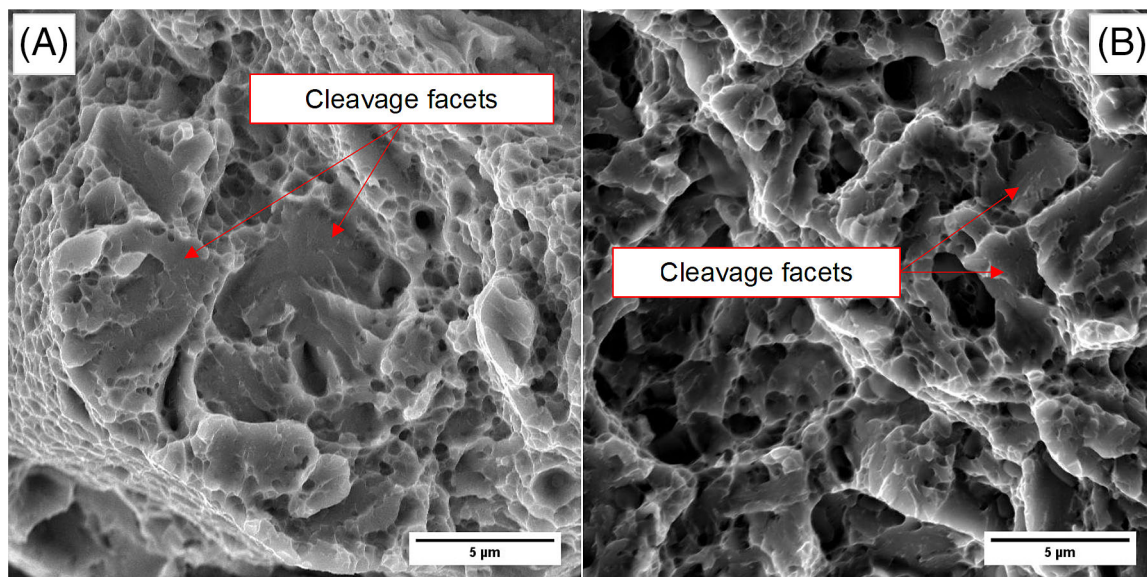
FIGURE 11 High magnification fracture morphology of tensile specimens subjected to heat treatment HTA (A) and HTB (B). [Colour figure can be viewed at [wileyonlinelibrary.com](https://onlinelibrary.wiley.com/doi/10.1111/ffe.14025)]

necking, its width is related to the area reduction Z%.<sup>48</sup> At higher magnification (Figure 11), the fracture surfaces showed a mixed ductile-brittle appearance

composed of micron and sub-micron sized dimples and cleavage facets, consistent with unstable crack propagation in high strength martensitic steels.
