# Static and dynamic stability analyses of the 800m high Åknes rock slope, western Norway

Thesis for the degree philosophiae doctor

Trondheim, July 2008

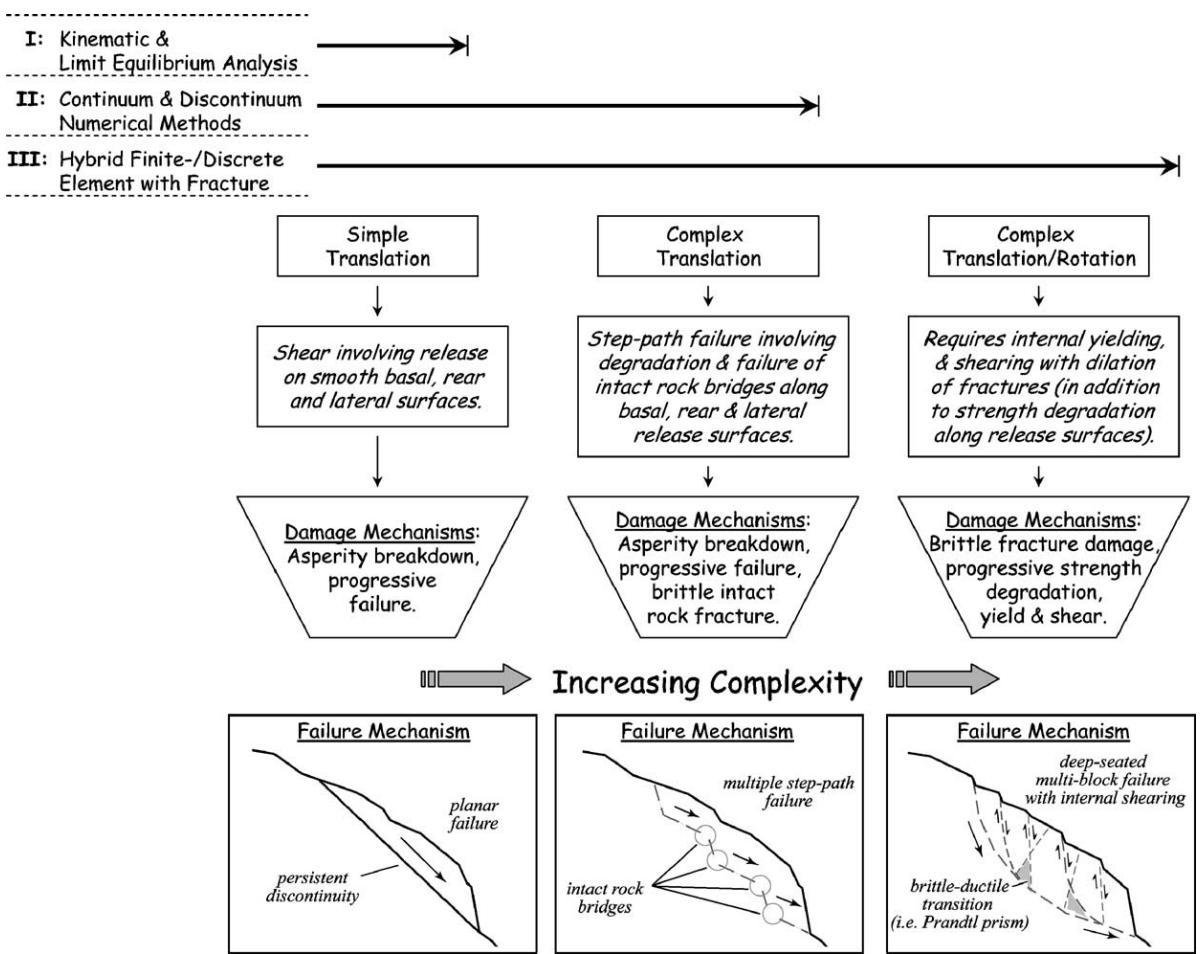
Fig. 4. Flowchart illustrating three levels of landslide analysis and the modes of translation/rotational failure they apply to. From Stead et al., 2006.

Fig. 4 illustrates three levels of landslide analysis, including the methods described above.

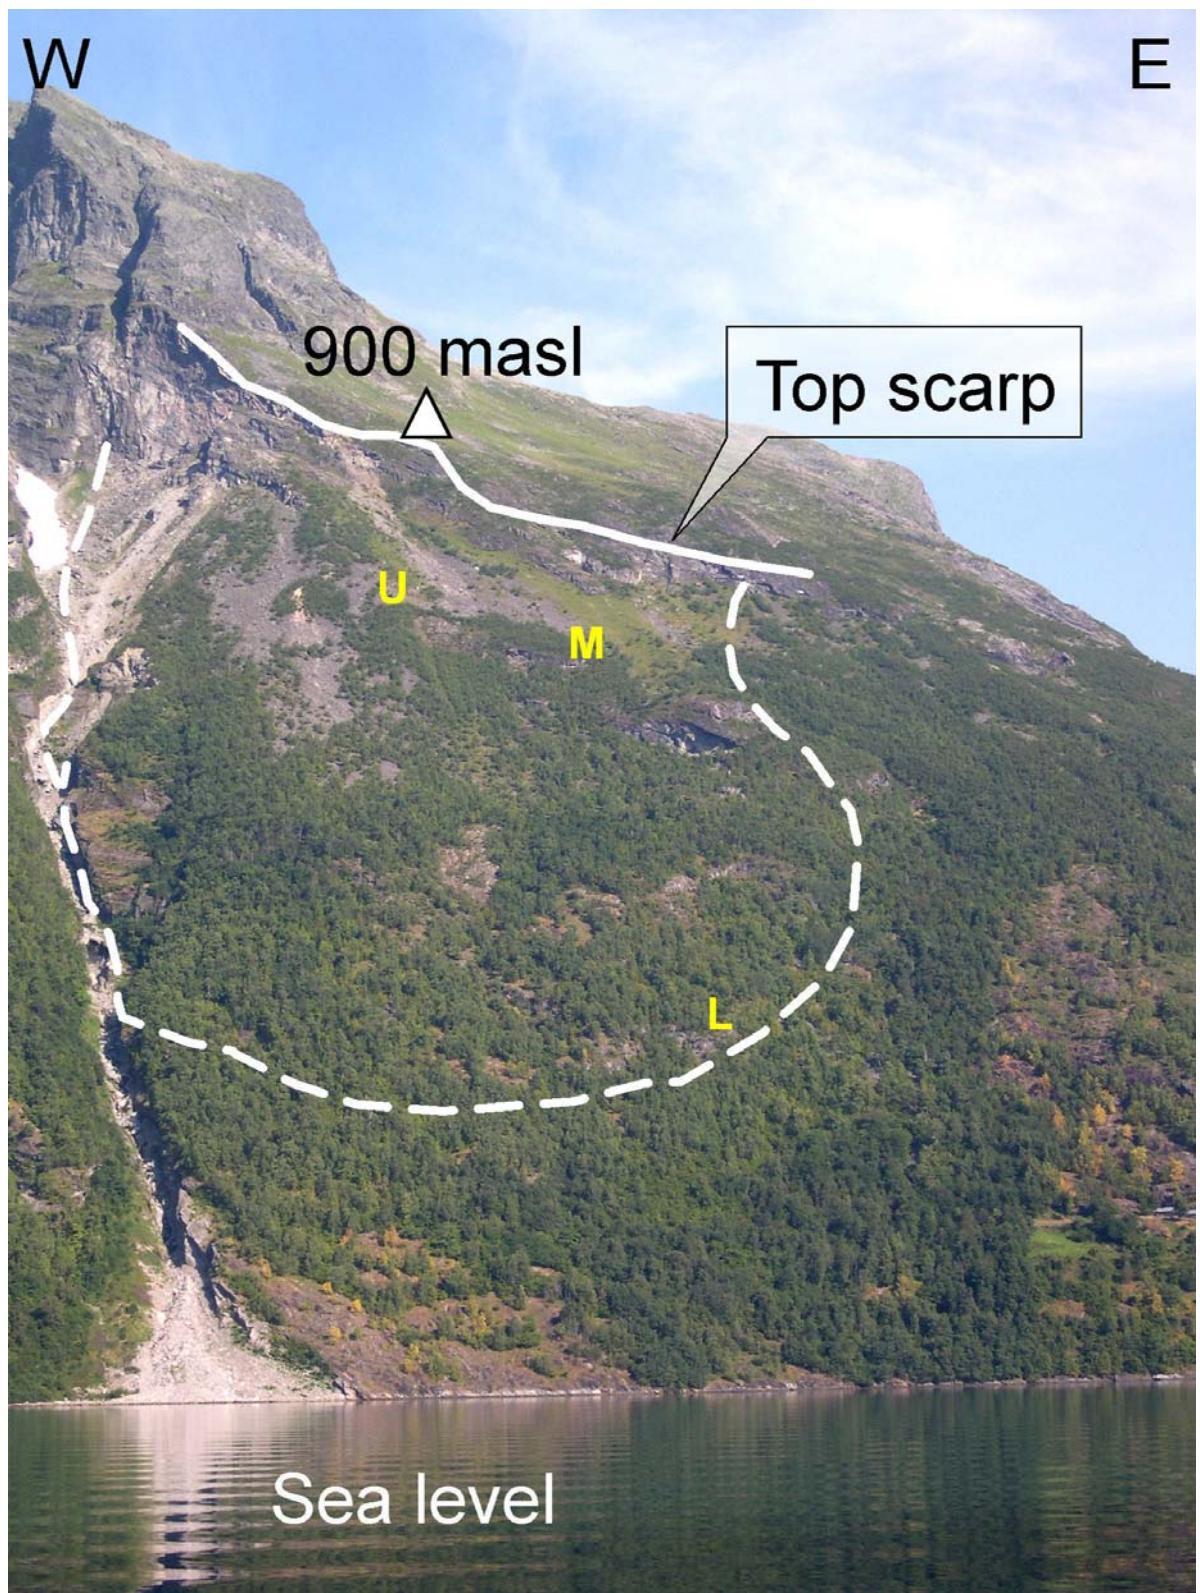
**Fig. 6.** Overview of the Åknes rock slope. The white lines indicate the contour of the unstable area as derived through various investigations (slightly modified after Derron et al. 2005). The length of the "top scarp"/upper crack is about 800m. The length along the dip direction of the slope inside the assumed unstable area is about 1100m. U, M, L: Upper, middle and lower borehole sites.

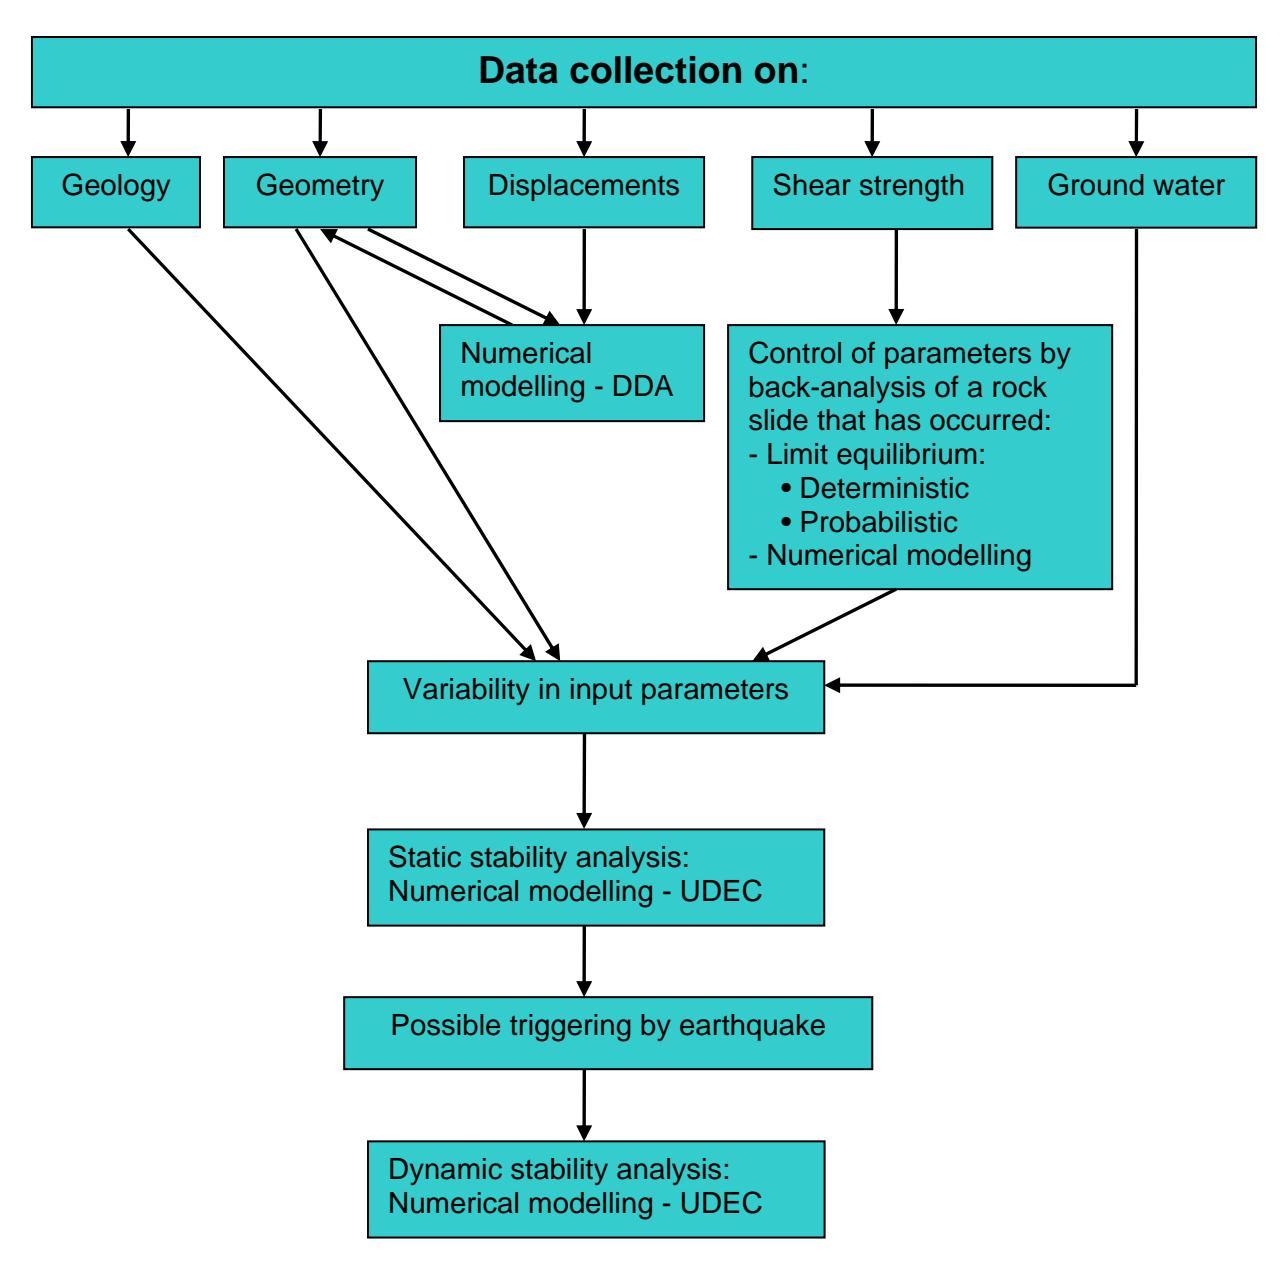
**Fig. 7.** Flow chart for stability analysis of the Åknes rock slope. Abbreviations: DDA – Discontinuous Deformation Analysis, UDEC – Universal Distinct Element Code.

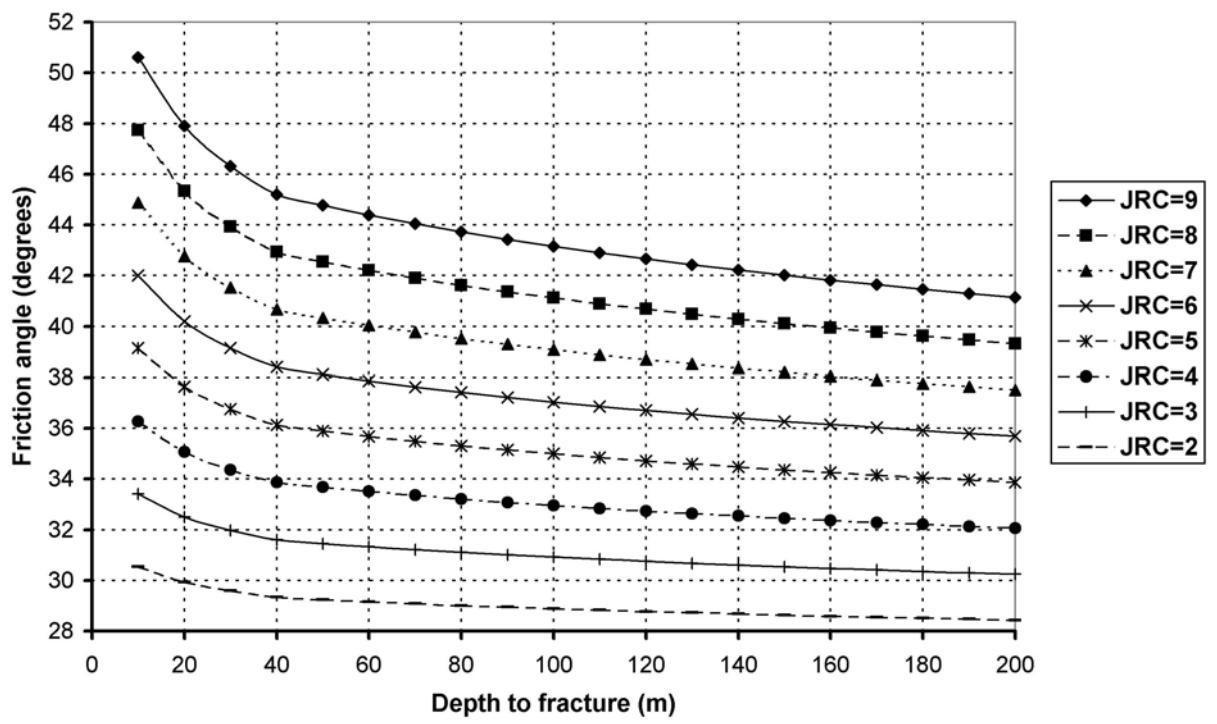
Fig. 8. Active friction angle vs. depth at different JRC for a fracture with dip 35° at depth to ground water equal to 40m. From Paper IV: Fig. 15.

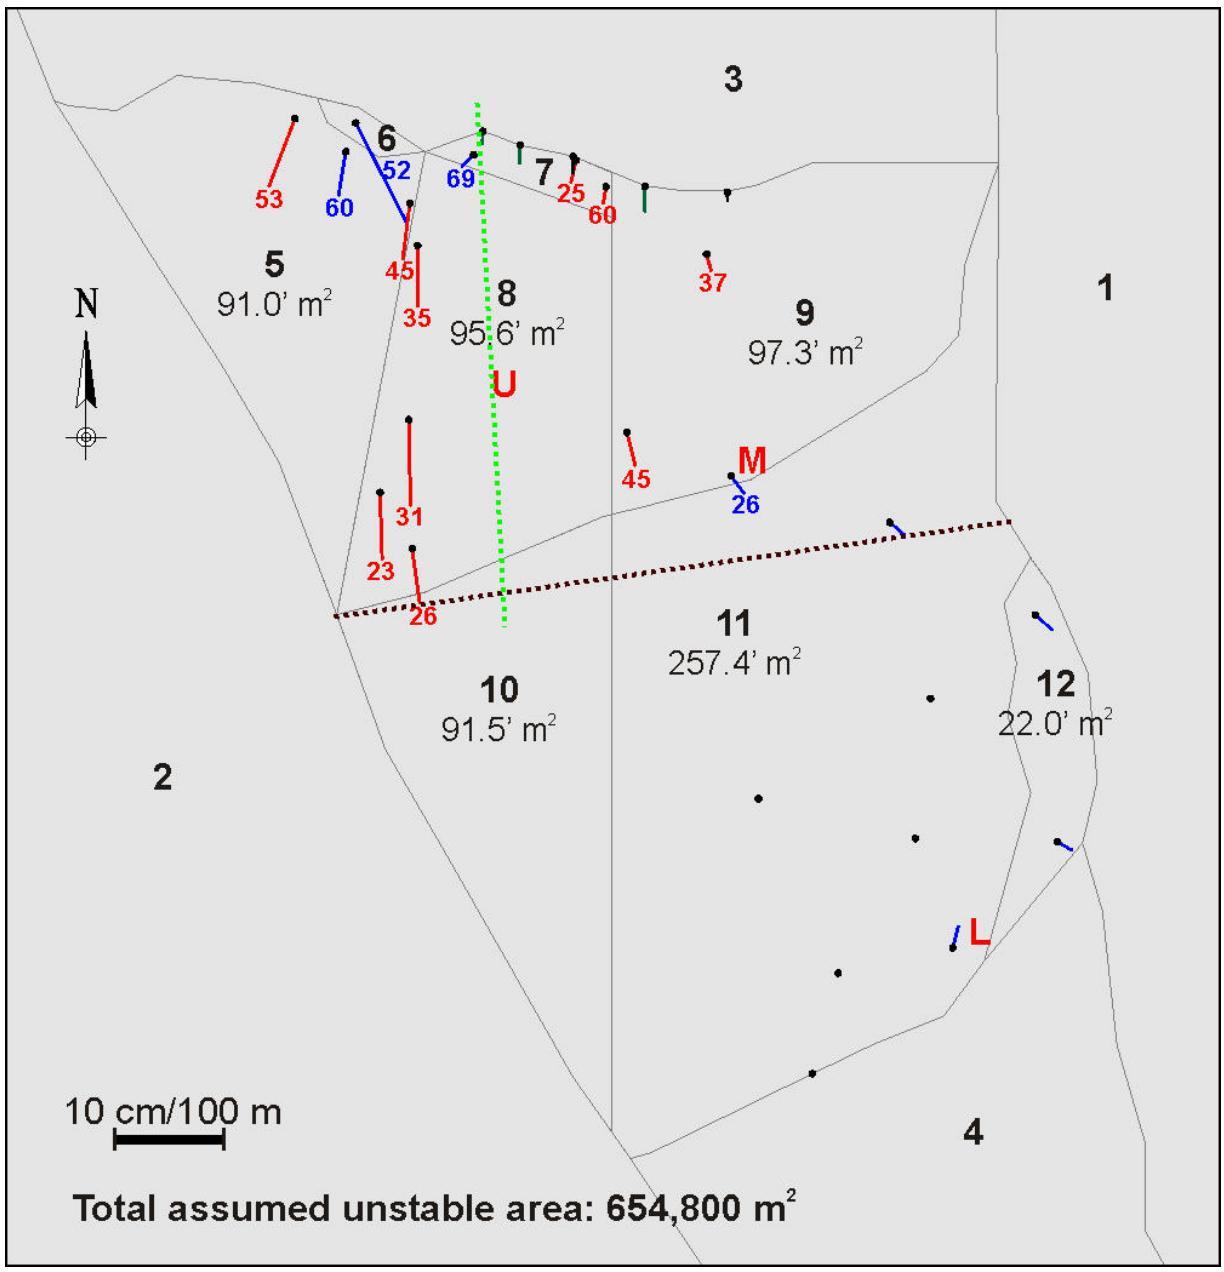
**Fig. 9.** Initial block model and annual average slope displacements 2004-2006. Red: Total station, blue: GPS, green: extensometer. Red and blue numbers: dip of the displacement vector from the first measurement to the last measurement. The last measurements were performed during autumn 2007 for GPS and during autumn 2006 for the total station. Scale: cm for displacements, m for block model. The red letters show the locations of the boreholes (Upper, Middle, Lower). The model measures 1100m × 1140m. Black broken line: modified block boundary after DDA computation (Fig. 33, Paper IV). Green broken line: profile for numerical modelling shown in Fig. 11. This figure is a modified version of Fig. 6 in Paper IV.

As indicated above, sliding can take place at 120m depth / altitude  $\sim$ 540m.a.s.l. at the upper borehole on a sliding surface daylighting at altitude ~530m.a.s.l. The model showing this is illustrated in Fig. 11, and the location of the profile is shown in Fig. 9. The model is similar to the upper half of most models analysed in Paper IV regarding geometry of the slope surface, the location of the upper tension fracture, the location of the daylighting fracture and the location of the ground water table, i.e. 40 - 50m below the slope surface. It should be noted that kinematic constraints have been reduced compared to the models analysed in Paper IV in that two vertical fractures have been added just to the left of the lower break point. The limiting friction angle for the non-vertical fractures in the model equalled 25° when the friction angle of the vertical fractures were set to 49.5°, i.e. the same friction angle that was used for the vertical fractures in most models analysed in Paper IV. A limiting friction angle of 25° is equal to the residual friction angle calculated for the foliation parallel fractures in Paper II. Thus, the model shown in Fig. 11 corresponds to movements taking place at 120m at the upper borehole at a surface daylighting in the middle of the slope with the friction at the foliation parallel fractures degraded to the residual friction angle. The model also implies that movement at 120m depth by the upper borehole is possible without movements taking place in the lower half of the slope where movement measurements have not been performed, i.e. Block 10 and the western part of Block 11 (Fig. 9).

Upward movements in the lower part of the slope are discussed in Paper III and Paper IV based on displacement data from autumn 2004 to autumn 2006. GPS measurements performed autumn 2007 (Eiken, 2008) show that a systematic trend of upward movements does not exist (Fig. 13). It is concluded that atmospheric conditions probably cause the slight changes in altitude. In all, the updated GPS measurements show that the lower part of Block 11 (Fig. 9) still moves negligibly.

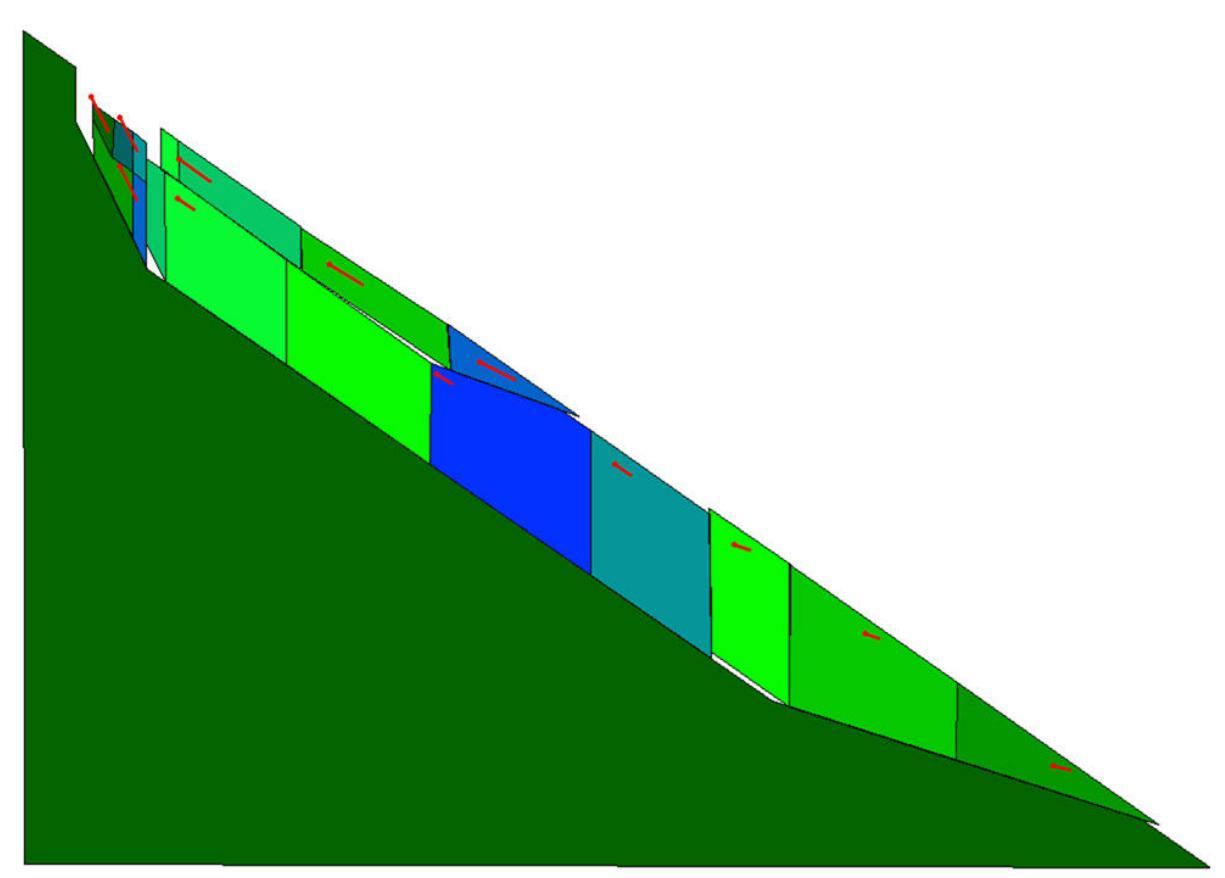
**Fig. 10.** Conceptual model of a slope dipping 35° and sliding taking place at two depths. The red lines show how the monitoring points have displaced during the DDA computation. The red dots show the position of the monitoring points before block movements occurred in the model.

lowermost part of Block 8 may be connected to the assumed daylighting sliding surface. An attempt to illustrate the situation is shown in Fig. 10 with the steepest dip of displacements in the upper part caused by a steep but not vertical fracture, slope parallel displacement dip caused by a slope parallel fracture and more gentle displacement dip caused by the daylighting of sliding surfaces of dip 20°. It should be noted that the dip of the lowest displacement vector in the upper layer of the sliding blocks would have been smaller if relatively more of the total displacement had occurred on the shallow sliding surface compared to the deep sliding surface.

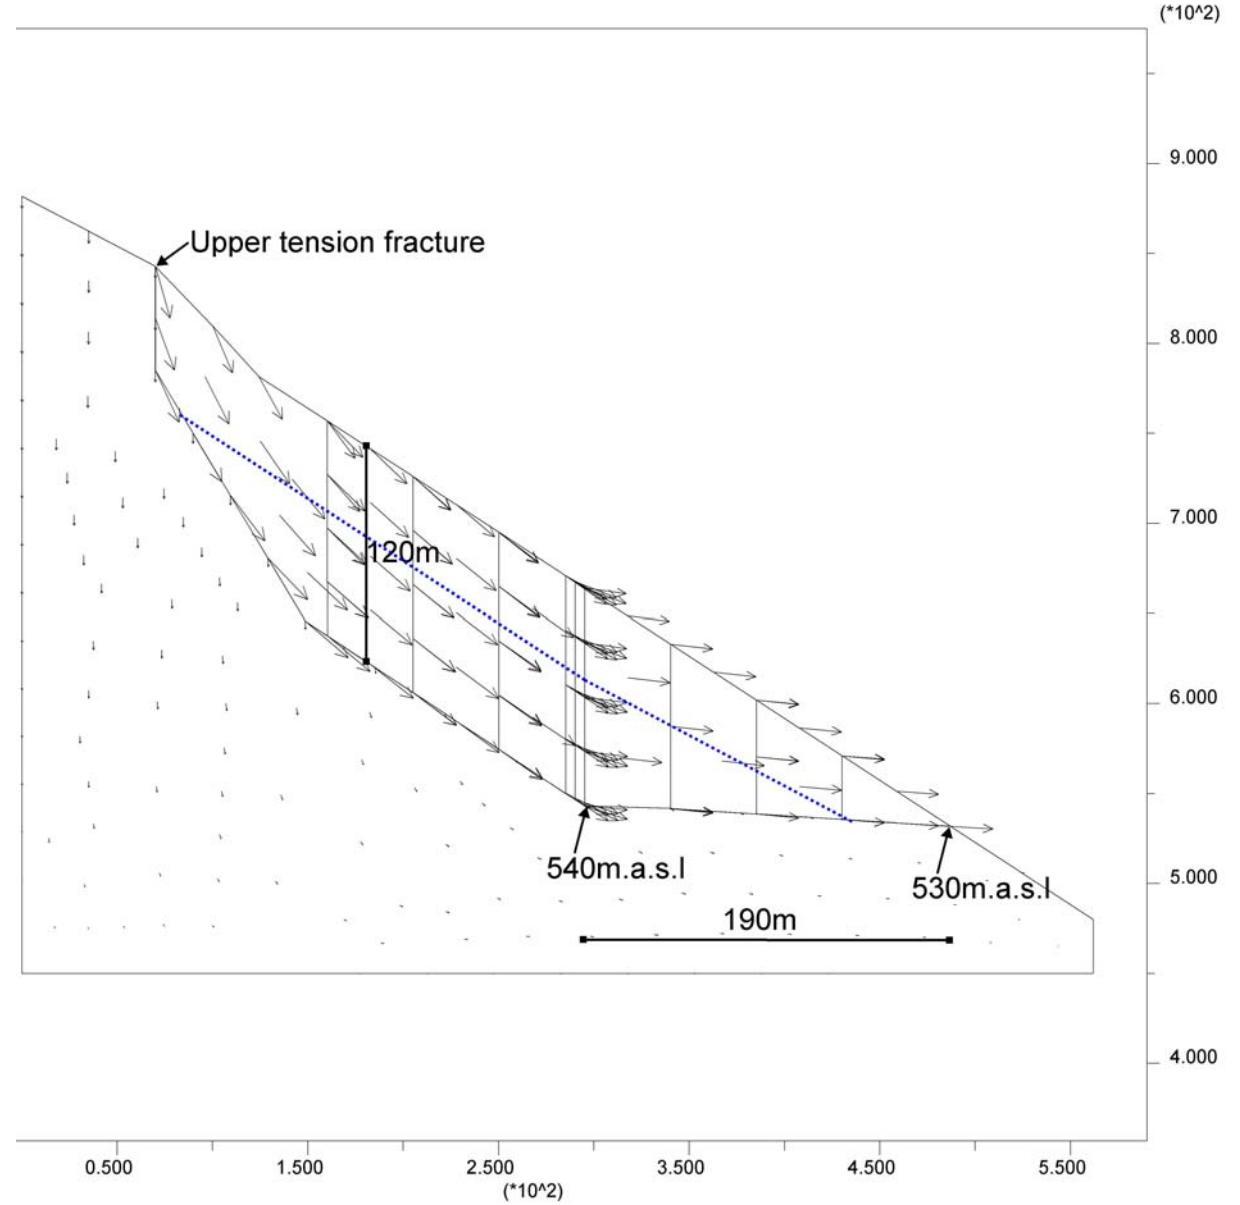
**Fig. 11.** UDEC model of the upper half of the Åknes rock slope. The arrows show computed displacement vectors in the model. The blue broken line shows the ground water table.

A modified version of the block geometry shown in Fig. 11 was used for demonstrating an effect of internal shears as discussed previously: One vertical fracture was added 2m to the left of the break point at 150m (along the horizontal axis) for the purpose of reducing the kinematic constraints around this breakpoint. Then the model was computed with friction angle of the vertical fractures equal to 49.5° and 25° respectively. With a friction angle of 49.5° the limiting friction angle of the non-vertical fractures equalled 26°, i.e. an increase of 1° compared to the model shown in Fig. 11 without the extra fracture near the breakpoint at 150m. The limiting friction angle of the non-vertical fractures increased to 30° when the friction angle of the vertical fractures in this model. These results indicate that varying the number of vertical fractures, their location and their friction angle in the larger models analysed in Paper IV might have given some difference in limiting friction angles (i.e. limiting JRC) of the foliation parallel fractures in these models.

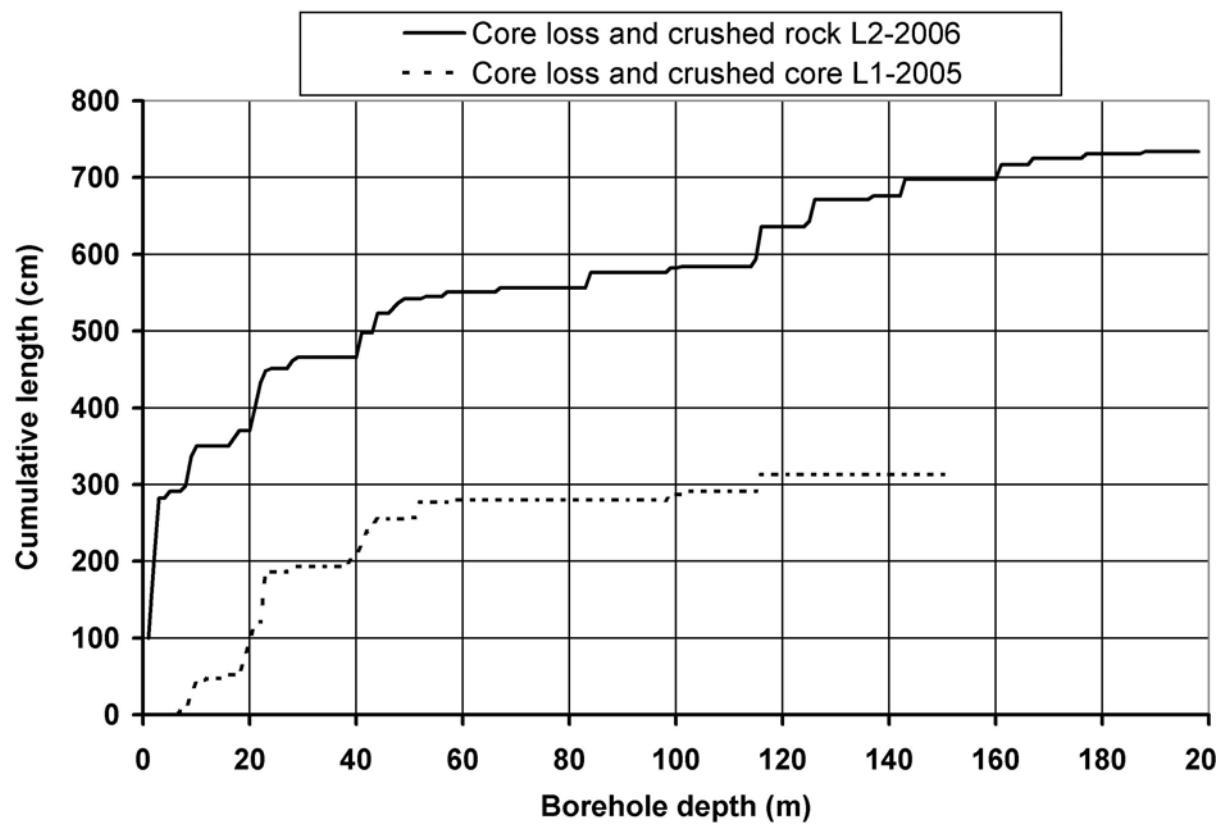
Fig. 12. Lower boreholes L1 and L2. Cumulative length of core loss / crushed core.

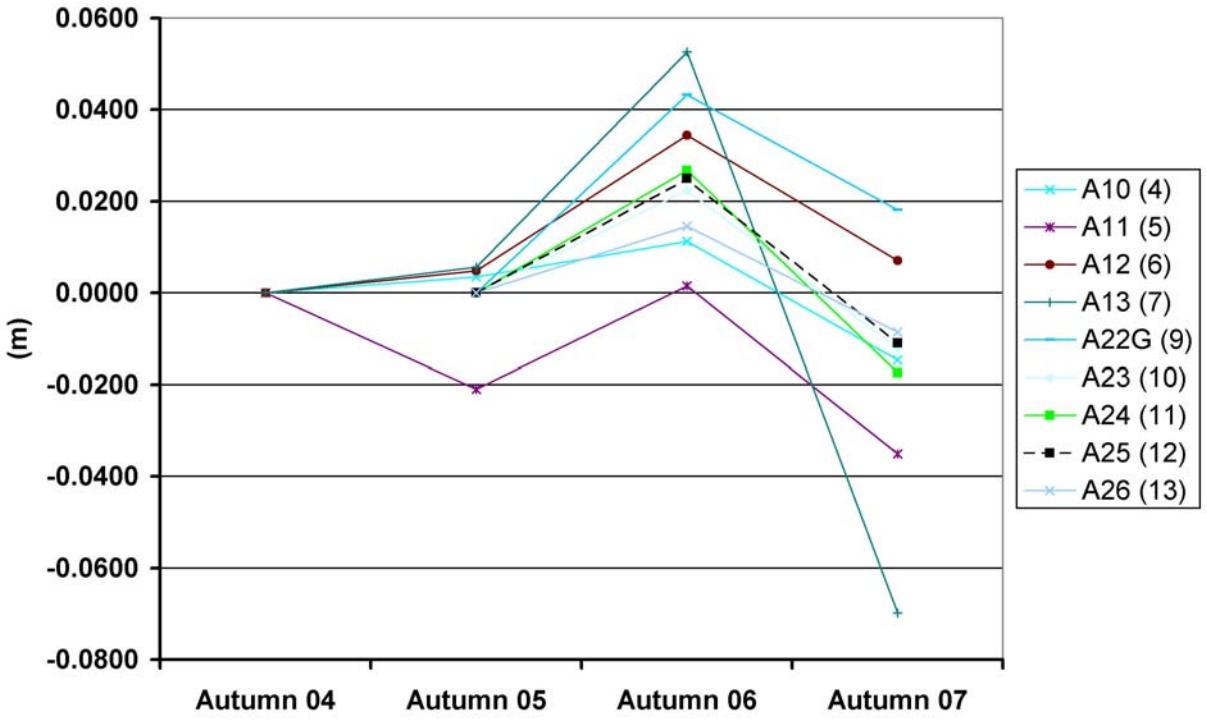
Fig. 13. Changes in altitude from GPS measurements in the lower part of the slope.

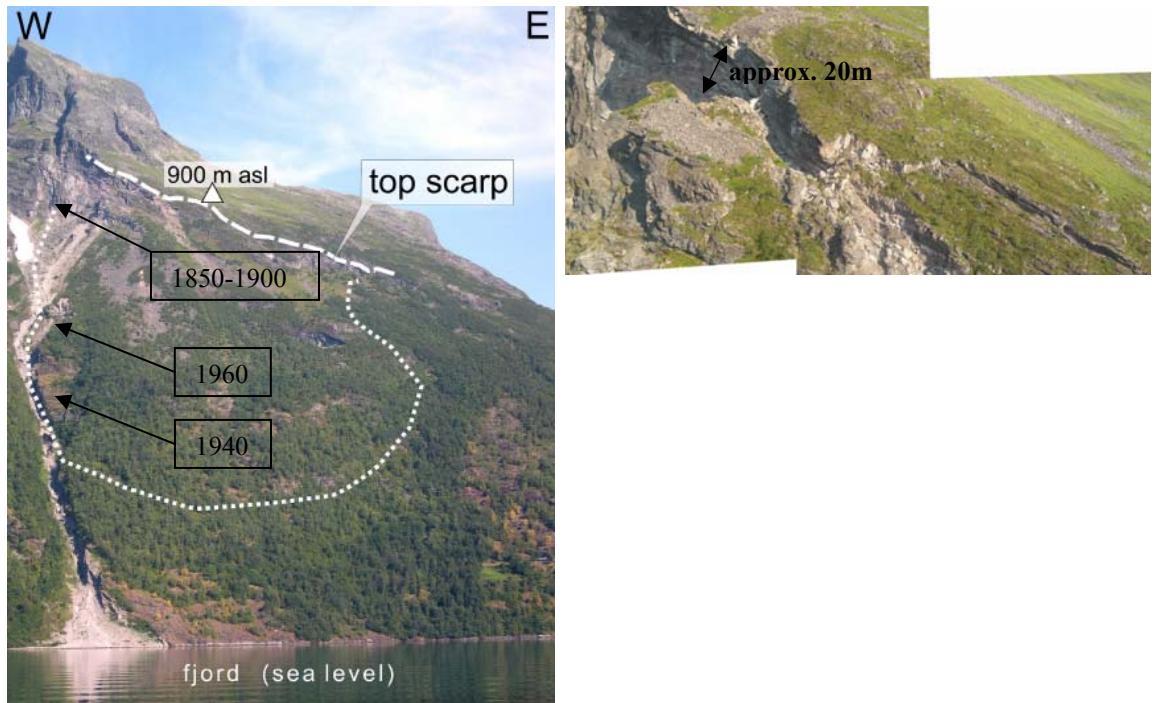
Figure 3. Overview of the Åknes rock slope. The white dotted line indicates the contour of the landslide (slightly modified after Derron, M.-H., et.al. 2005). The length of the "top scarp"/upper crack is about 700m measured from west to east. Numbers show approximate dates of known rock slides.

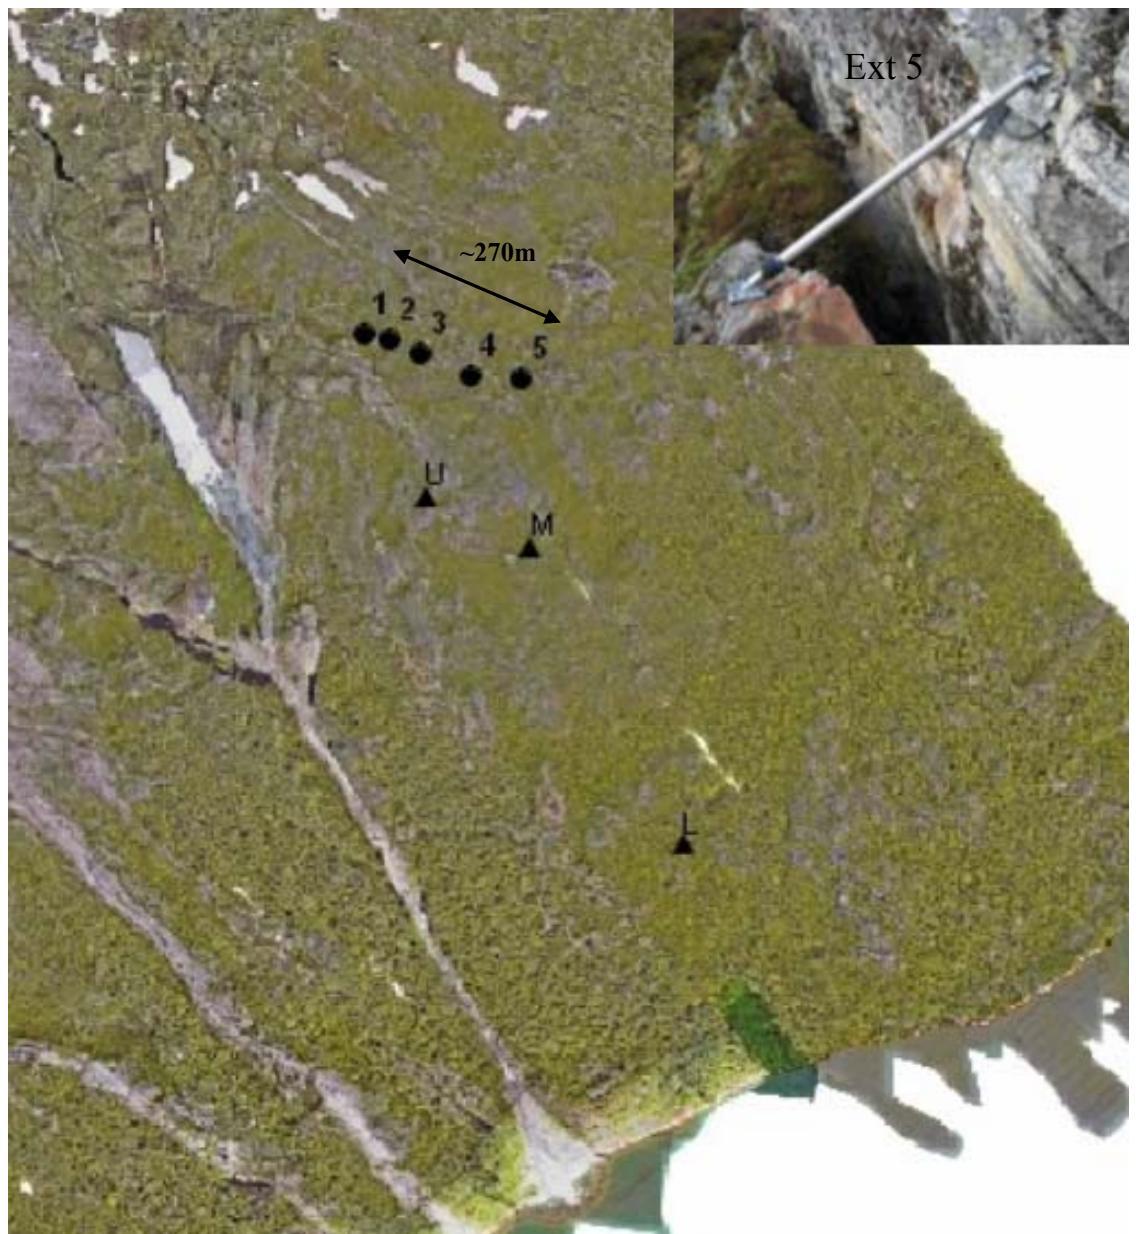
Figure 5. Ortophoto of the Åknes Landslide area. The extensometers along the upper crack are marked with circles and numbers (Nos.1 – 5). A detail of Ext 5 is shown. Locations of core borings are marked with triangles. (U = upper, one boring, M = middle, two borings and L = lower, one boring).

The first three extensometers for automatic reading were installed in 1993. Each extensometer is fixed in solid rock at both sides of the upper crack and it measures the distance between these fixed points. Measurement takes place once a day through 40 readings in a short period of time of which the mean value is stored in a computer as the recorded value. The extensometer monitoring programme was extended with two more extensometers in 2004. The locations of the extensometers are shown in Figure 5. The monitoring results are shown in Figure 6 and 7. Figure 8 shows the results of manual measurements which started in 1986. The manual measurements were carried out by measuring manually the distance between fixed bolts on each side of the upper crack with a measuring rod.

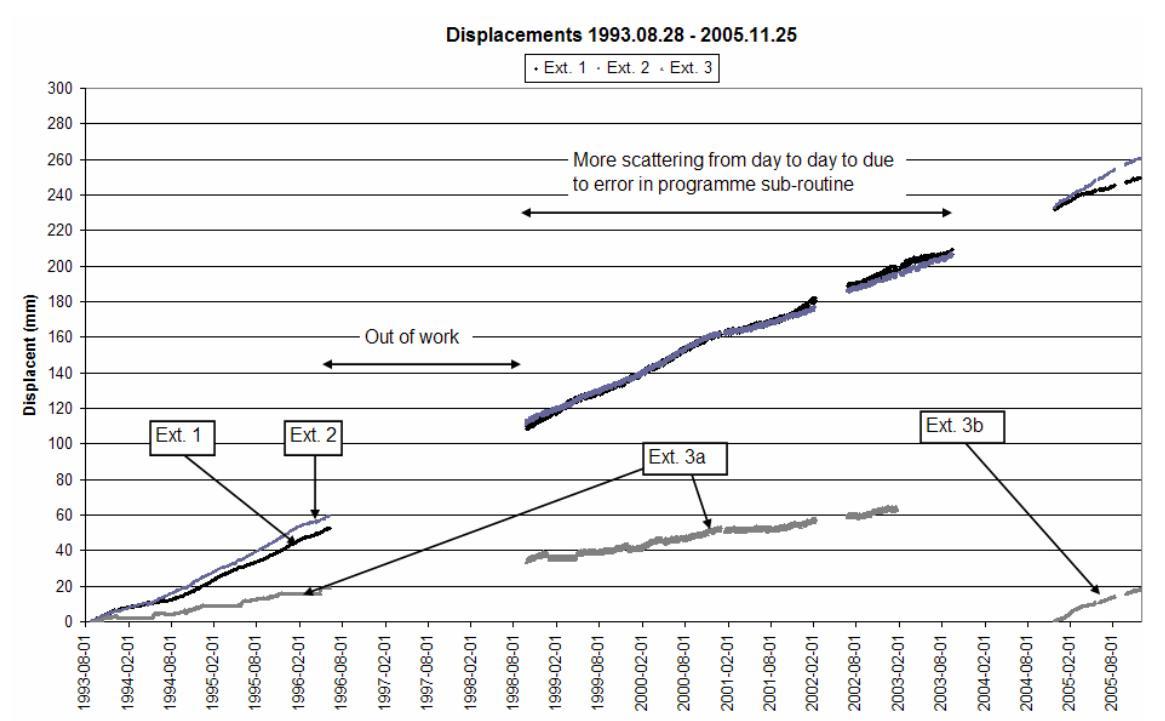
Figure 6. Displacements at the upper crack. Extensometer readings from 1993-08-28 to 2005-11-25. Ext 3b is a replacement of Ext 3a which was destroyed. Ext 3b is aligned more parallel to the slope movement than Ext 3a, which means that Ext 3b picks up a larger portion of the movement.

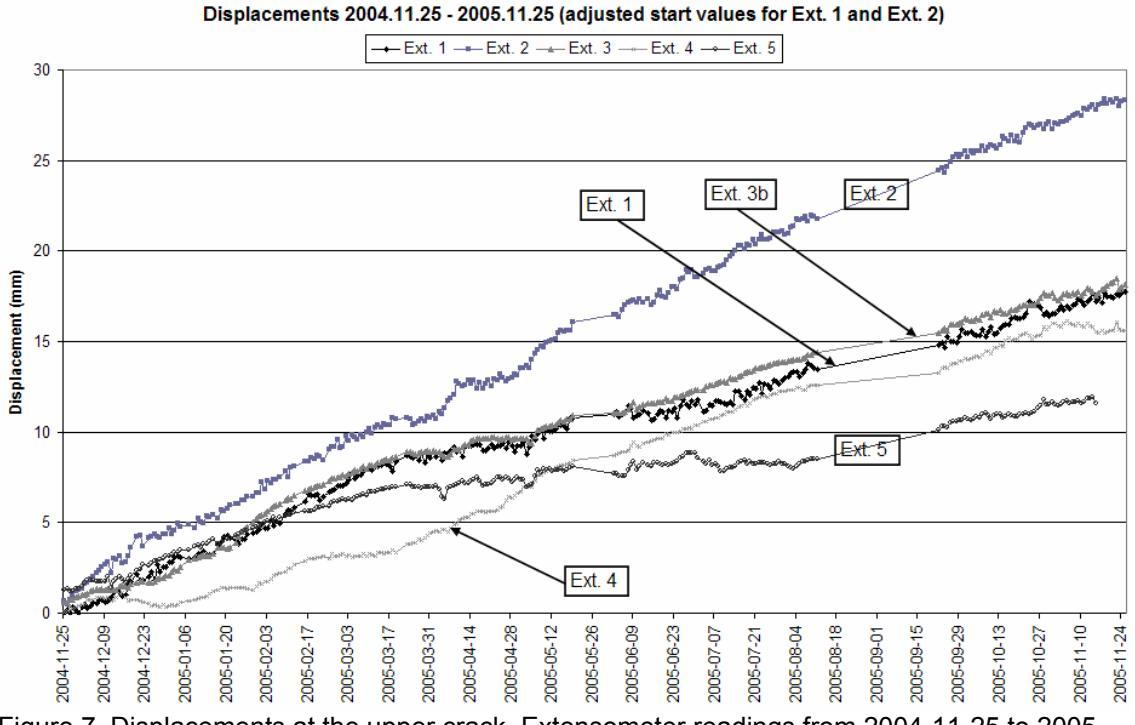
Figure 7. Displacements at the upper crack. Extensometer readings from 2004-11-25 to 2005-11-25.

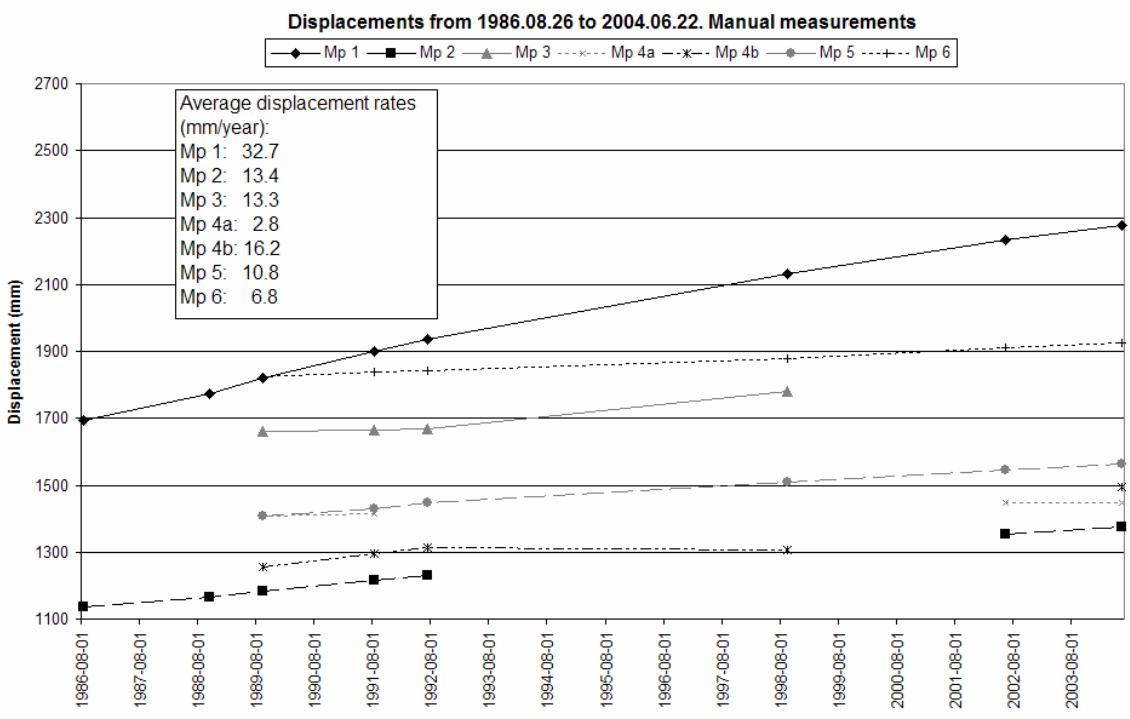
Figure 8. Displacements at the upper crack. Manual measurements from 1986-08-26 to 2004-06-22.

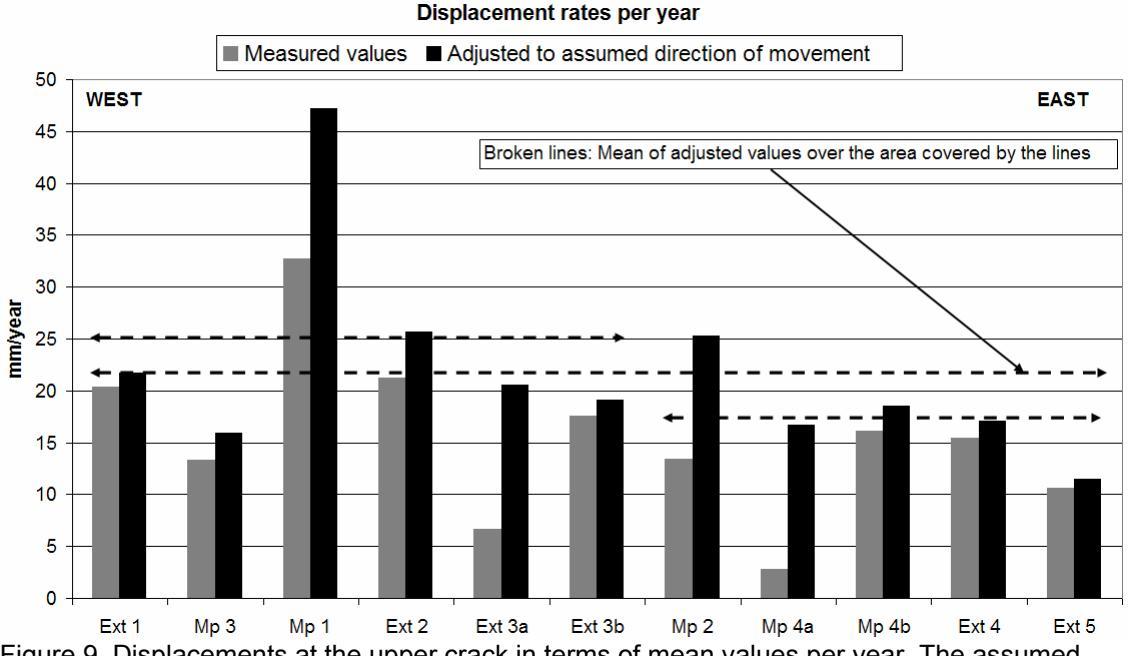
Figure 9. Displacements at the upper crack in terms of mean values per year. The assumed direction of movement is N157°/35° (dip direction/dip angle), which is sub-parallel to the slope itself. Ext 3a was in operation up to 2003-01-22. Ext 3b was put into operation 2004-11-25 at almost the same location as 3a, but aligned more parallel to the assumed direction of movement.

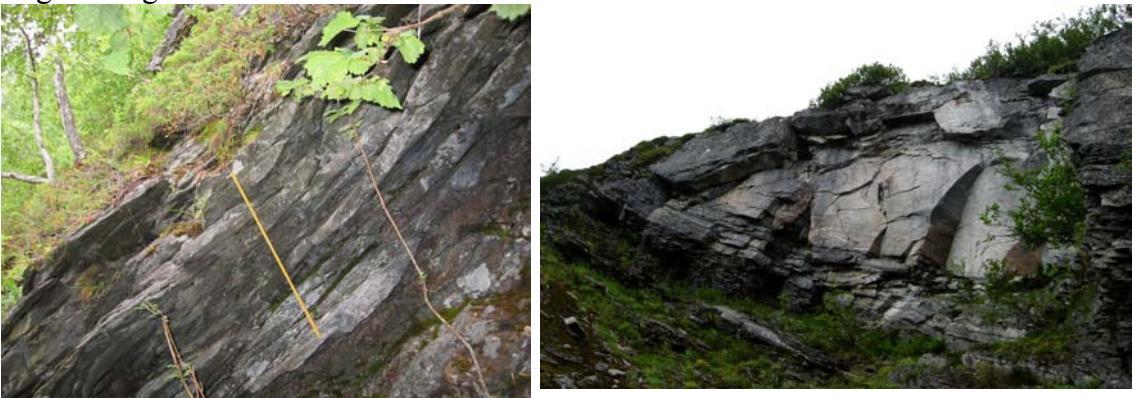
Figure 10. Rock outcrops. Left: dense jointing along the foliation. Right: dense jointing along the foliation with more massive rock above.

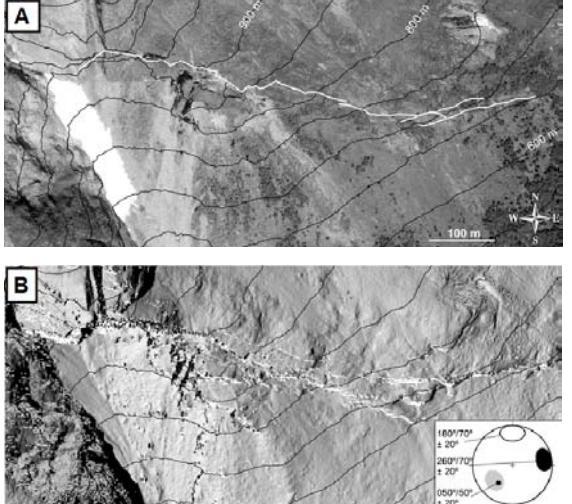
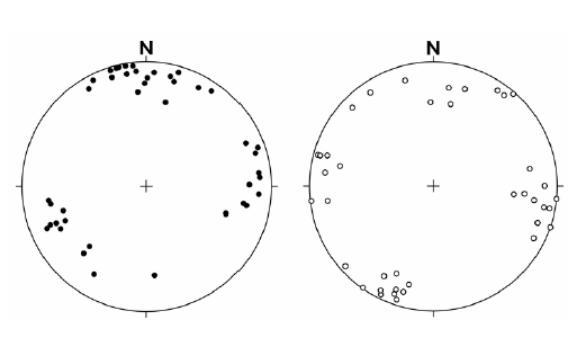
Figure 11. A) Orthophoto of the upper part of the Åknes landslide. The white line is the open upper crack. B) Detection of the cells of the DEM which have orientations that correspond to the joint sets J1 (foliation joints, white), J2 (black) and J3 (grey) respectively. From Derron, M.-H., et.al. (2005).

Derron, M.-H., et.al. (2005) identified three joint sets in the upper part of the landslide area by structural analysis of the DEM (Figure 11). The mean orientations of the joint sets are: J1-N180/45 (foliation parallel joints), J2-260/70 and J3-050/50. Derron, M.-H., et. al. (2005) compared this to field mapping of joints along and near the upper crack and found a fairly good agreement (Figure 12).

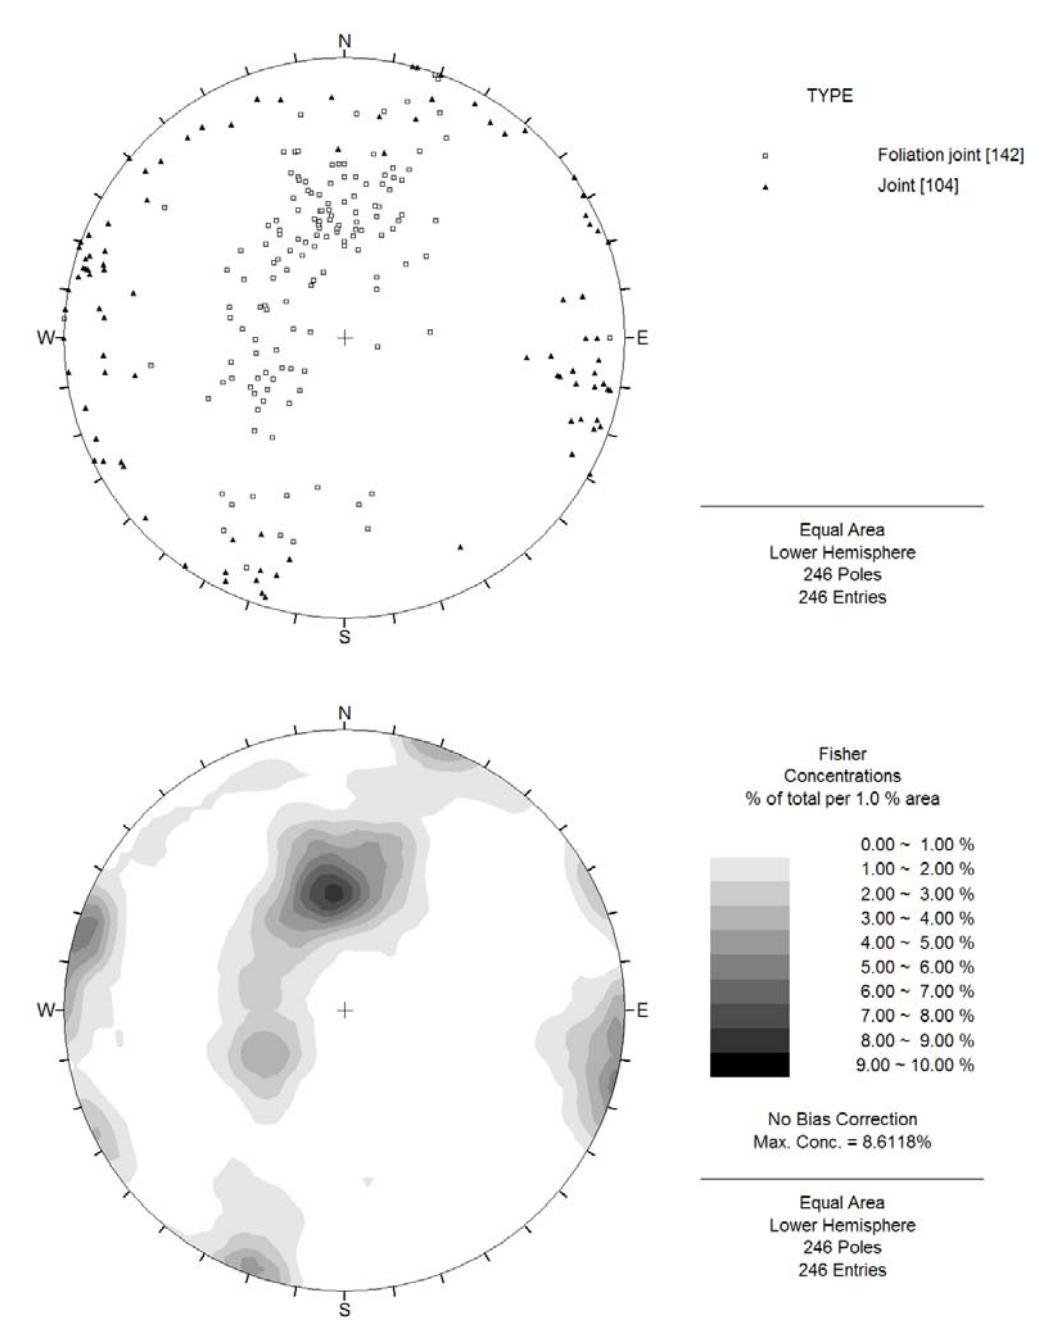
Figure 13. Structural measurements in the landslide area. Top: Pole plot of all the joints. Bottom: Contour plot.

246 orientations have been measured by field mapping in the whole landslide area, distributed as 142 foliation parallel joints and 104 joints that are not parallel to the foliation (Figure 13). Figure 13 compared with Figure 12 shows that the joint orientations are much more scattered when measurements from the whole landslide area are included. Figure 13 shows also that the joints that are not parallel with the foliation are generally sub-vertical.
