# Static and dynamic stability analyses of the 800m high Åknes rock slope, western Norway

Thesis for the degree philosophiae doctor

Trondheim, July 2008

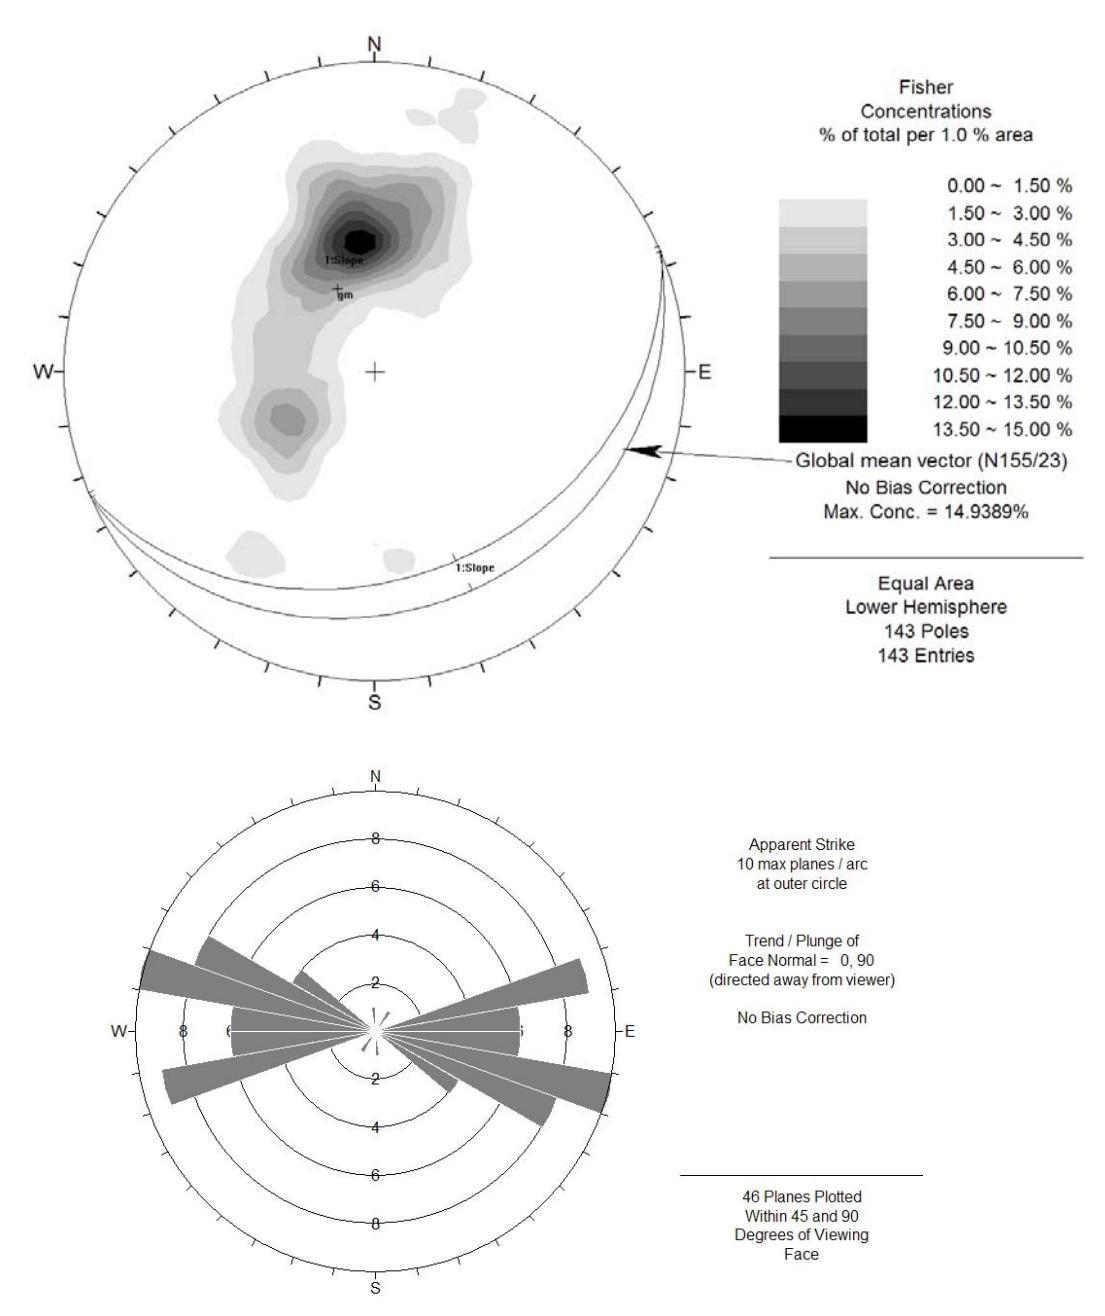
Figure 14. Foliation joints. Top: Contour plot with the global mean vector and the slope orientation. Bottom: Rosette plot.

Only foliation parallel joints have been plotted in Figure 14. It is clear from the plot that the global mean vector of the foliation joints (N155°/23°) is nearly parallel with the slope orientation (N157°/34°).

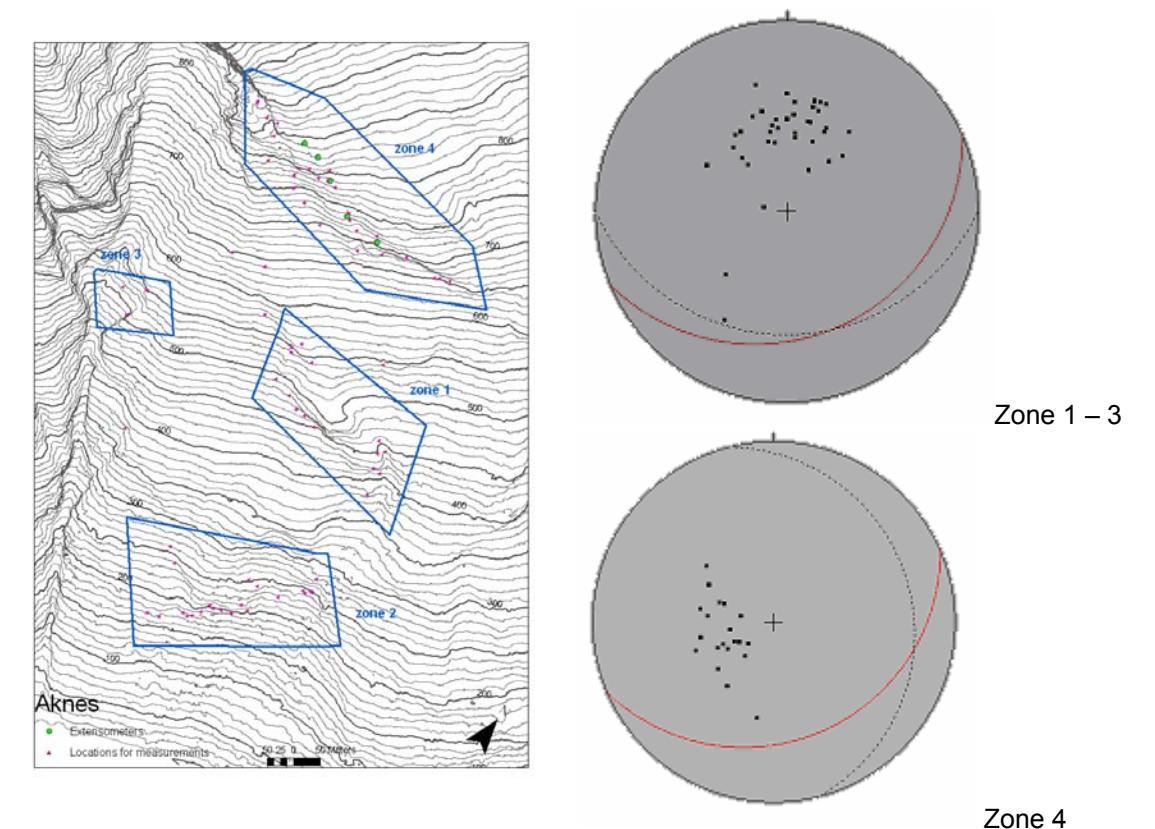
Figure 15. Pole plots showing foliation joints in different areas of the slope. The mean great circle calculated from the pole plot is shown as the dotted line. The slope is shown as the solid line.

Foliation joints from different areas are shown in Figure 15. The figure shows that the foliation generally dips quite parallel to the slope in Zones 1 - 3 whereas the foliation dips more easterly and non-parallel to the slope in the upper part along the upper crack (Zone 4).

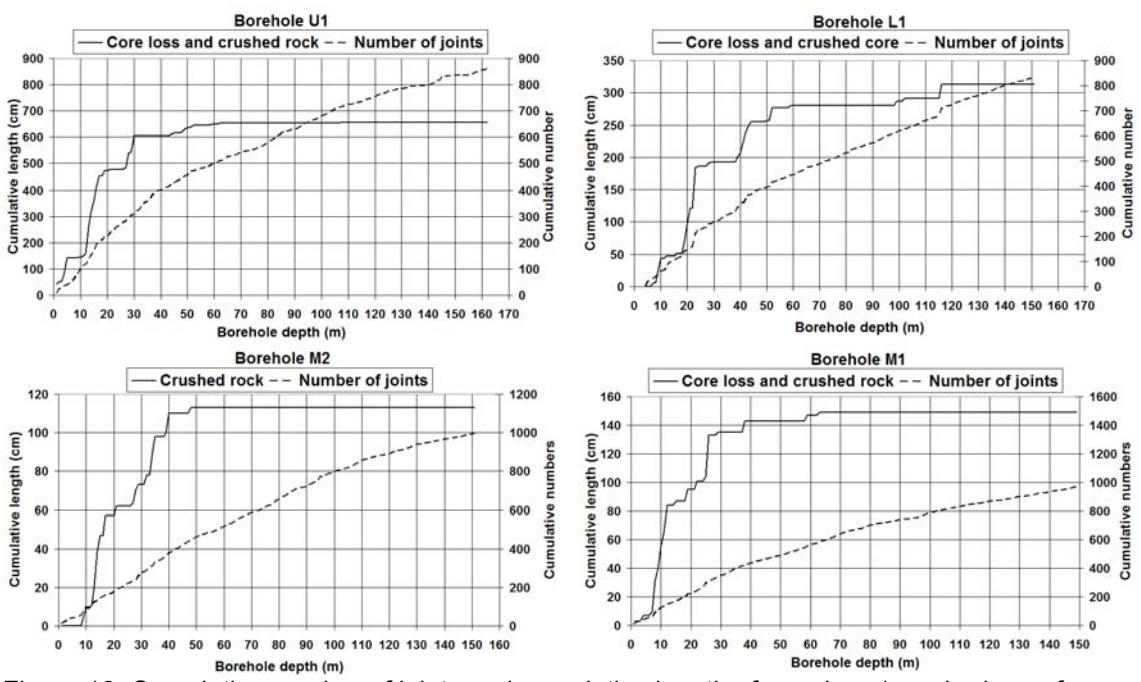
Figure 16. Cumulative number of joints and cumulative length of core loss / crushed core for Boreholes U1 (vertical), L1 (vertical), M2 (vertical) and M1 (60°).

The jointing and core loss / crushed core in the boreholes are summarized in Figure 16.

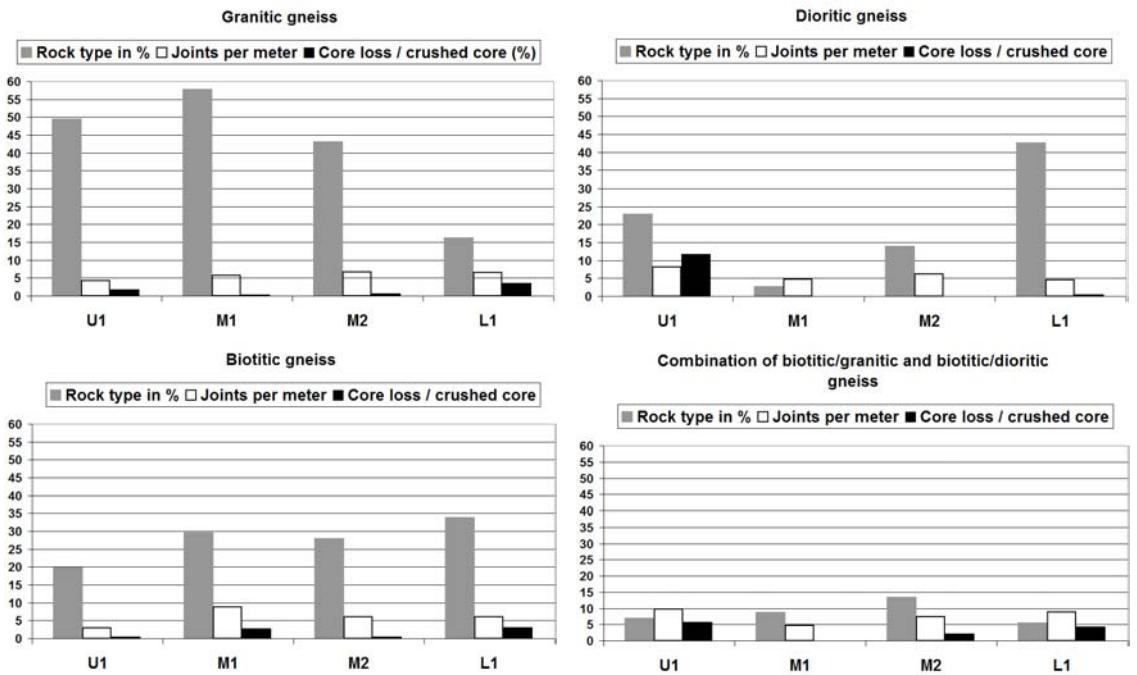
Figure 17. Rock type distribution, joint frequency and core loss / crushed core for the full lengths of Boreholes U1, M1, M2 and L1. Core loss / crushed core is given as percentage of the total length of the rock type in the borehole.

Figure 17 shows the rock type distribution, joint frequency and core loss / crushed core for the full lengths of the four boreholes. Figure 18 shows the same information, but restricted to the upper 60m of all four boreholes. Figure 17 does not reveal any specific trends with respect to core loss / crushed core and joint frequency versus rock type. Figure 18, however, shows that the biotitic gneiss and biotitic gneiss in combination with granitic or dioritic gneiss has more core loss / crushed core than the other rock types, and also; it is more jointed. Figure 19 shows that the dioritic gneiss has most core loss / crushed core when one looks at the total without considering the distribution in the various boreholes. However, this is caused only by the large portion of core loss / crushed core of dioritic gneiss in Borehole U1.

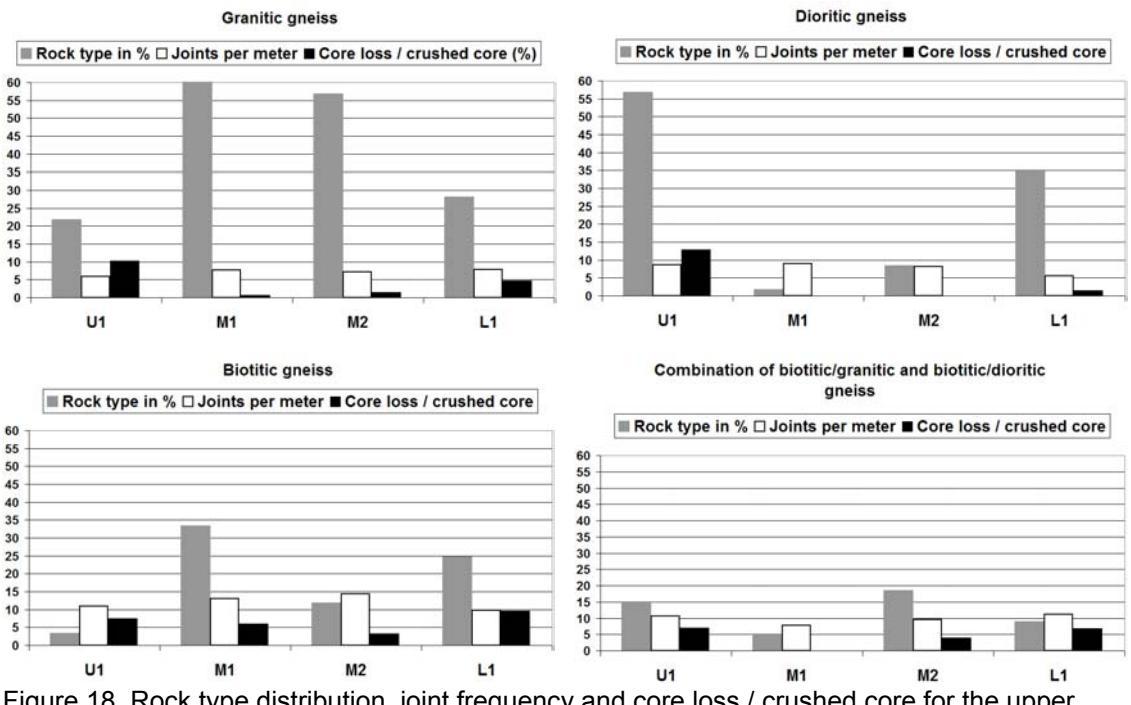
Figure 18. Rock type distribution, joint frequency and core loss / crushed core for the upper 60m of Boreholes U1, M1, M2 and L1. Core loss / crushed core is given as percentage of the total length of the rock type in the upper 60m of the borehole.

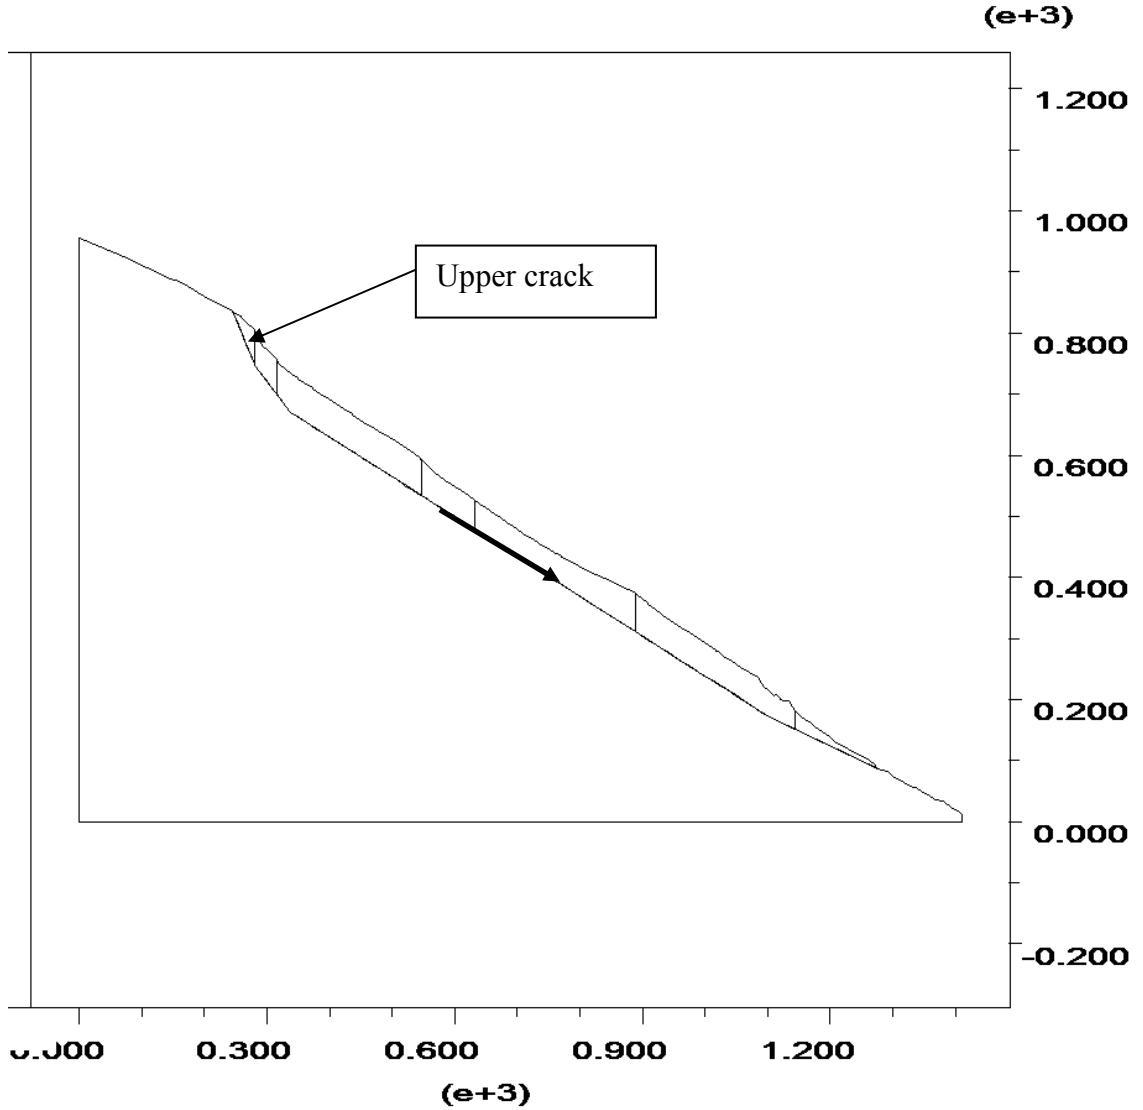
Figure 21. Profile trough the central part of the landslide area. Possible lowest level of shear movements are indicated (modified after geophysical survey conducted by the Geological Survey of Norway).

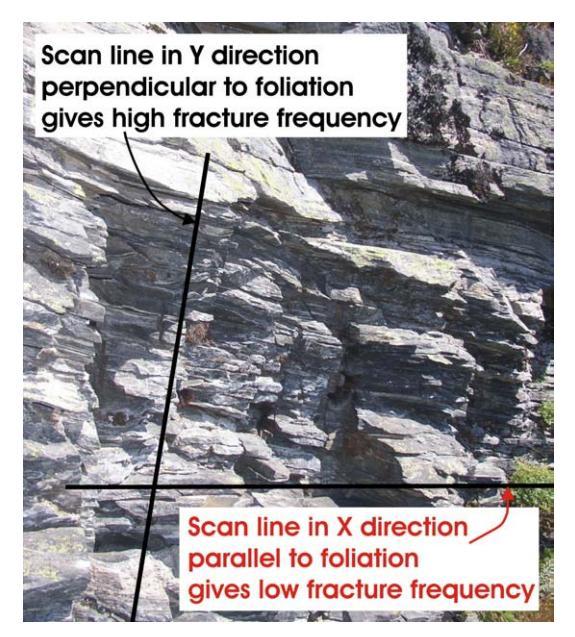
**Fig. 3.** Example of how structural data such as fracture frequency is collected with the help of scan lines. Fracture frequency is collected in x direction parallel to foliation, in y direction perpendicular to foliation, and if possible in z direction to estimate the block size of the area. Fracture frequency collected in y direction gives commonly the highest value.

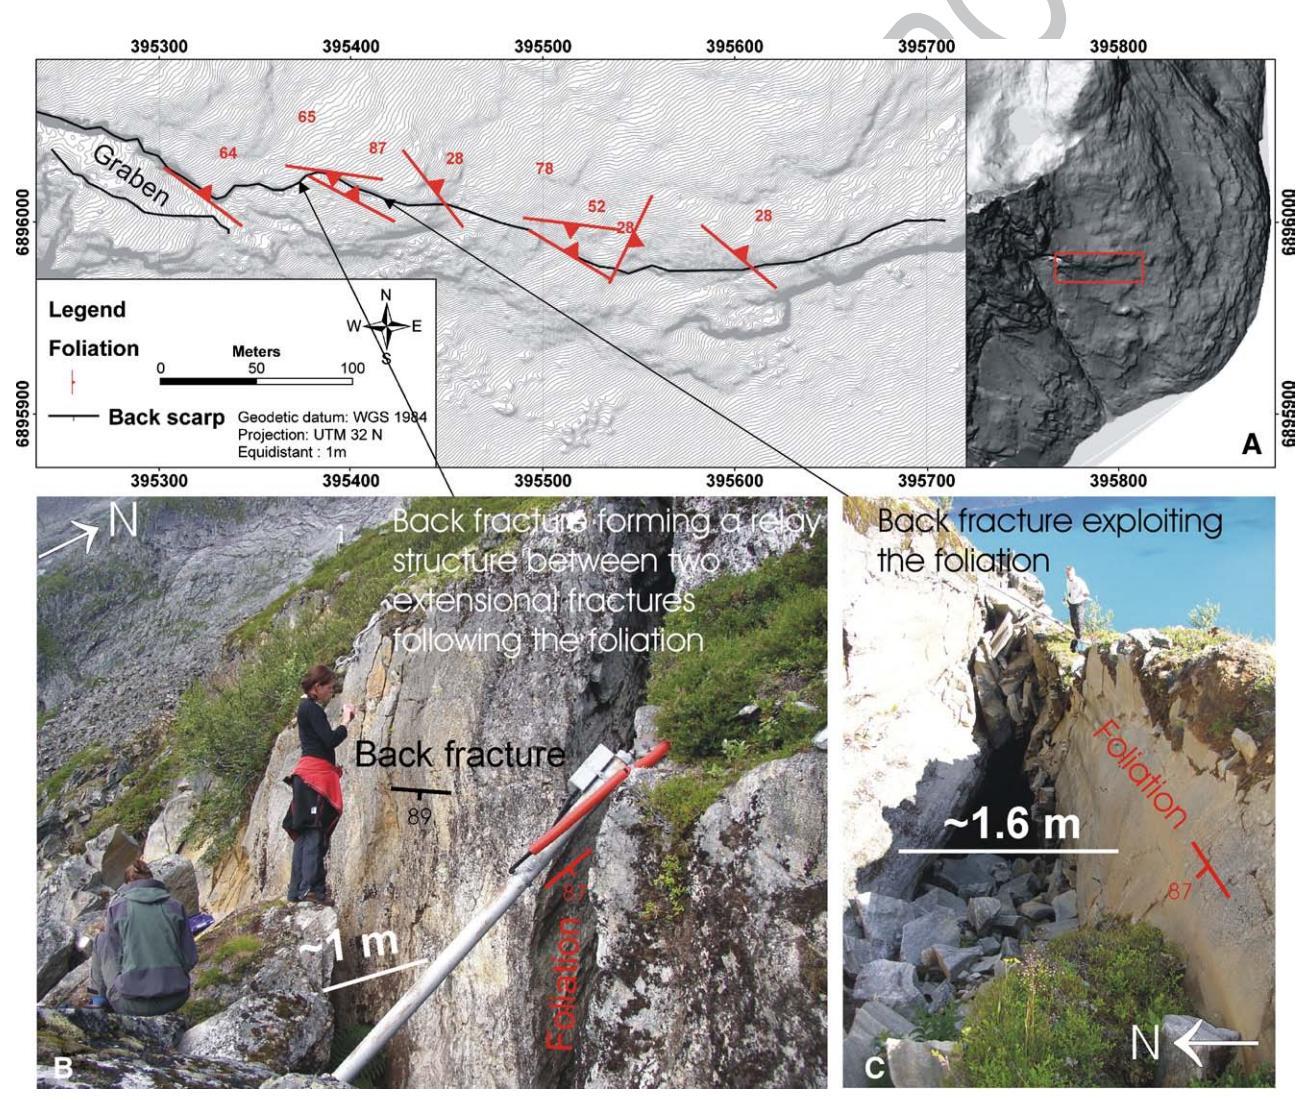
**Fig. 4.** The foliation of the bedrock controls the development of the back scarp. Where the orientation of the foliation is favourable for extensional fracturing (i.e. when sub-vertical or dipping down slope), the back fracture follows the foliation. In contrast, where the foliation is not favourable for reactivation, the back fracture reuses pre-existing fracture sets that commonly have an E–W strike, and is steeply dipping. Locally, the back scarp zone splits into segments that form relay structures (B). A) Map showing the back scarp zone and the foliation along this zone experiencing extension. B) Example of site where the foliation is not favourable and the back (extensional) fracture has formed a relay structure between two larger extensional fractures, the latter following the foliation. C) Example of back fracture that is controlled by the foliation, which is sub-vertical and undulating due to mesoscopic folding. Both localities are monitored by extensometers, recording the horizontal and vertical movements along the back fracture.

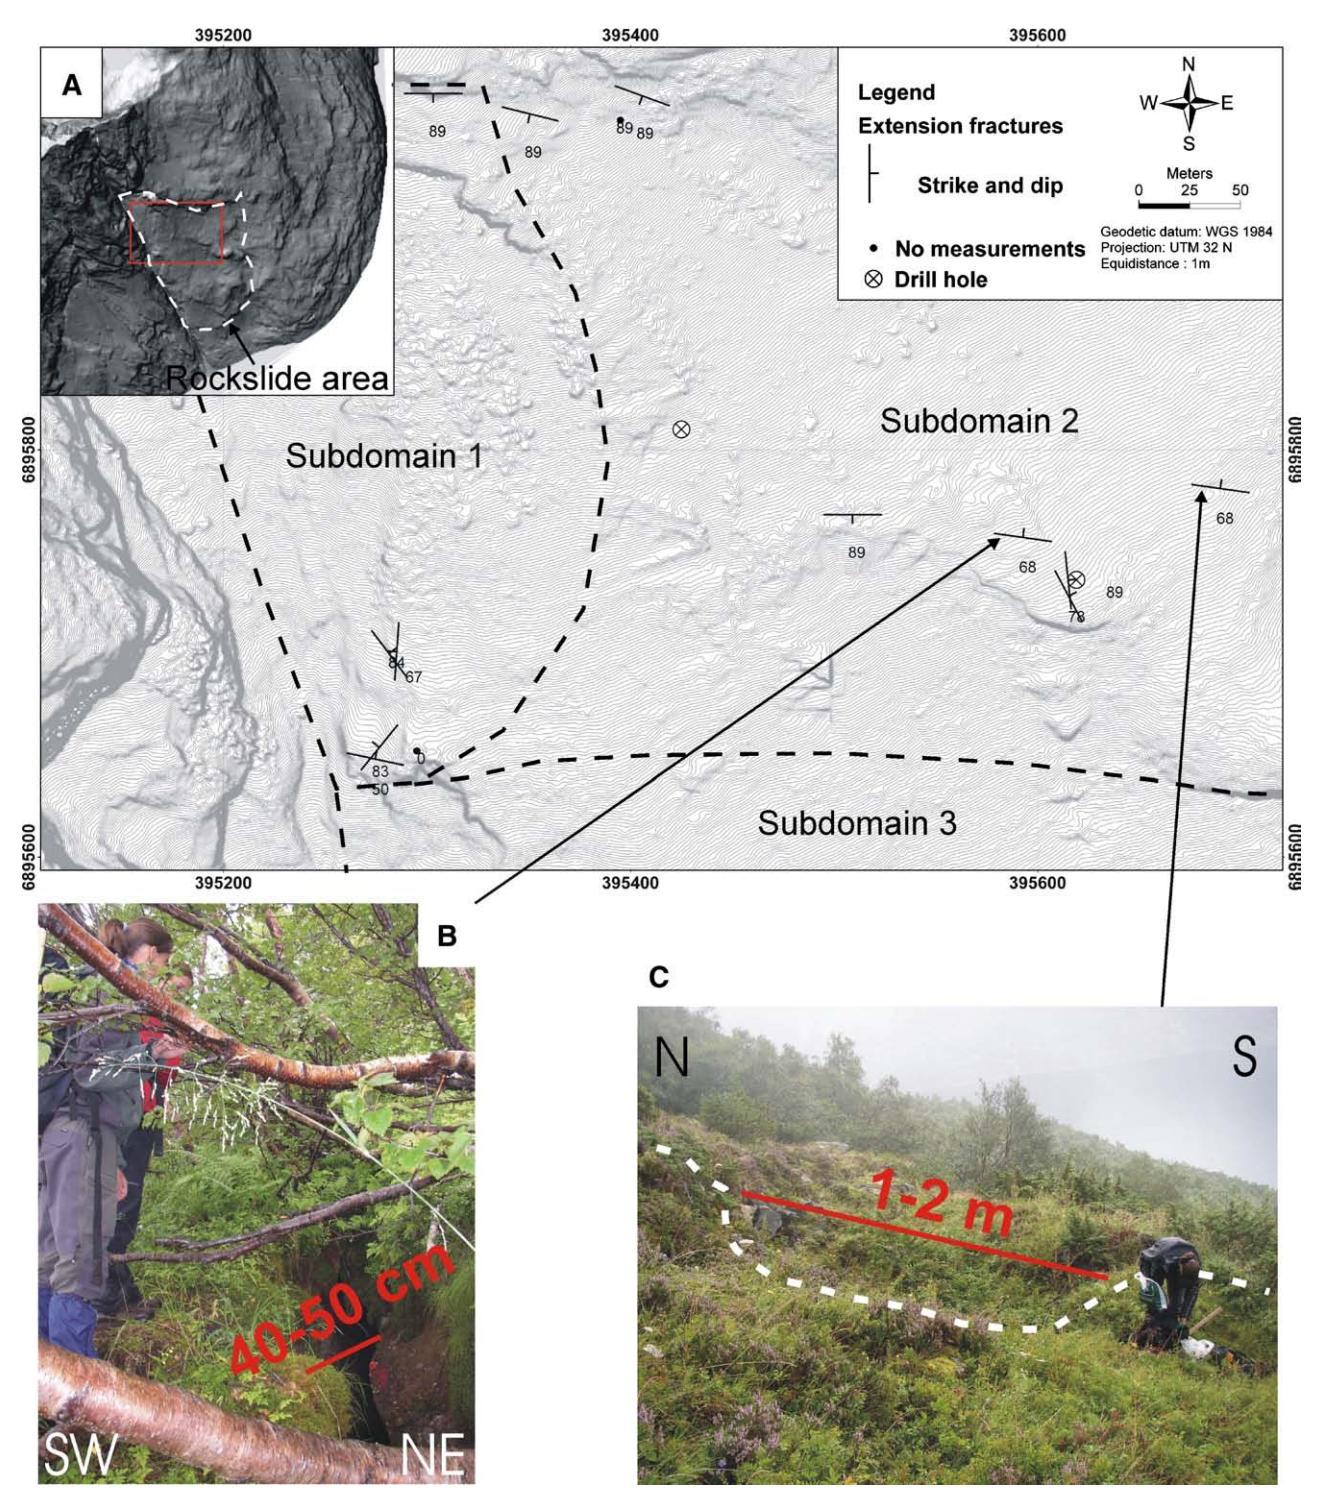
**Fig. 5.** A) Extensional fractures located in the Åknes slope. In sub-domain 1 are pre-existing fractures oriented c. N–S and c. E–W reactivated by extension, with separation up to 50 cm. In sub-domain 2 are extension fractures that are slope parallel observed as shown by example B) and C) These extension fractures are oriented perpendicular to the movement direction (c. E–W trending and 60–90° dip to N–NNE), and are fractures caused by the movement of the rockslide.

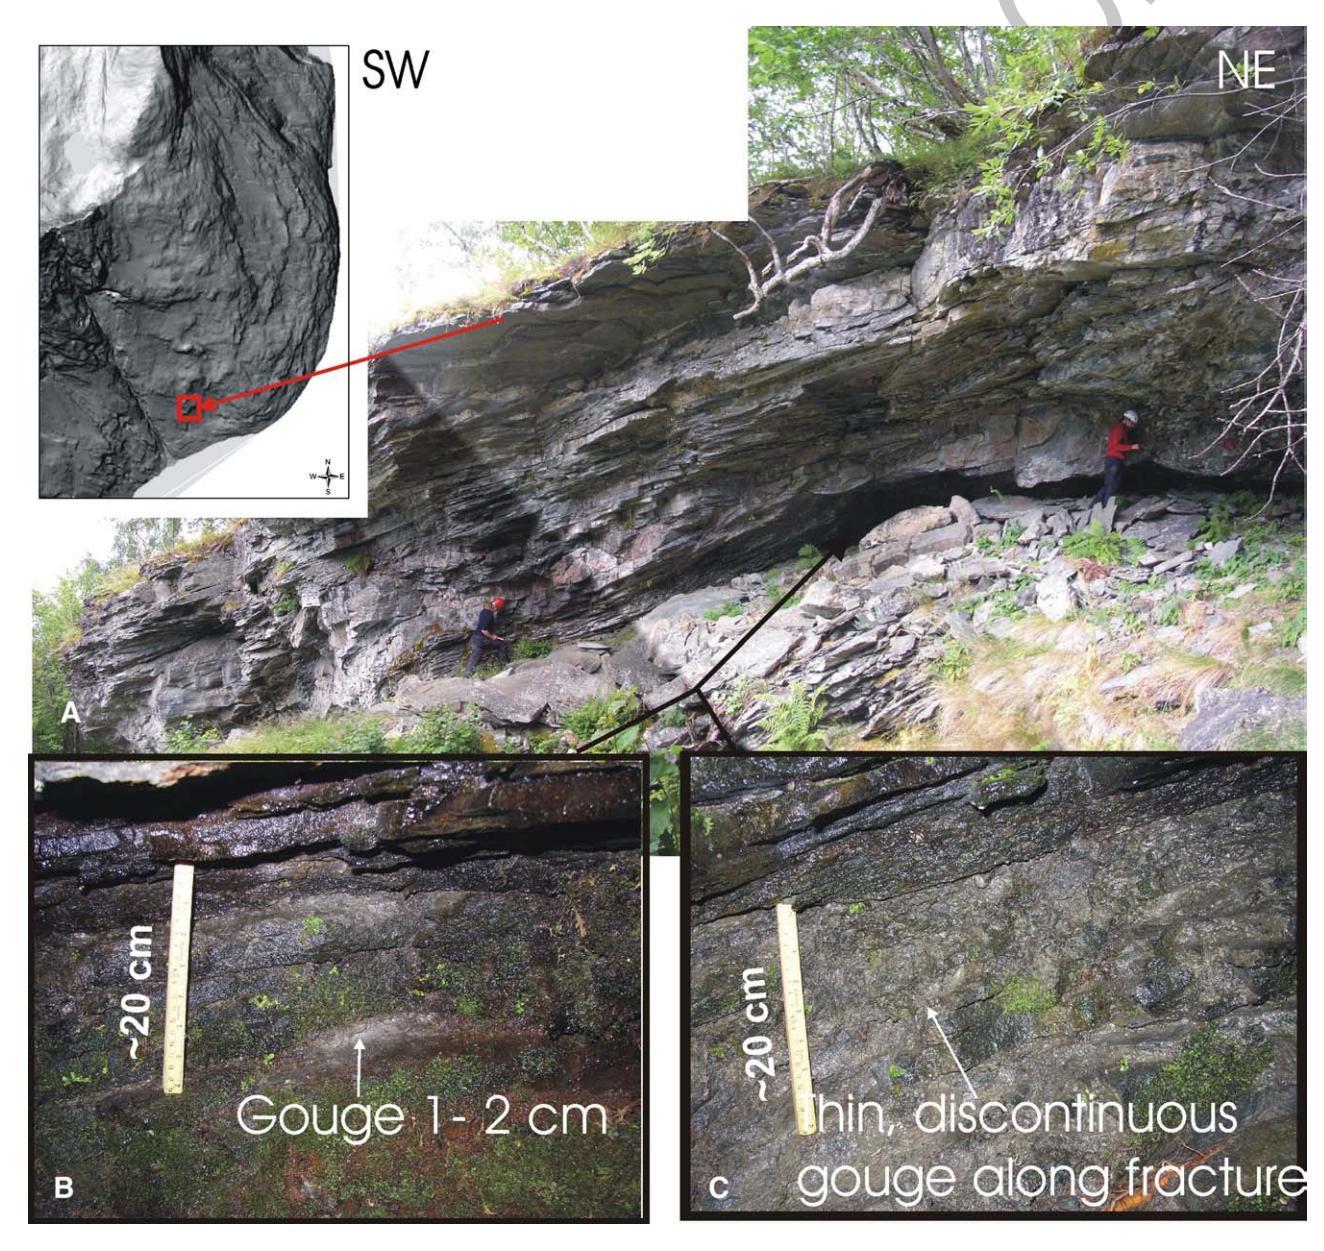
**Fig. 6.** A) Sliding surface of the toe zone where the basal thrust daylights the rock slope surface. Due to upward and forward separation, the transported block is pushed on top of the vegetated slope, causing the formation of a rock overhang that partly has caved in. B) Fault gouge is located as a thin layer (1–2 cm) with undulating thickness along the shear surface. (C) Example of a network of thin gouge layers that fill fractures within the intensely deformed zone of the sliding surface. This sliding surface is exposed for at least 50 m along strike, and the thickness of the gouge rich zone is approximately 20 cm on average along the exposure. The moss growing on the fractured zone indicates water seepage.

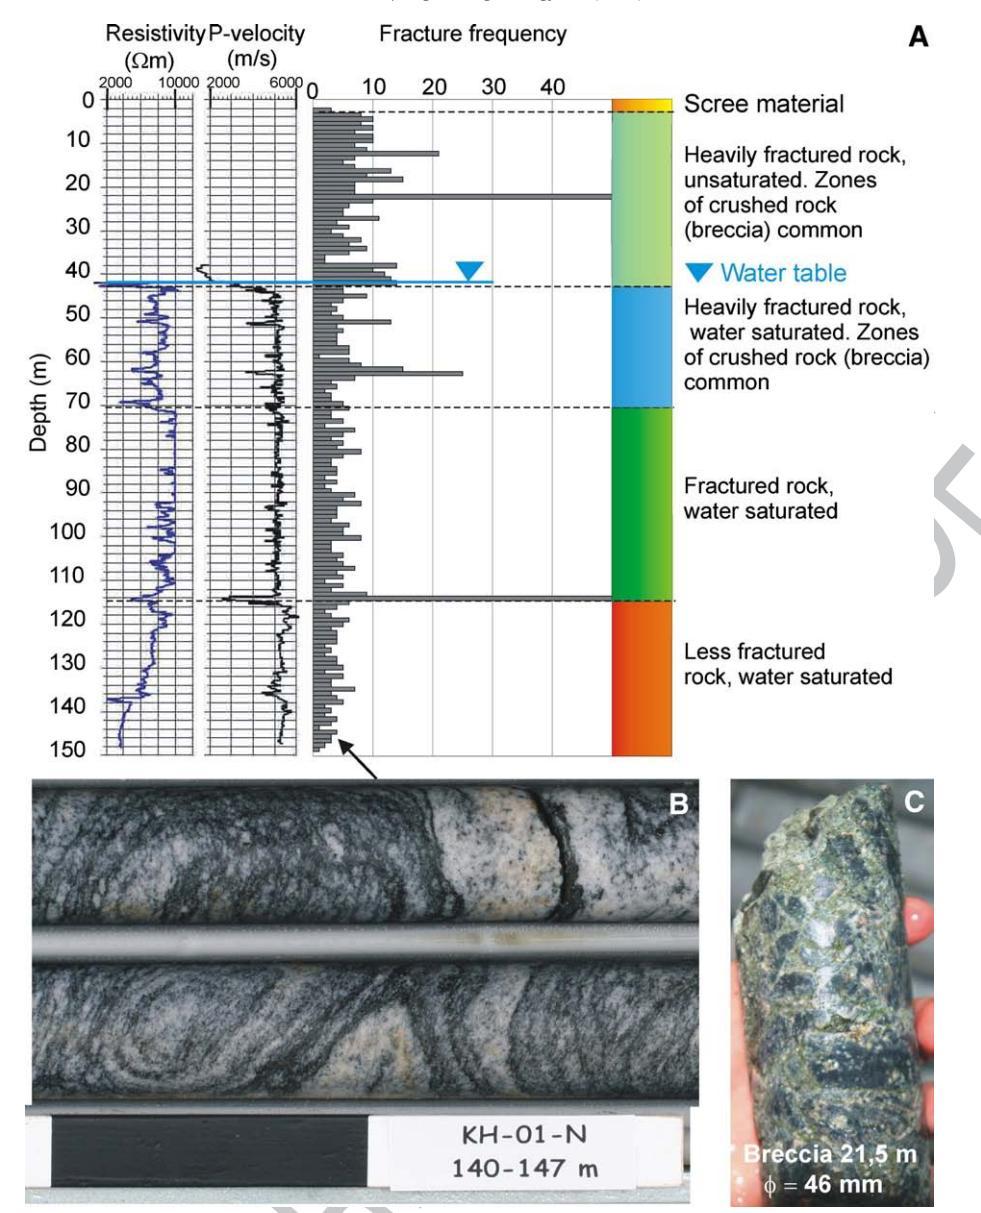
**Fig. 8.** A) Drill hole and drill core data that show that the fracture frequency decreases with depth. Five zones can be identified on the basis of fracture intervals and responses in the resistivity and P-wave logs of the borehole walls. The colour codes are based on the zonation in the 2D resistivity profile given in Fig. 6D. This colour code is implemented on all subsurface data, to visualise the zonation in the subsurface, with the exception that the blue and green zones in the drill core and 2D resistivity coincide with the green zone in the seismic. B) Drill core showing that the bedrock is a granodioritic gneiss with a folded penetrative foliation on cm-scale. C) An up to 30 cm thick (proto-) breccia that occurs at 21.5 m depth.
