Degradation Mechanisms of AA 1350 Aluminium Alloy Conductor Strands in Air and Chloride Solution

Thesis for the Degree of Philosophiae Doctor

Trondheim, May 2020

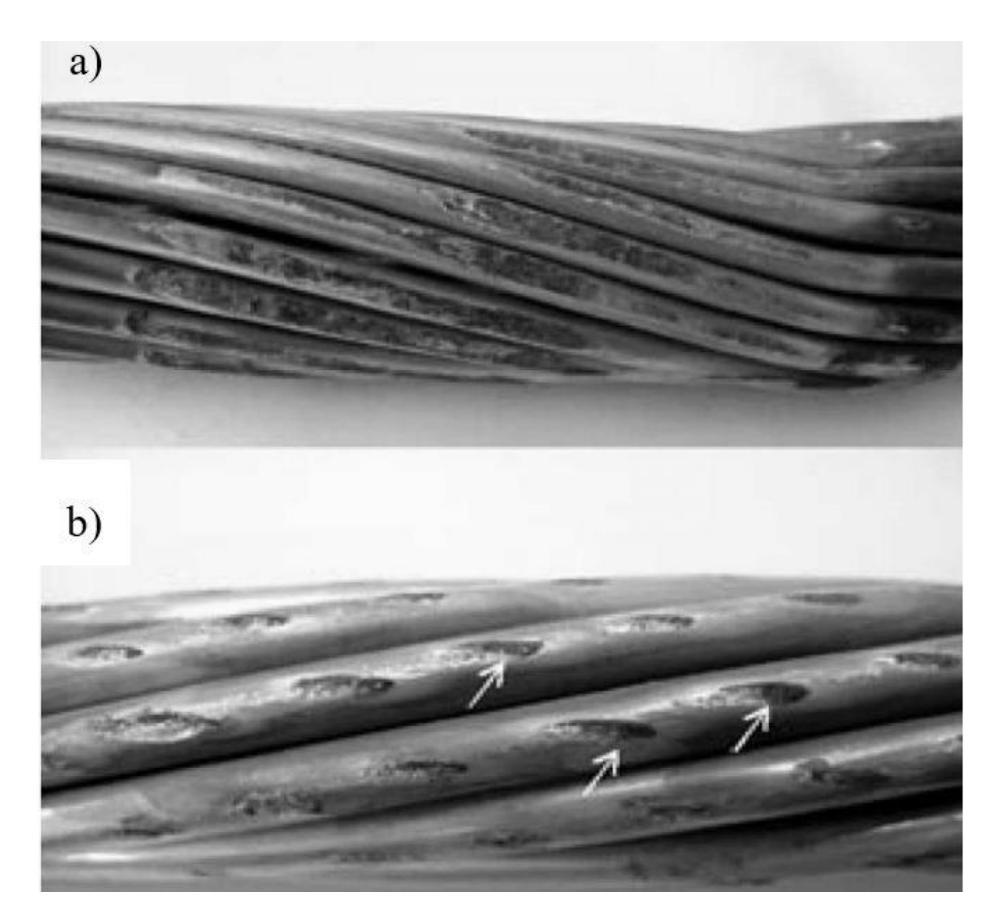
Fig. 2.9. Contact surface of a failed ACSR conductor strands at a spacer clamp. a) View of the plastic deformation on the outer layer aluminum strands. b) View of the inner layer aluminum strands showing elliptical fretting marks (see arrows pointing at dark oxide) located at the end of the clamping region [19].

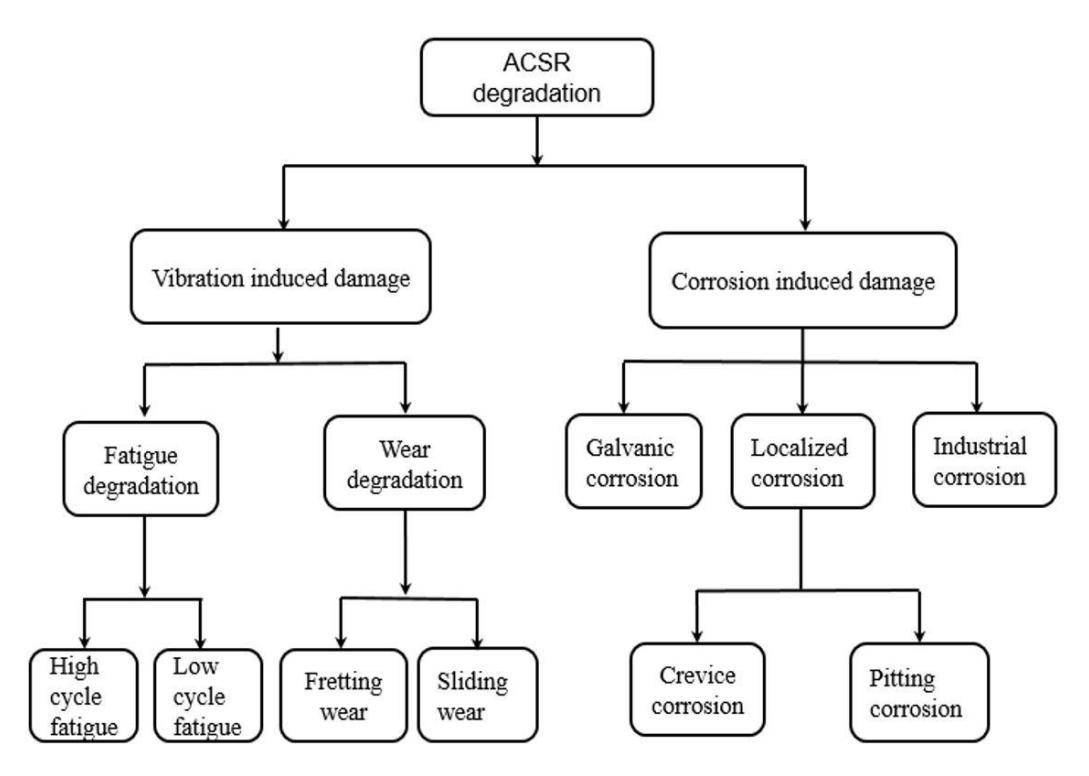
The aluminium strands of ACSR fail due vibration and corrosion induced degradations, as summarized in Fig. 2.11. The figure shows that vibration induced degradations can be classified into fatigue and wear types. While the fatigue degradation can further be classified into high cycle and low cycle fatigue, the wear degradations can be classified as fretting wear or sliding wear. Similarly, the corrosion induced degradations documented so far are mainly localized corrosion (pitting and crevice corrosion), galvanic corrosion, and atmospheric corrosion, in the present case due to pollution.

Fig. 2.11. Classification of conductor degradation.

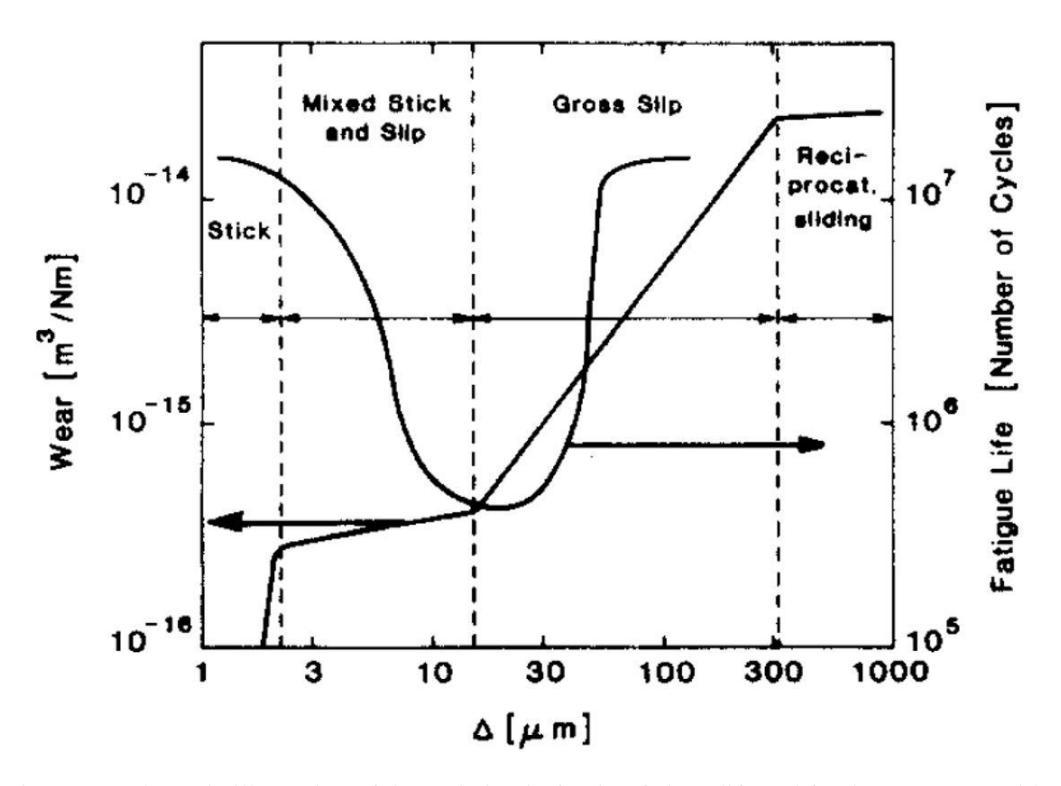
Fig. 2.13. Schematic illustration of the variation in fretting fatigue life and fretting wear rate with relative slip amplitude (Δ) ranges in different fretting regimes [39].

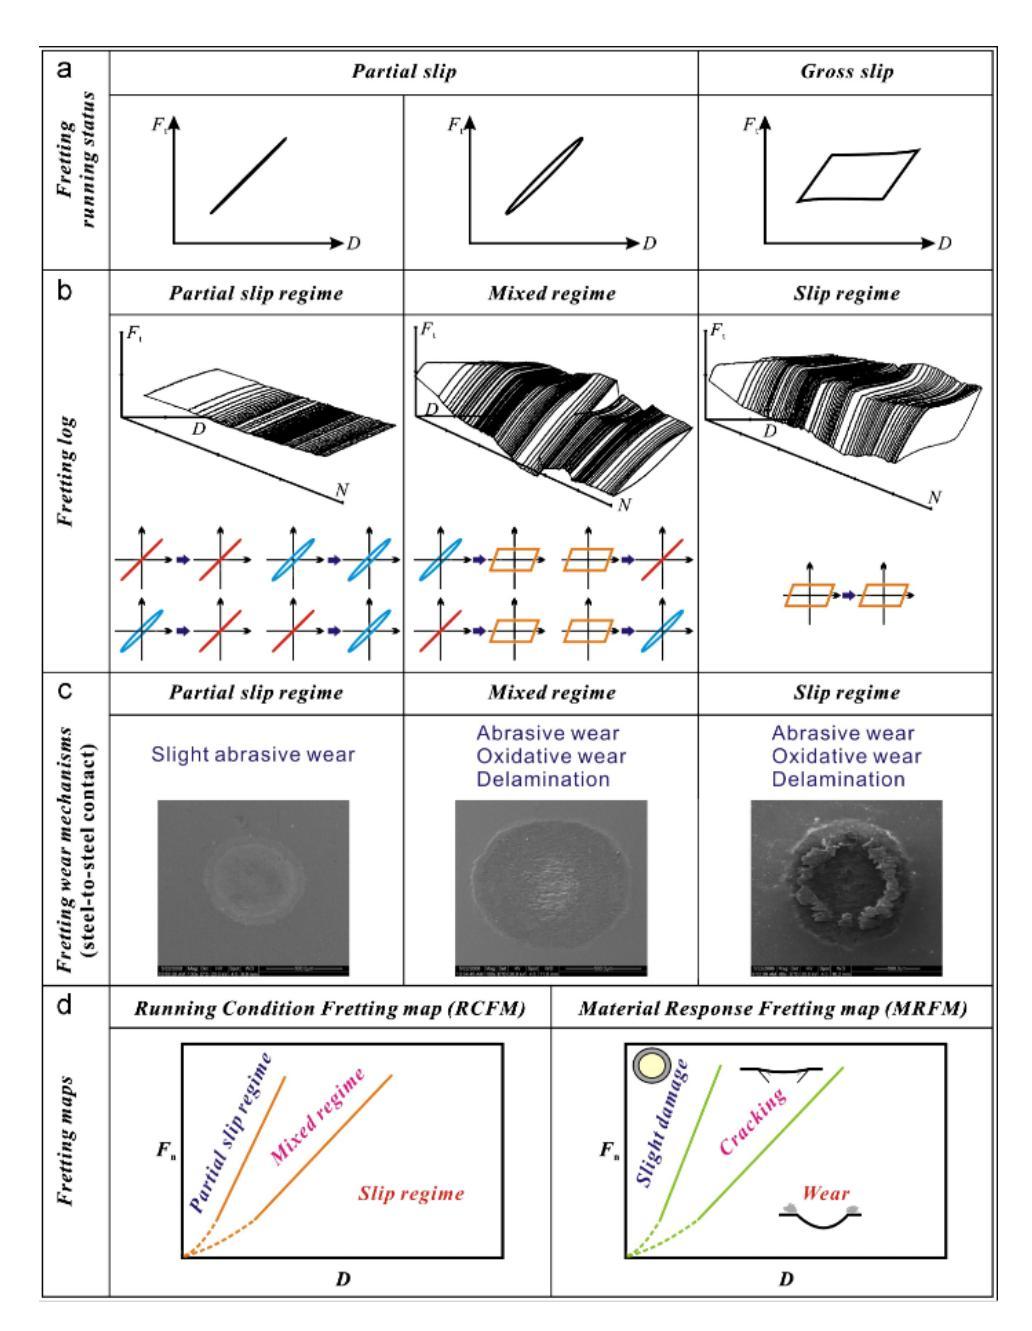
The sample surfaces in Fig. 2.16c experienced limited damage by oxidation and wear in the stick regime. The mixed stick slip regime, also called the intermediate regime, showed marginal wear and oxidation, but cracking occurred at the edge of the contact. In contrast to the other mixed stick slip regimes, the contact surface subjected to the gross slip regime underwent significant wear degradation enhanced by oxidation and marginal surface cracking. This indicates that the friction logs or fretting curves can be used to predict the conditions in which wear or fatigue degradation is expected.

Fig. 2.16. a) Classification of fretting regime into partial and gross slip fretting regimes based on kinematics at the contact interface. b) Classification of fretting regime into partial slip mixed and slip regimes as per evolution in the friction logs. c) Fretting degradations in partial slip, mixed, and slip regimes. d) Running condition and material response fretting maps [65]. F_t - is tangential force, D - is relative slip (displacement), F_n - is a normal force and N - is the number of cycles.

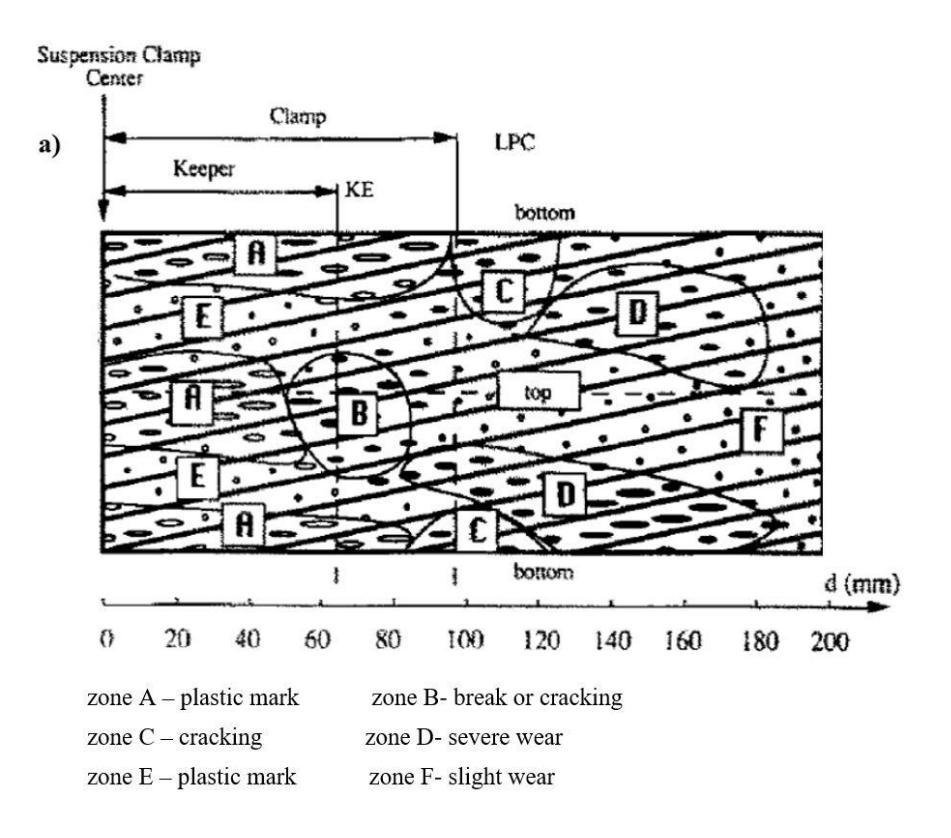
Fig. 2.24. Variation of fretting fatigue life as a function of a) fretting mark area and b) distance from the suspension clamp center [18].

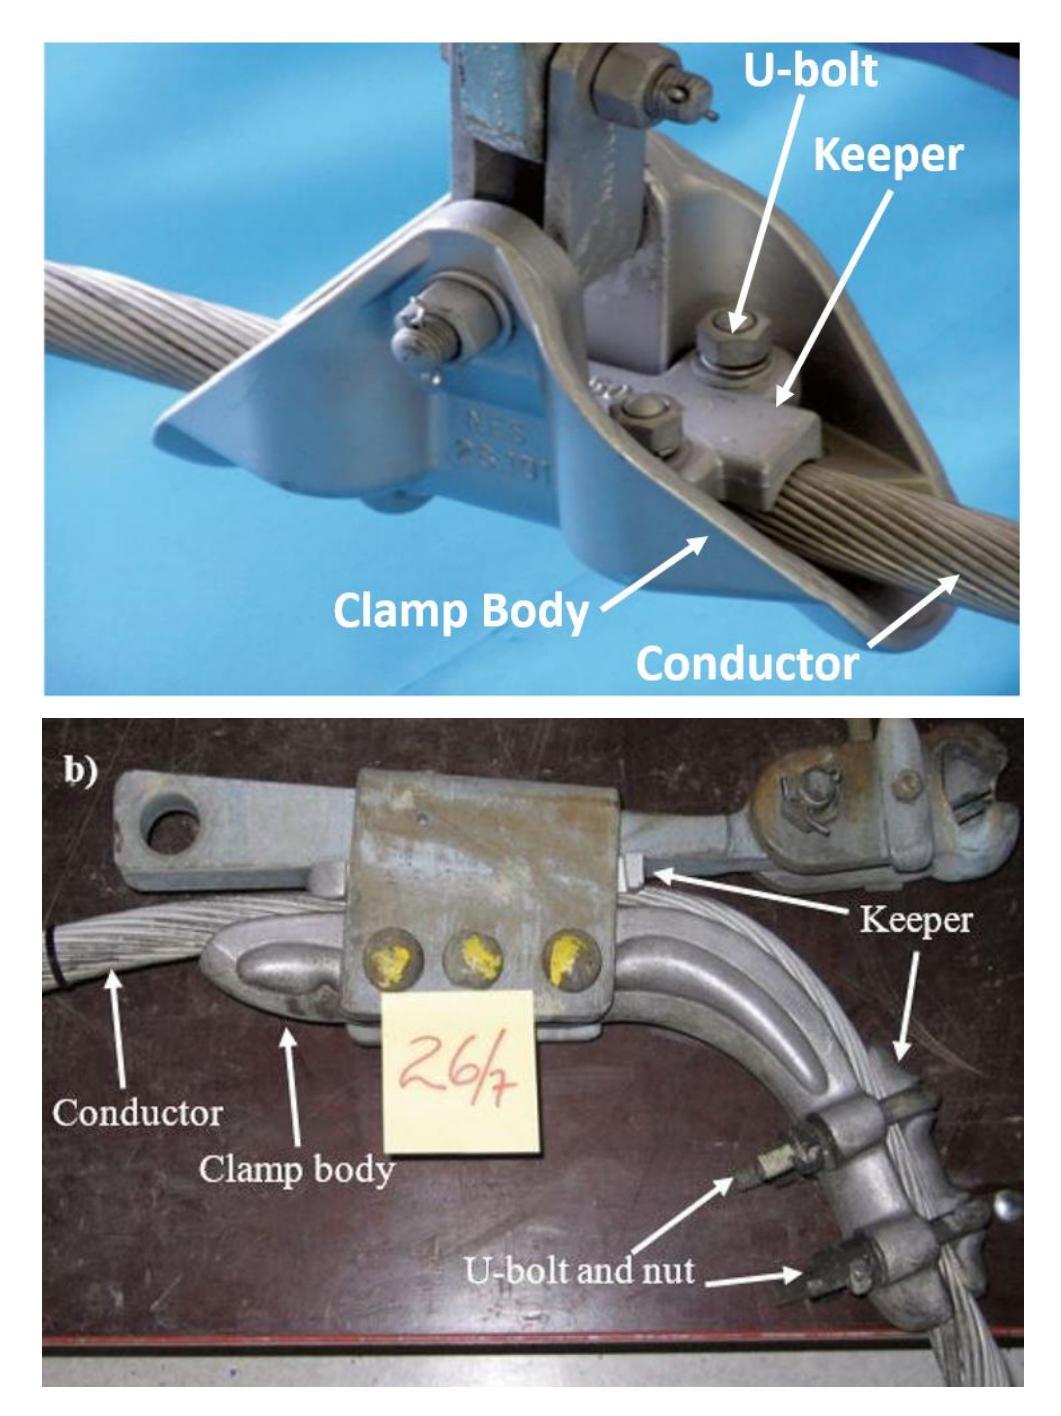
Fig. 3.1. a) Suspension clamp-conductor components [18]. b) Tension clamp-conductor components. The diameter of the outer layer aluminium in b) strands is 3.71 mm

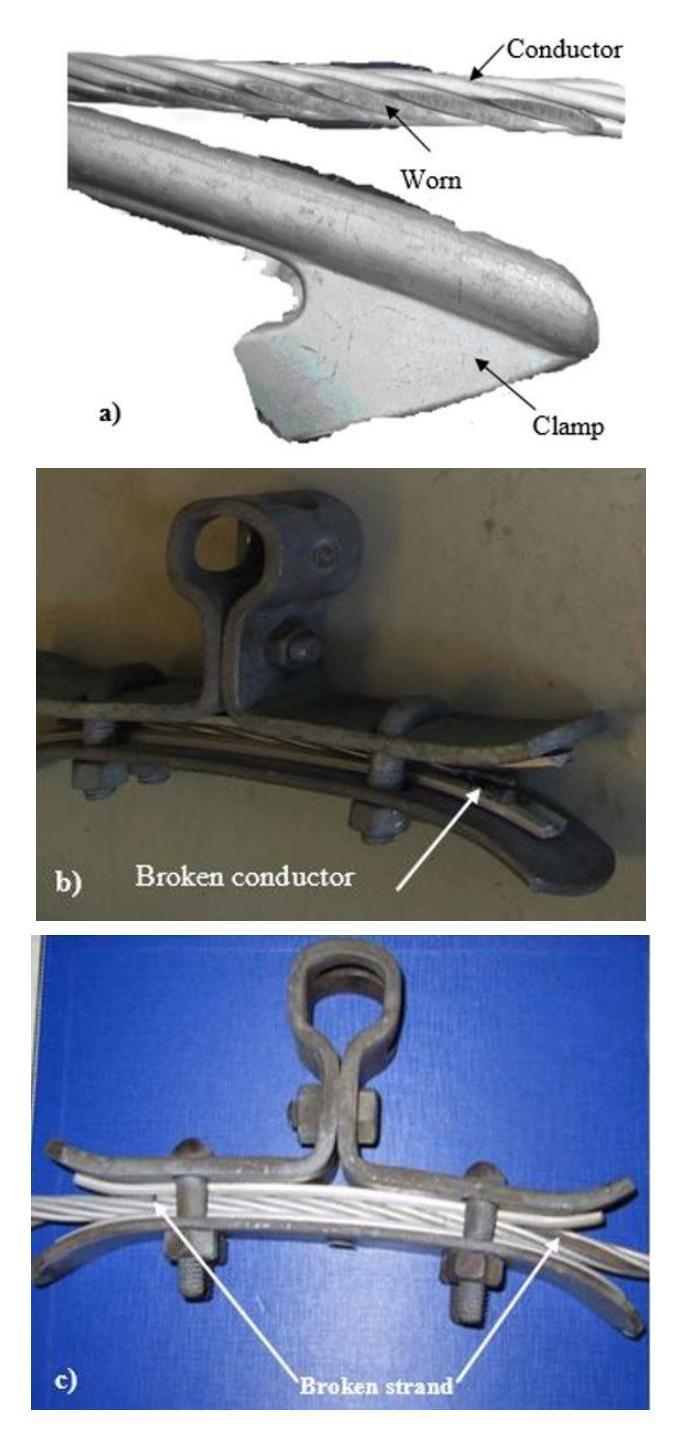
Fig. 3.2. Photographs of a) worn conductor, b) broken conductor and c) broken strands at both ends of the clamp (arrows). The diameter of the aluminium strands is 3.71 mm.

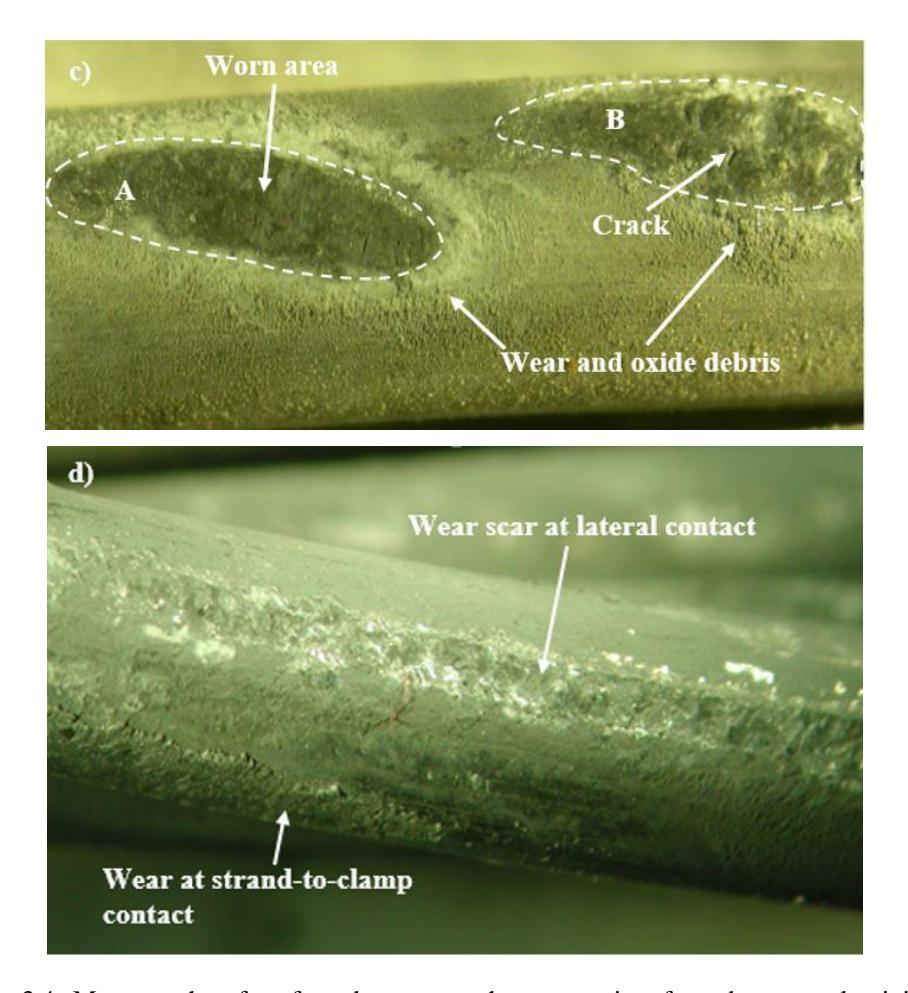
Fig. 3.4. Macrographs of surface damages at the contact interfaces between aluminium strands with actual diameter of 3.69 mm. a) Stick contact fretting condition with sparse oxide debris and intact elliptical plastic deformation mark, indicating no relative slip. b) Partial slip fretting contact condition with stick contact at the centre (A) and region of relative slip around (B), containing corrosion products and wear debris. c) Gross slip fretting contact condition with wear at the centre, surrounded by oxide and wear debris around the contact edge. d) Gross slip fretting contact at lateral and inner contacts characterized by wear and plastic deformation (indicated by arrows).

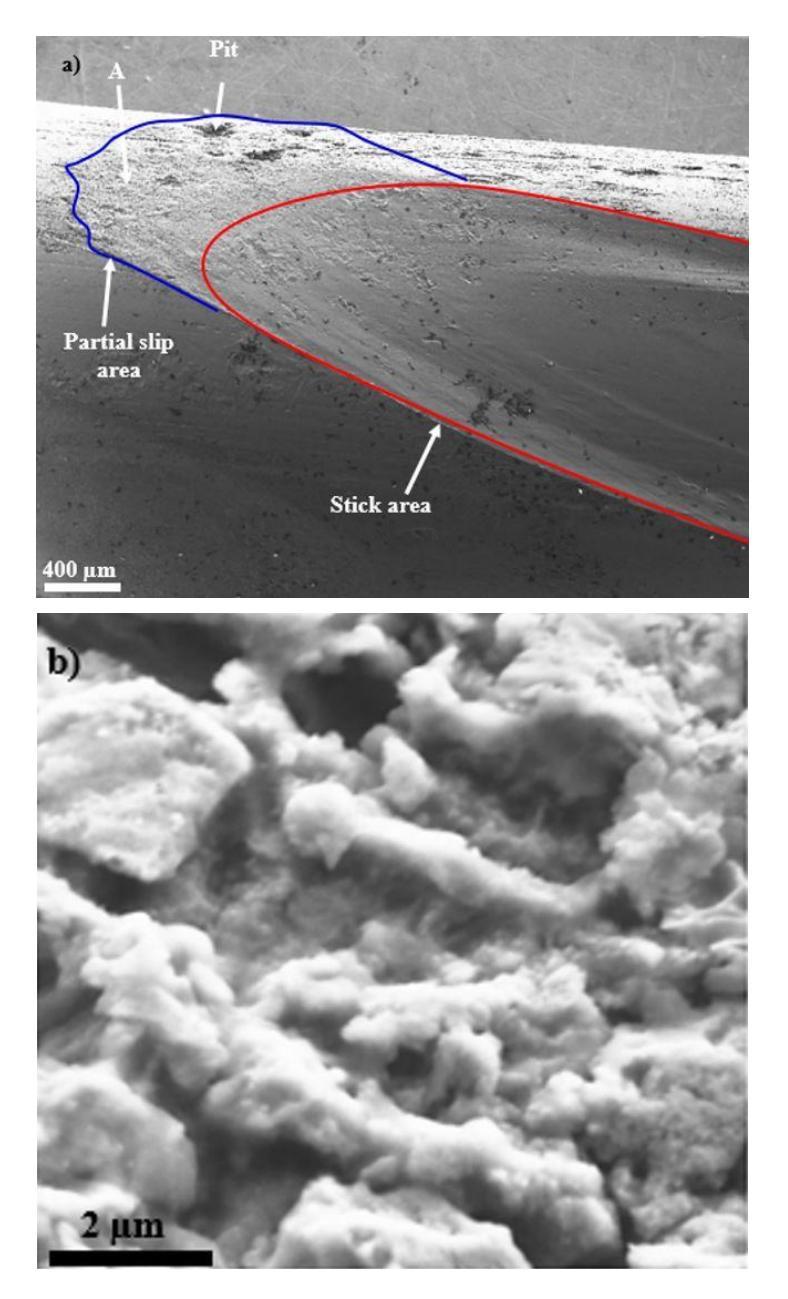
Fig. 3.5. Secondary electron SEM images of contact interface of a conductor strand, recovered after service in a marine environment, obtained after cleaning in hot chromic phosphoric acid bath. a) Image of partial slip fretting condition with stick contact at the centre and slip contact at the edge with wear and pits at edge and intact at the centre. b) Higher magnification Secondary electron SEM secondary electron image of zone A showing an etched area in the slip zone.

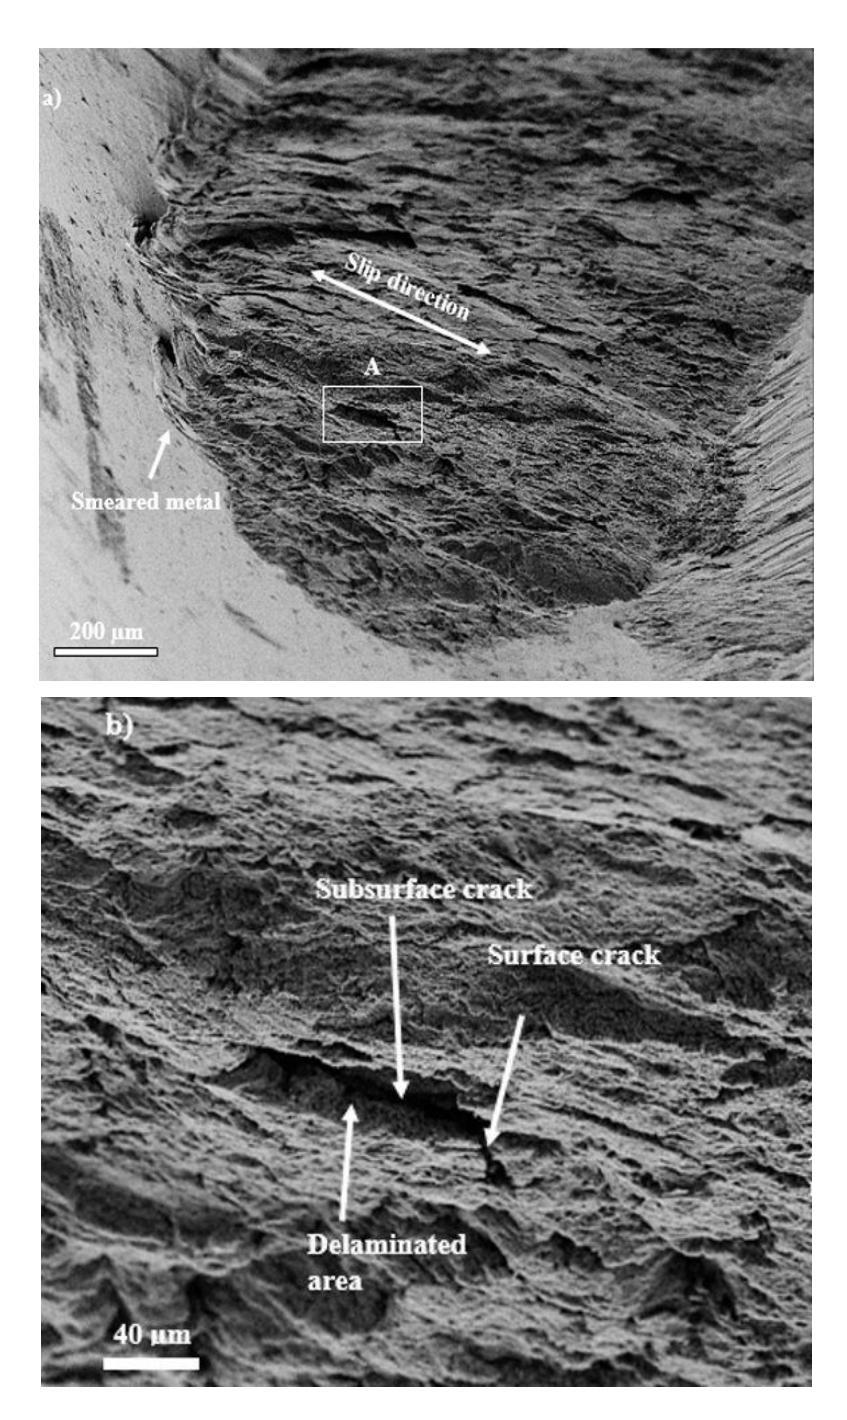
Fig. 3.6. a) Secondary electron SEM image of an elliptical contact surface exposed to gross slip fretting contact condition. b) Magnified view of the region marked A in (a) showing cracks and delamination caused by fretting in the wear track.

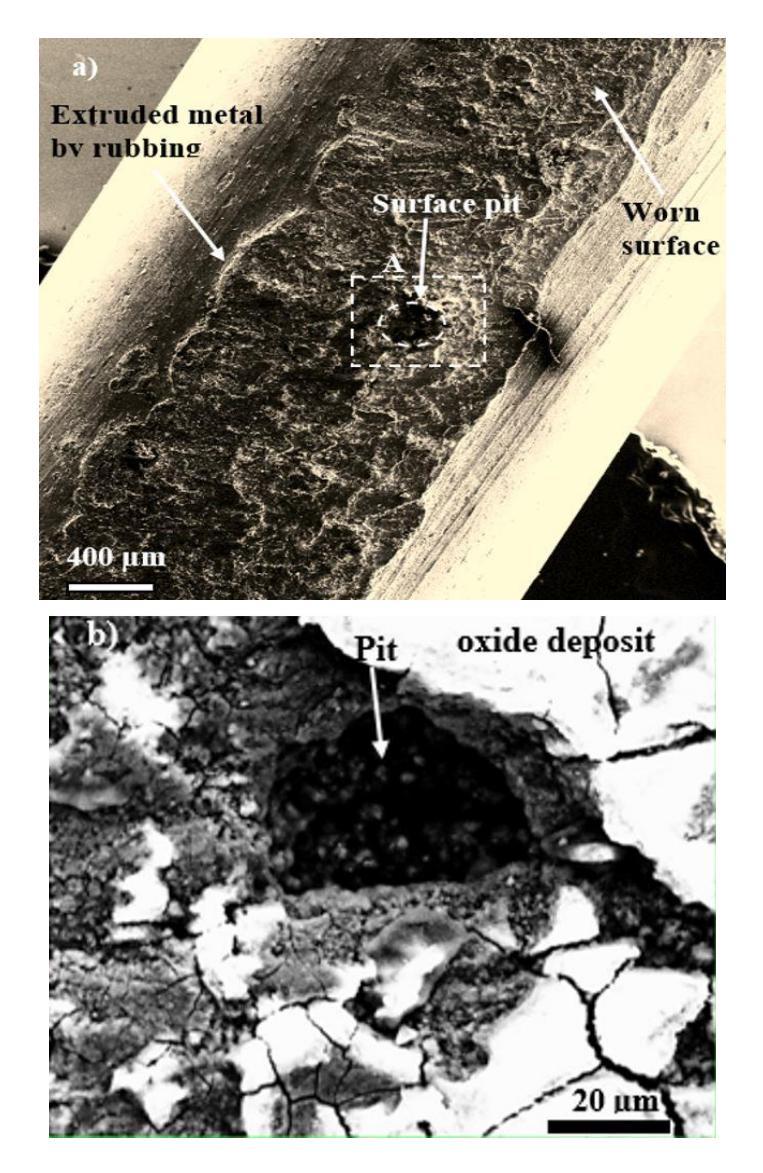
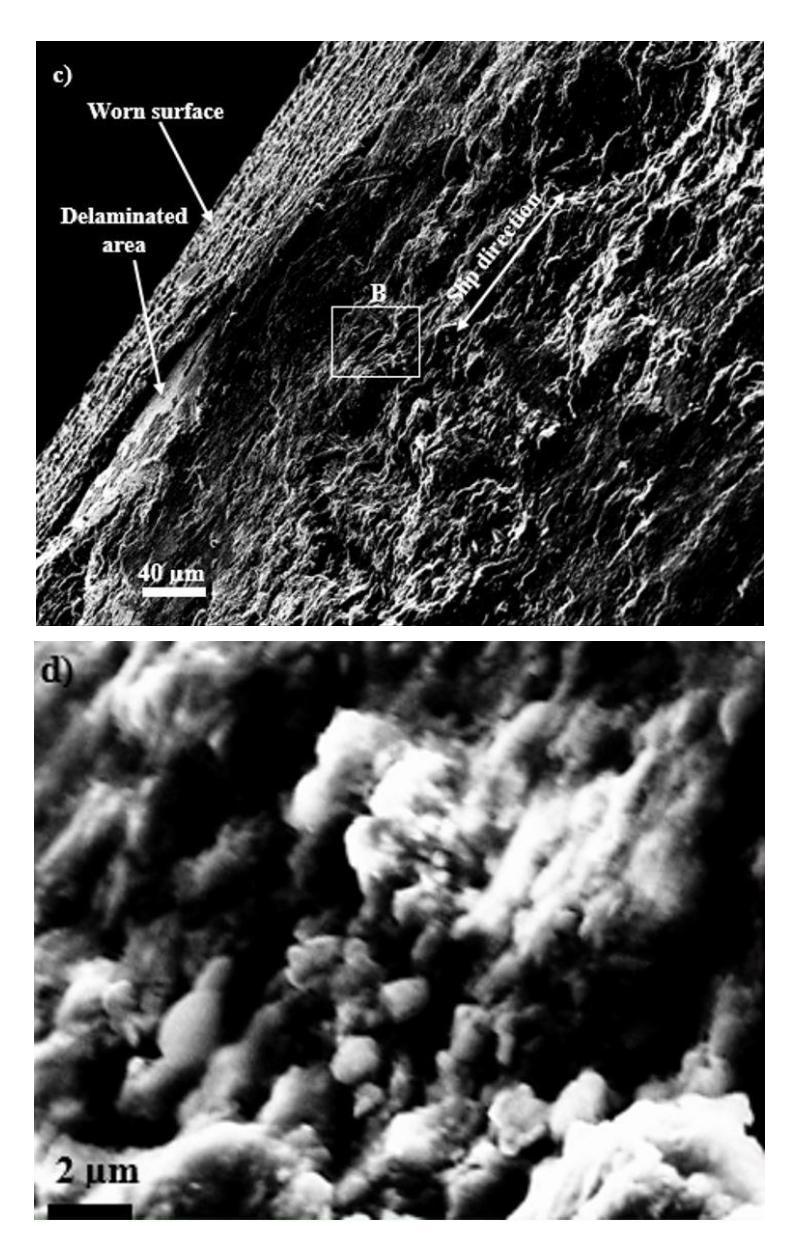
Fig. 3.7. Fretting wear - corrosion damage morphology on aluminium strand rubbed against the clamp. a) Image of worn surface damaged by wear and pit. b) Secondary electron SEM image of the worn surface showing broken oxide cake and pit marked A. c) Secondary electron SEM image of the worn surface after removing the oxide showing delamination and abrasive wear. The area marked B is magnified. d) High magnification secondary electron SEM micrograph of the area marked B in c) showing ridges of deformed metal.

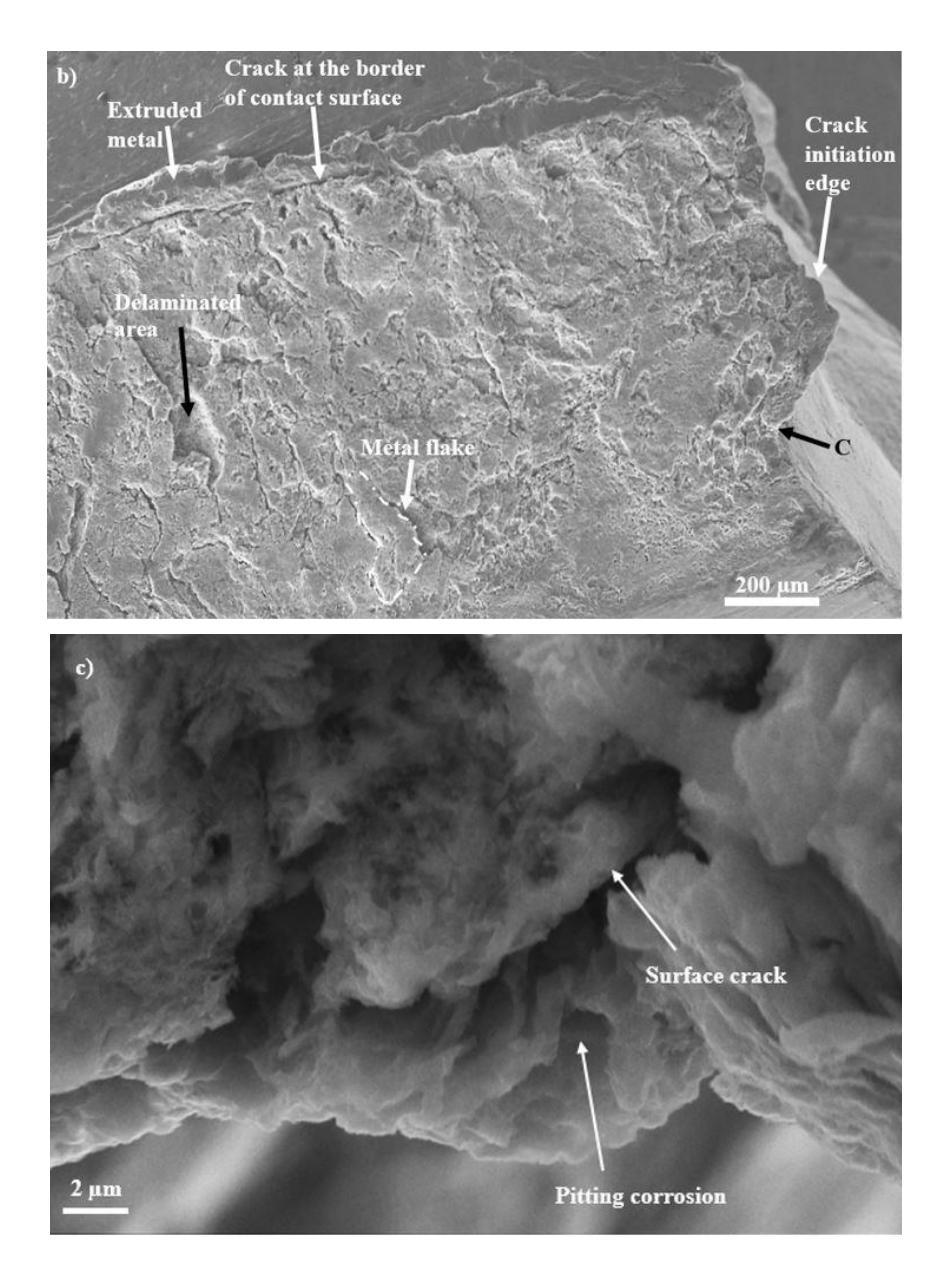
Fig. 3.8. Fretted site on broken aluminium strand. a) Fatigue crack at plastically deformed and worn elliptical mark. b) Secondary electron SEM image showing plastic deformation near crack initiation site taken after cleaning oxide deposit in hot bath of chromic phosphoric acid. c) Secondary electron SEM micrograph showing voids and corrosion etch at the crack initiation edge. The diameter of the aluminium strand shown in a) is 3.71 mm.

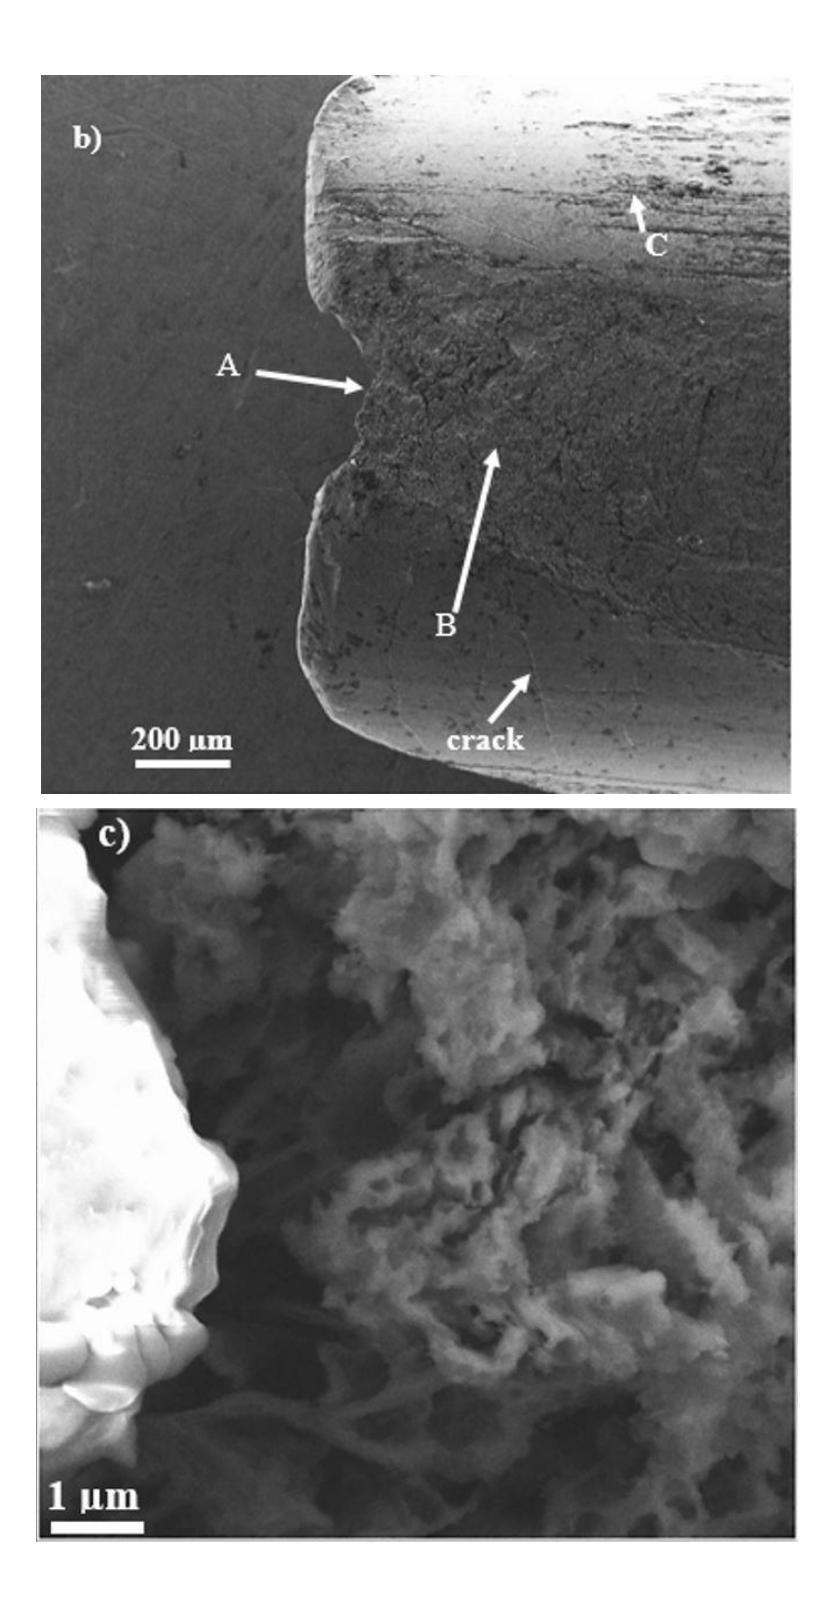
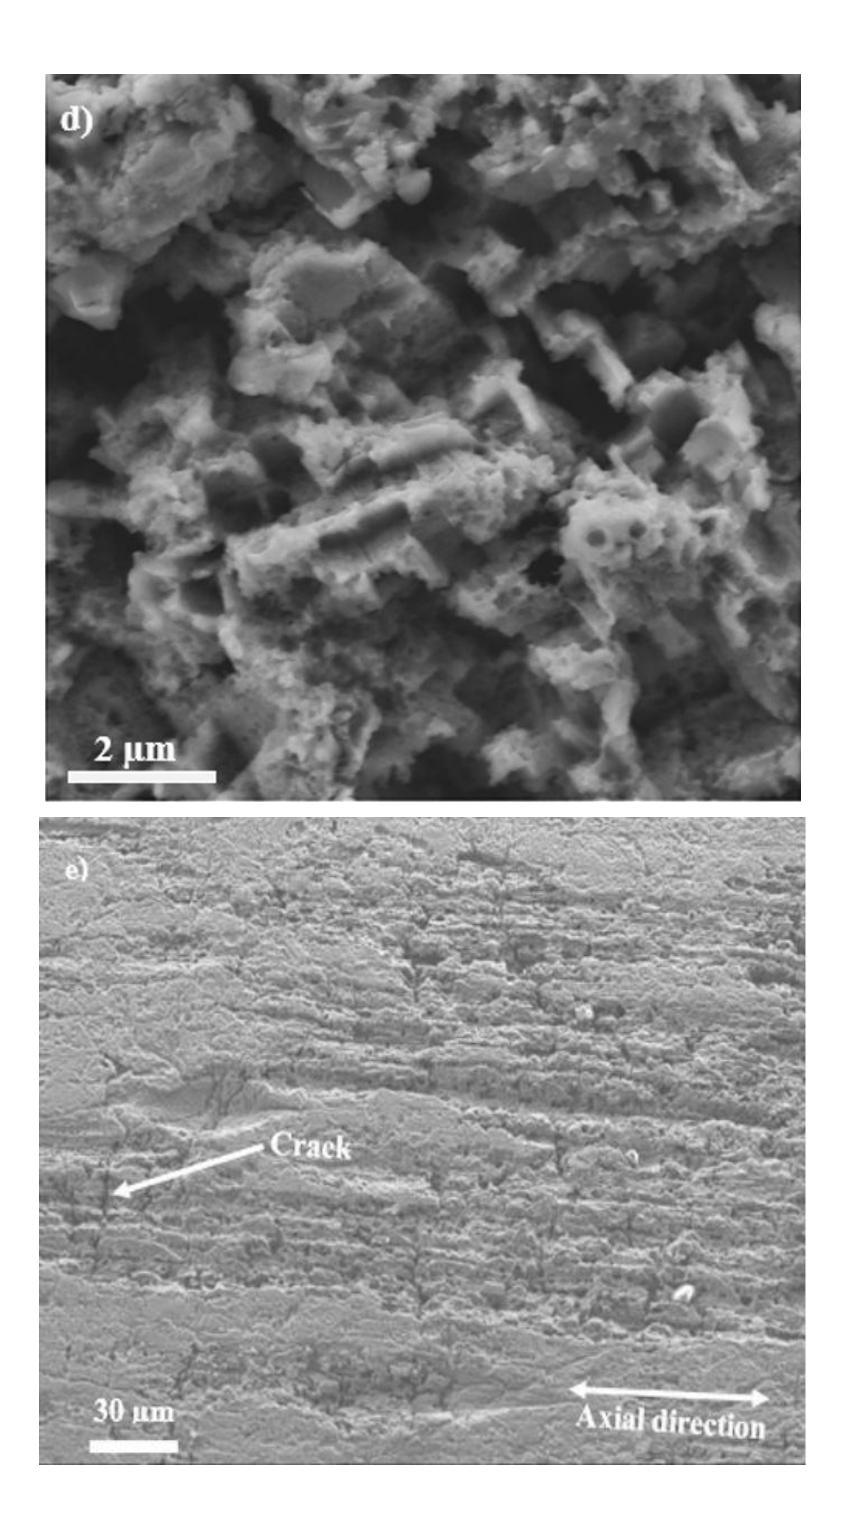
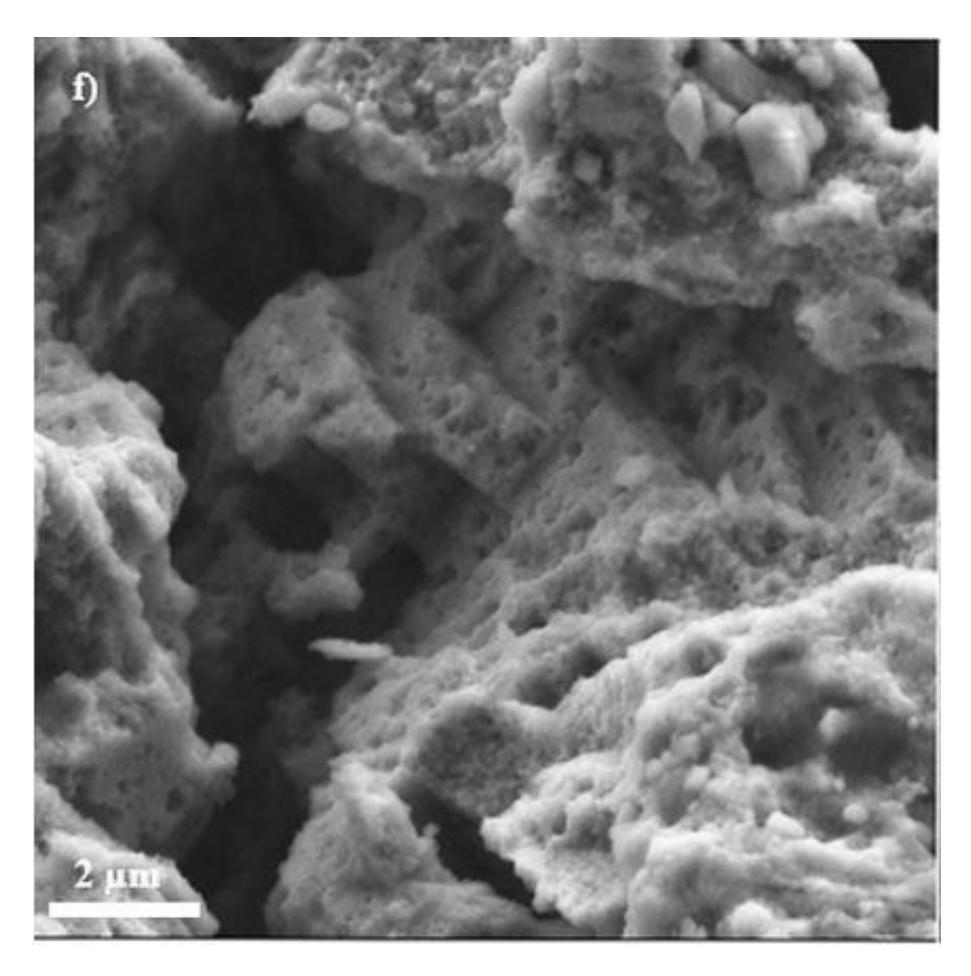
Fig. 3.9. Secondary electron SEM image of a) aluminium strand broken under partial slip fretting corrosion showing contact surface with slight wear, corrosion deposit and fracture, b) strand surface with corrosion deposit removed, showing crack initiation site (arrow A), wear track (arrow B), and abraded area beside the wear track and crack initiation site (arrow C), c) morphology of in the area indicated by arrow A, d) corrosion attack (etching) morphology of the worn surface indicated by arrow B, e) the surface indicated by arrow C, and f) abraded and cracked surface in e) showing etching inside the coalescing crack. The actual diameter of the aluminium strand shown in a) is 3.71 mm.

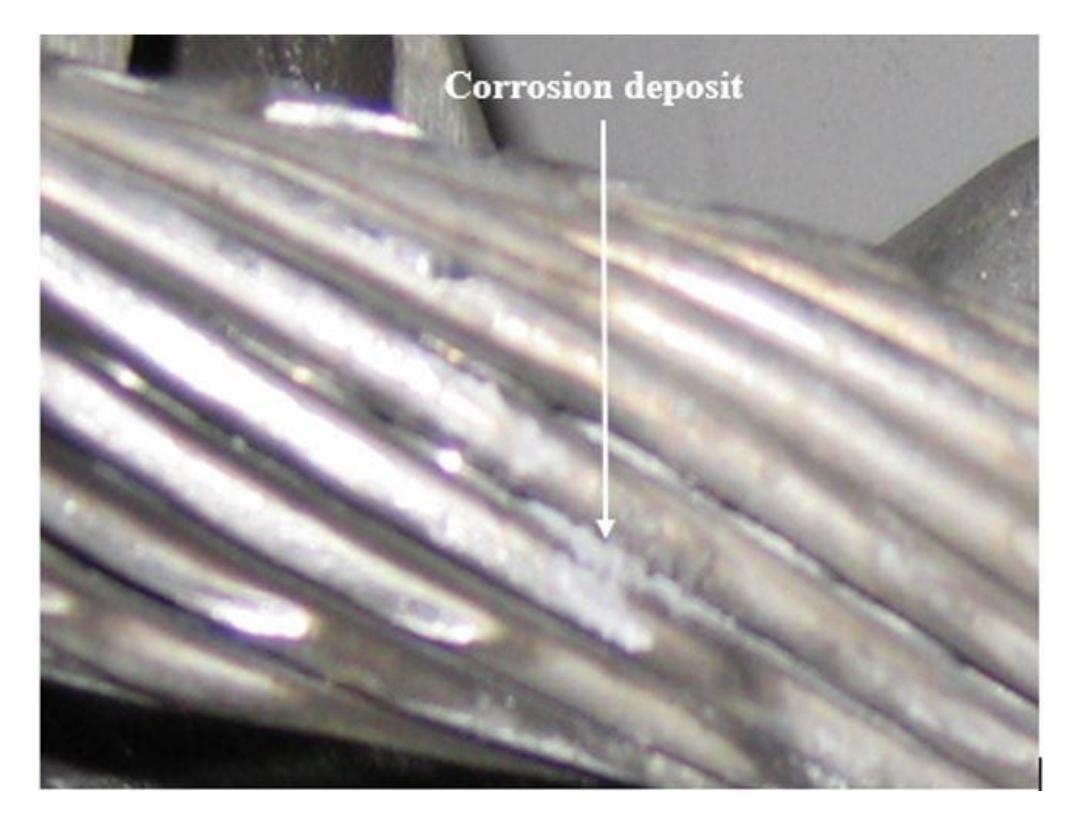
Fig. 3.12. Corrosion deposit between crevices of adjacent 26/7 ACSR conductor strands at the clamp edge. The actual diameter of the aluminium strands is 3.71 mm.

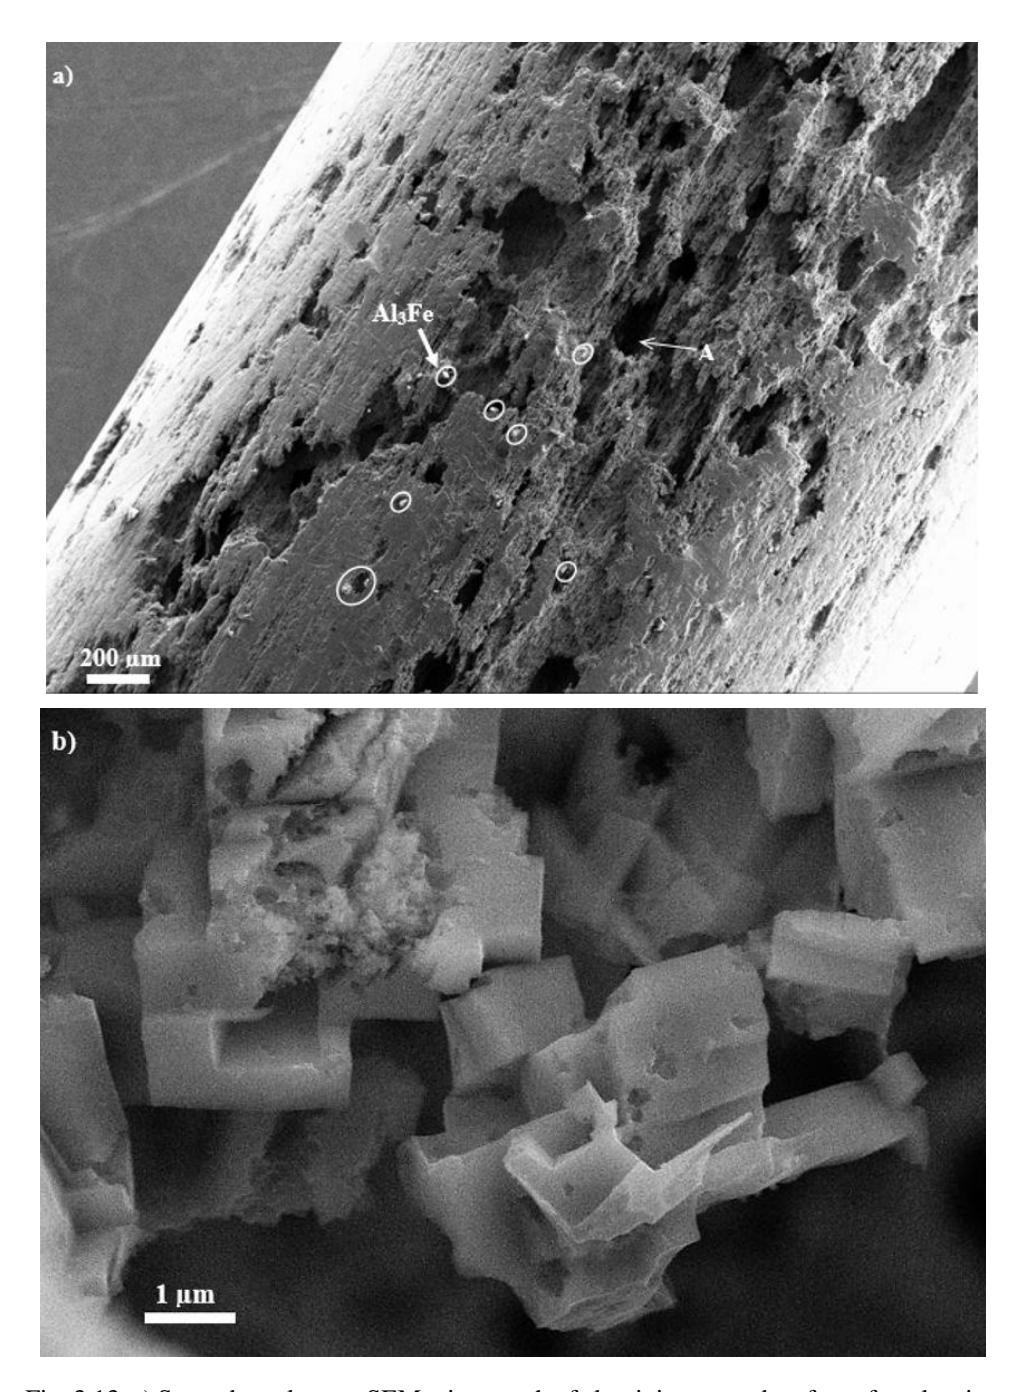
Fig. 3.13. a) Secondary electron SEM micrograph of aluminium strand surface after cleaning the corrosion deposit in a hot bath of chromic phosphoric acid (G1-90) showing crevice corrosion attack. b) Secondary electron SEM micrograph of (zone A) showing pitting corrosion attack.

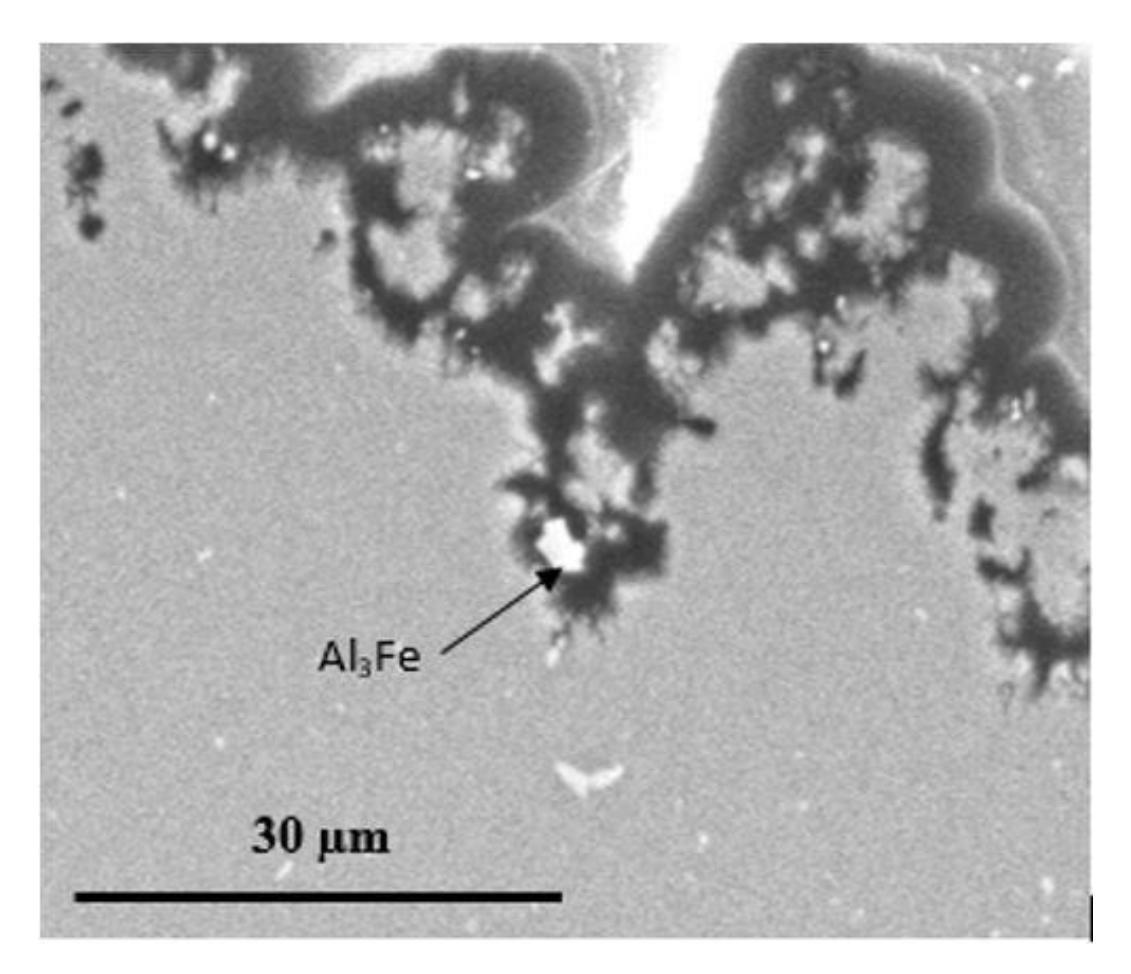
Fig. 3.14. Secondary electron SEM cross sectional image of surface damaged by crevice corrosion and wear showing pitting corrosion attack around noble Al₃Fe intermetallic phases.

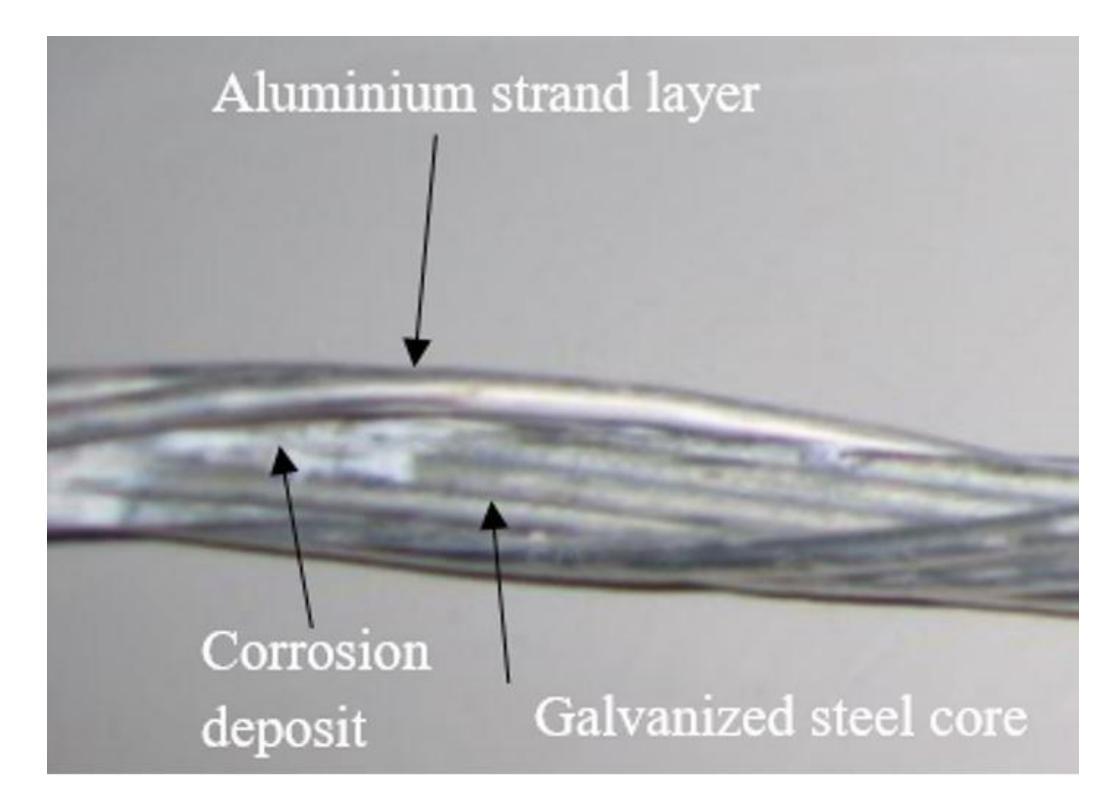
Fig. 3.15. Corrosion deposit between aluminium strands and the galvanized steel core, caused by galvanic corrosion. The diameter of the aluminium strand is 3.69 mm.
