Degradation Mechanisms of AA 1350 Aluminium Alloy Conductor Strands in Air and Chloride Solution

Thesis for the Degree of Philosophiae Doctor

Trondheim, May 2020

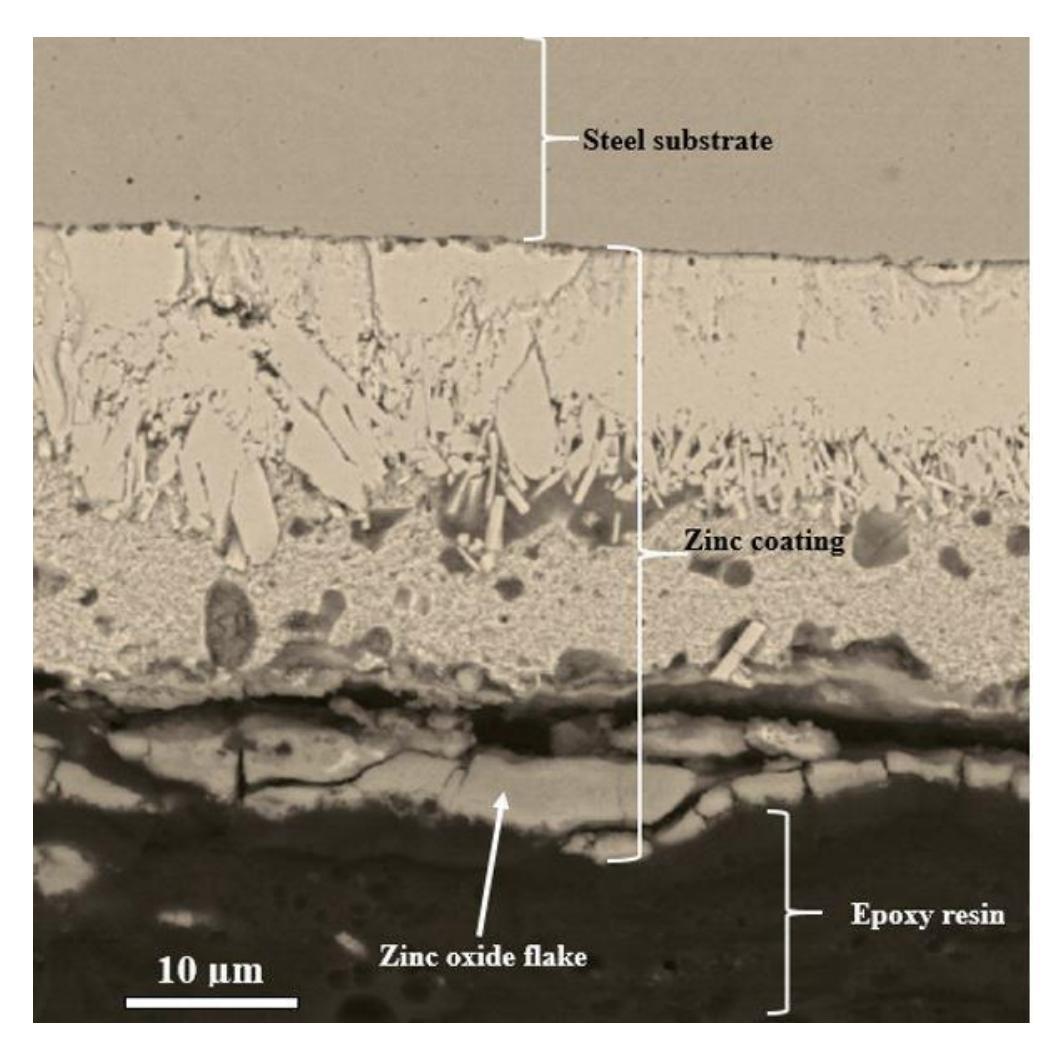
Fig. 3.16. Backscattered electron image of cross-sectional view of a galvanised steel strand showing the steel substrate and the zinc coating. The coating is oxidized at its surface in the form of zinc oxide flake.

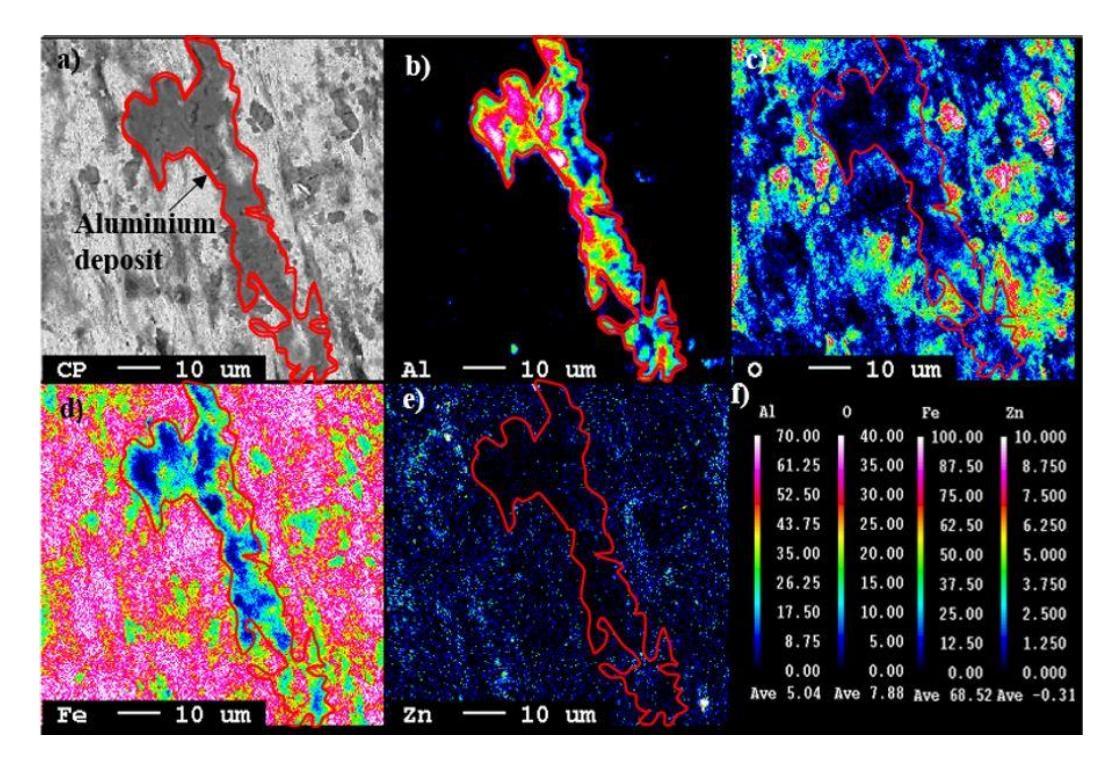
Fig. 3.17. a) Wavelength-dispersive spectroscopy (WDS) elemental maps of a selected area on galvanized steel strand for b) Al, c) O, d) Fe, and e) Zn. F) Colour bar indicating the concentration level of each element in atom percent.

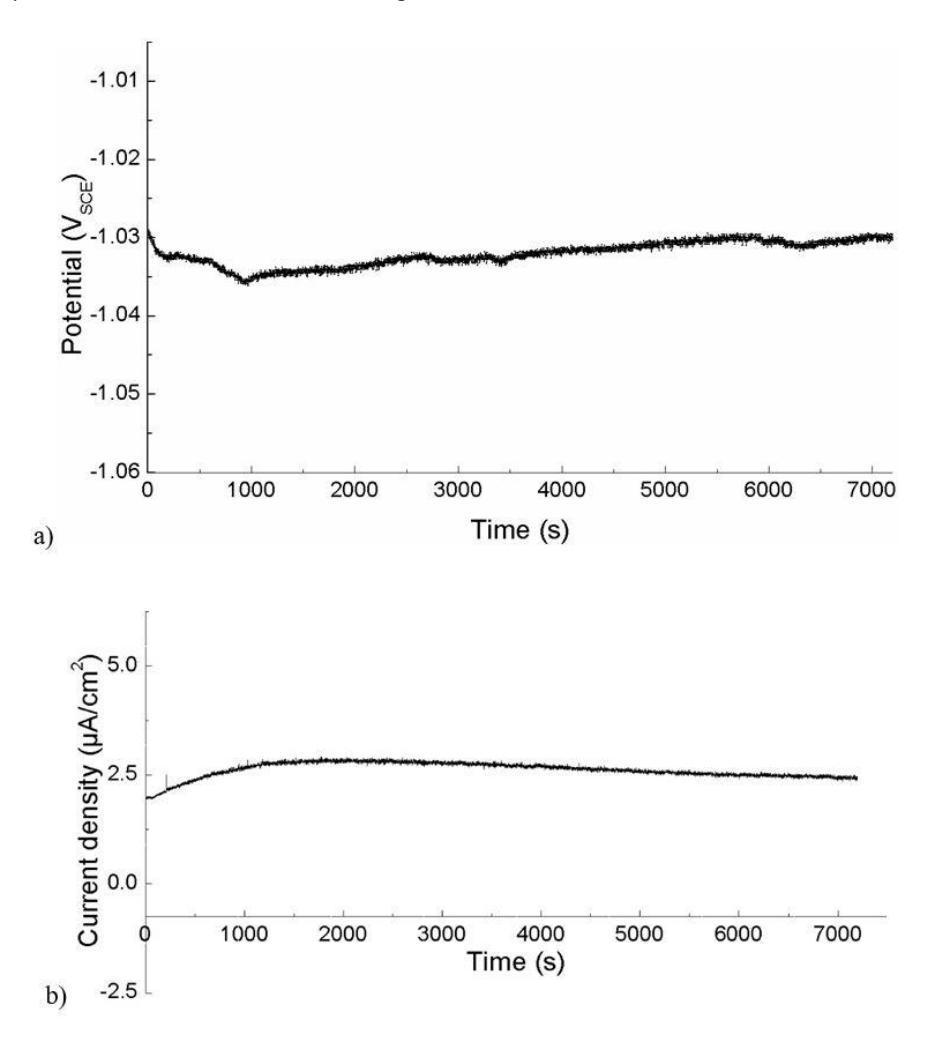
Fig. 4.3 Measured a) couple potential and b) current density between galvanized steel and aluminium strands during the galvanic corrosion test as a function of immersion time in 3.5% NaCl solution. The exposed area of each sample was 0.81 cm².

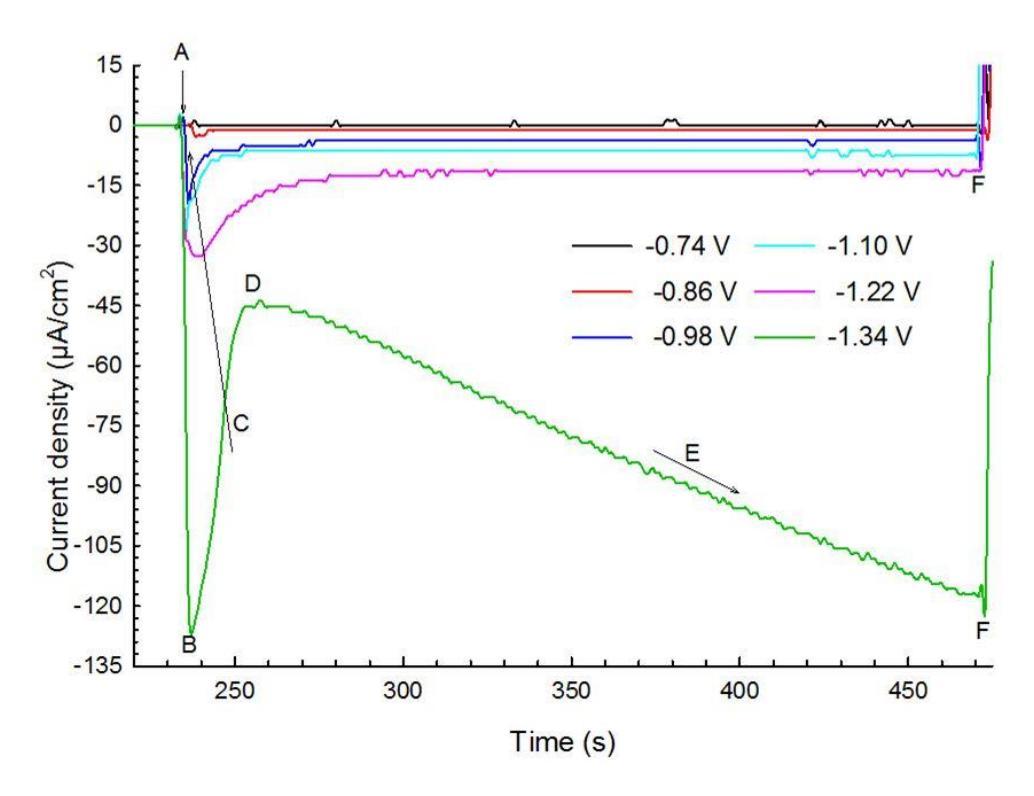
Fig. 4.6 Potentiostatic current densities recorded on AA 1350 alloy surfaces (for 240 s) held at the specified potentials (SCE) in 3.5% NaCl solution from the moment the potentials were applied (A) to the onset of sliding wear (F). The labels B and D represent the maximum and minimum negative current densities, respectively. Arrow C indicates decreasing trend of the negative current densities with decreasing negative potential. Arrow E indicates monotonically increasing negative current density.

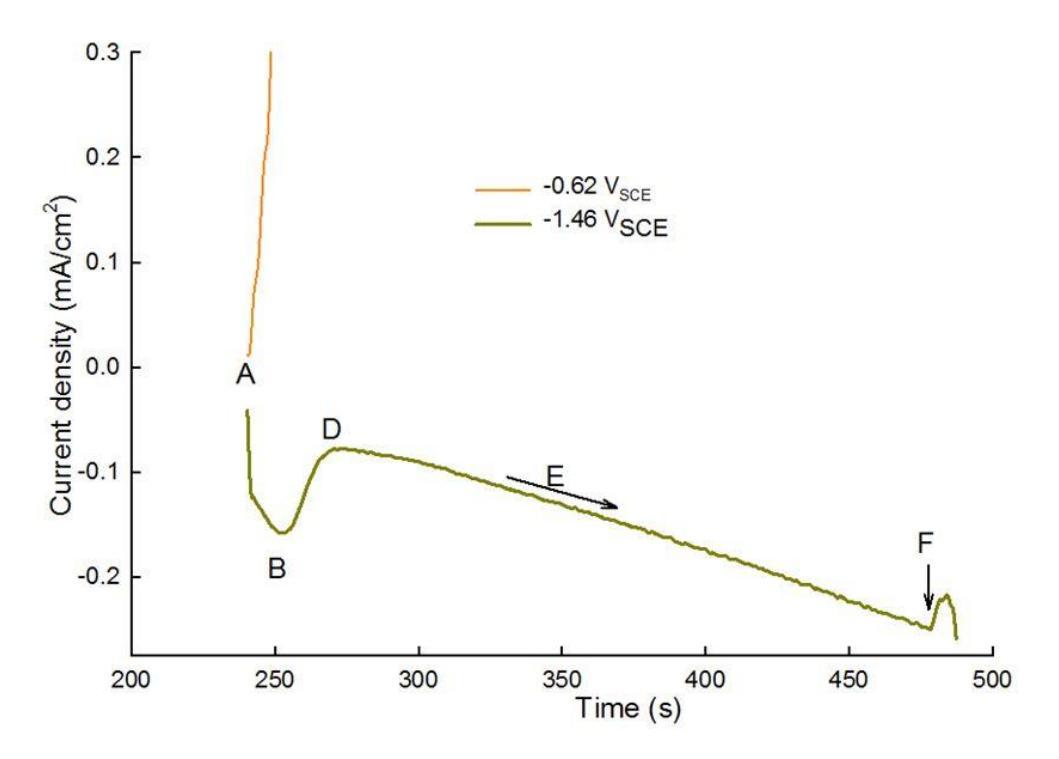
Fig. 4.7 Potentiostatic current densities, recorded on polished AA 1350 alloys held at -0.62 V_{SCE} and -1.46 V_{SCE} for 240 s in 3.5% NaCl solution, from the instant the potentials were applied (A) to the onset of sliding (F). The specimens were held at OCP for 240 s prior to application of the potential. The labels B, D and E represent the maximum, minimum, and increasing trend, respectively of the negative current density at the cathodic potential.

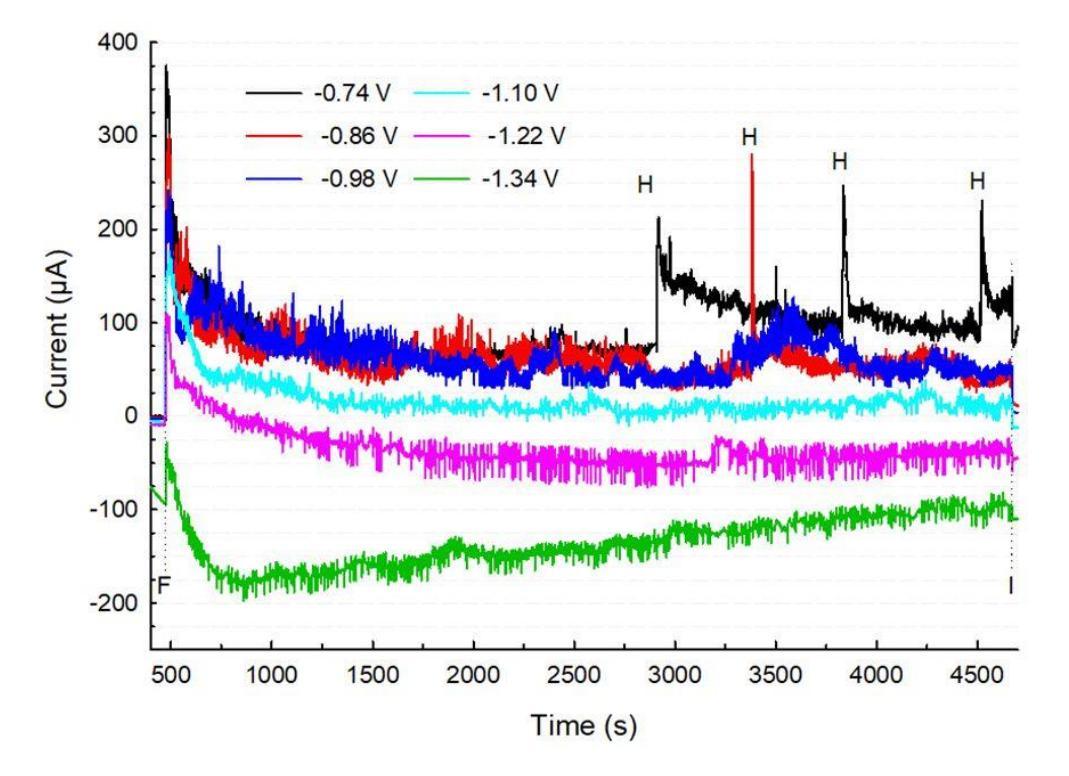
Fig. 4.8 Potentiostatic current transients recorded from the start (F) to interruption (I) of sliding wear on AA 1350 alloy held at various applied potentials (SCE), specified in the figure, for 4200 s in 3.5% NaCl solution, applied normal force of 2 N, displacement frequency and stroke of 1 Hz and 5 mm, respectively. Prior to the start of sliding, the samples were held for 240 s at OCP, followed by 240 s at their respective potentiostatic potentials, as shown in Figs. 4.6 and 4.7. Sporadic current surges occurred after reaching steady-state for -0.74 and -0.86 V_{SCE} (labelled H). The current levels increased in the negative direction with increasing negative potential. After the sliding was stopped, the samples were held at the same respective potentials for 240 s and then at OCP for another 240 s (Fig. 410.).

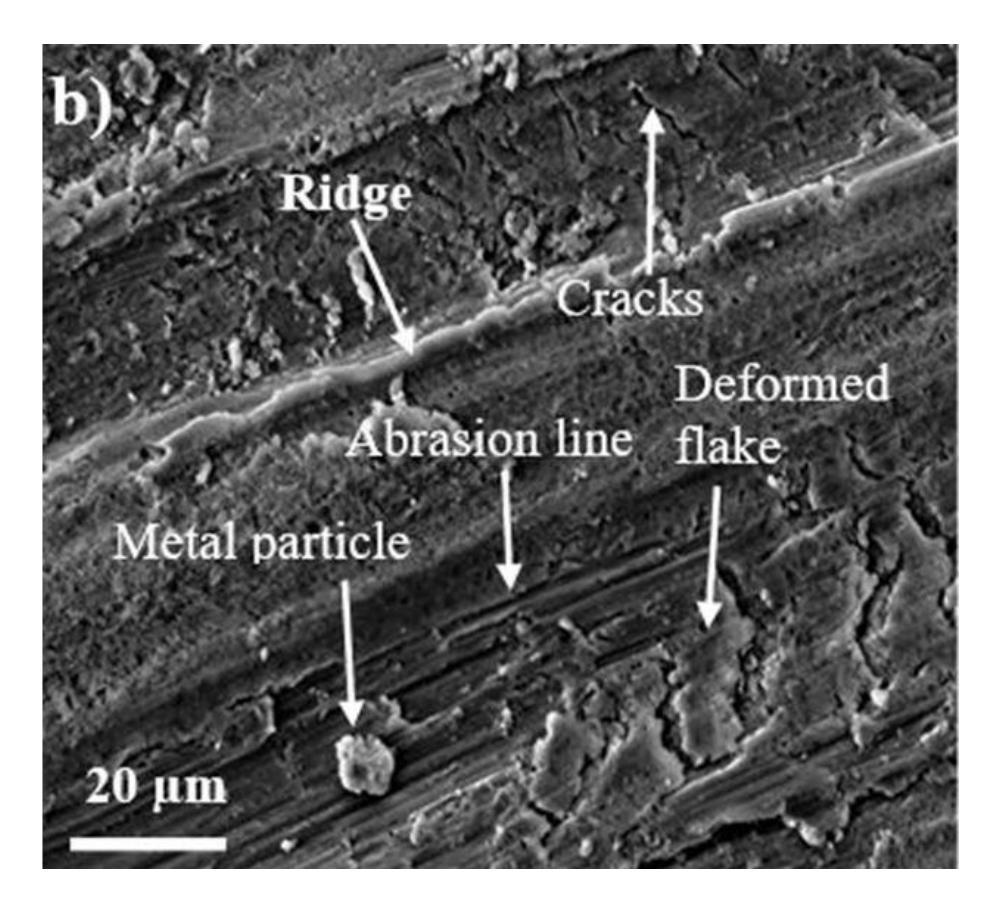
Fig. 4.13 Secondary electron SEM image inside the wear track of AA 1350 alloy after sliding test against an alumina ball (4.76 mm diameter) in air a) showing particles of metal and oxide distributed on the surface degraded by surface cracks transverse to the sliding direction b) Micrograph of the surface after cleaning in a hot bath of chromic phosphoric acid showing abrasion marks, metallic particles and flakes adhered to the surface.

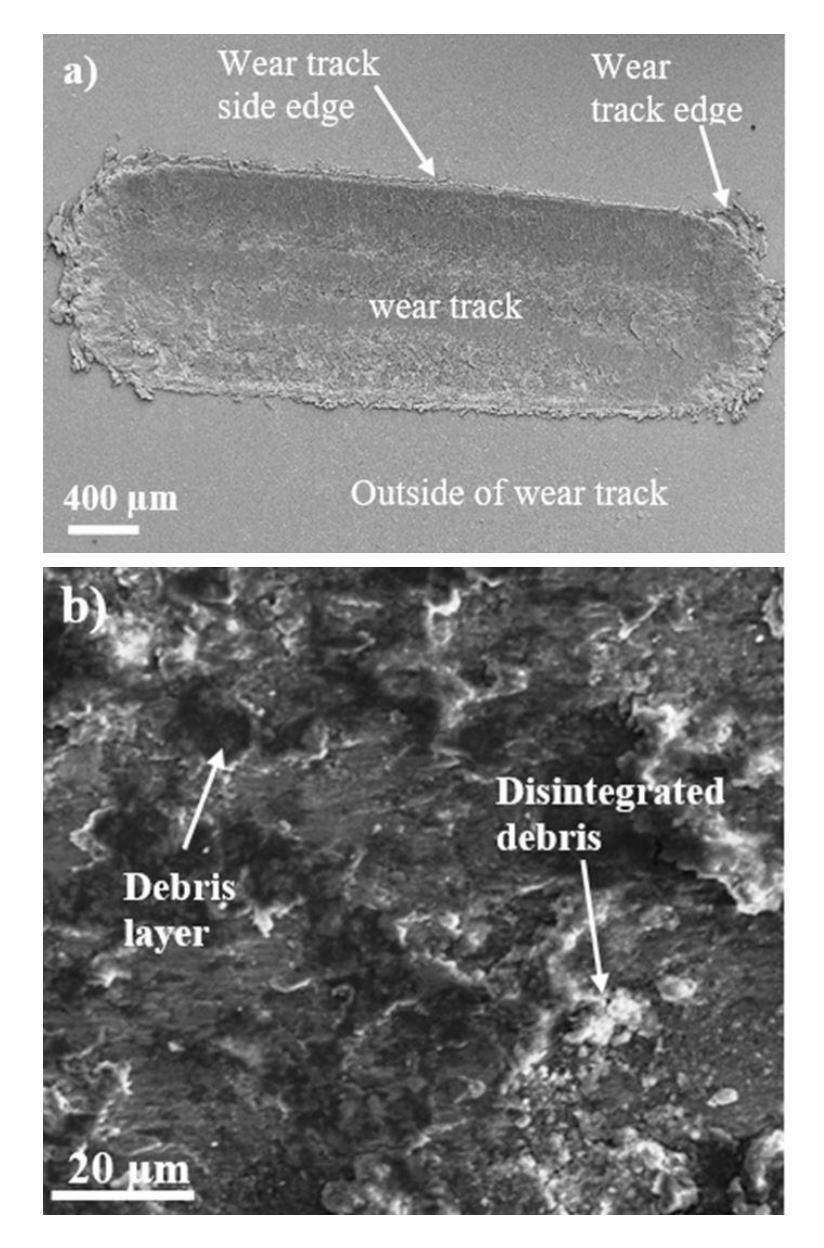
Fig. 4.15 Secondary electron SEM micrograph of AA 1350 alloy specimen surface after sliding test in a 3.5% NaCl solution at OCP. a) Overview of inside and outside of the wear track with wear debris accumulated at the edges. b) High magnification image of the surface inside the wear track showing layer of debris. The test was performed at a normal force 2 N, a frequency 1 Hz, displacement amplitude of 5 mm and duration of 4200 s.

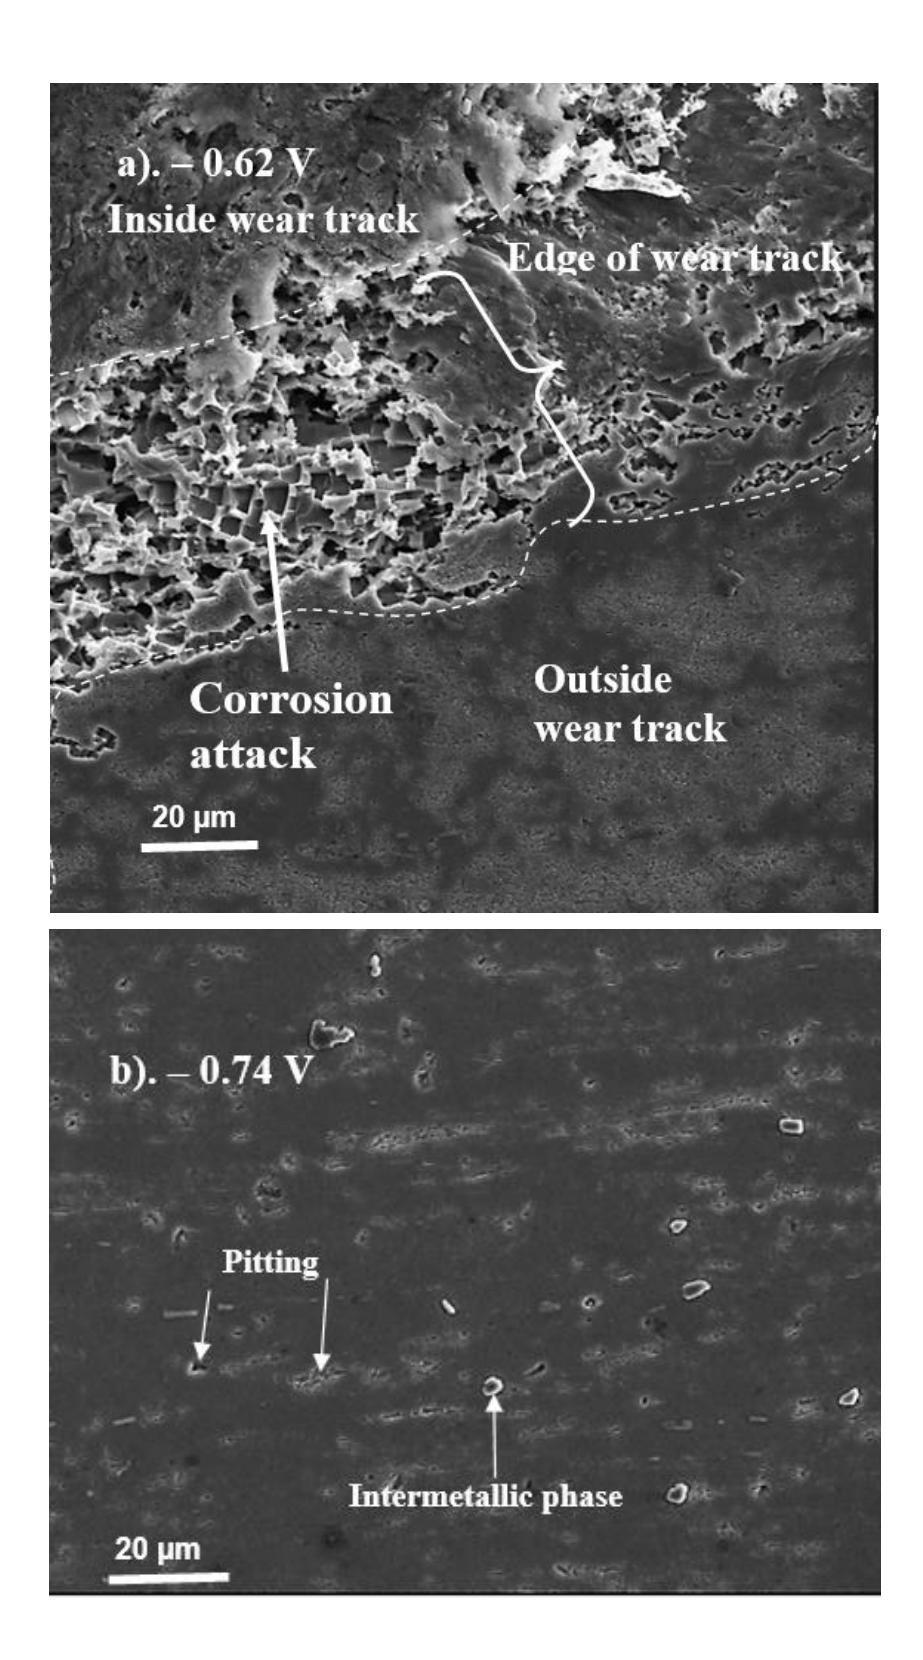
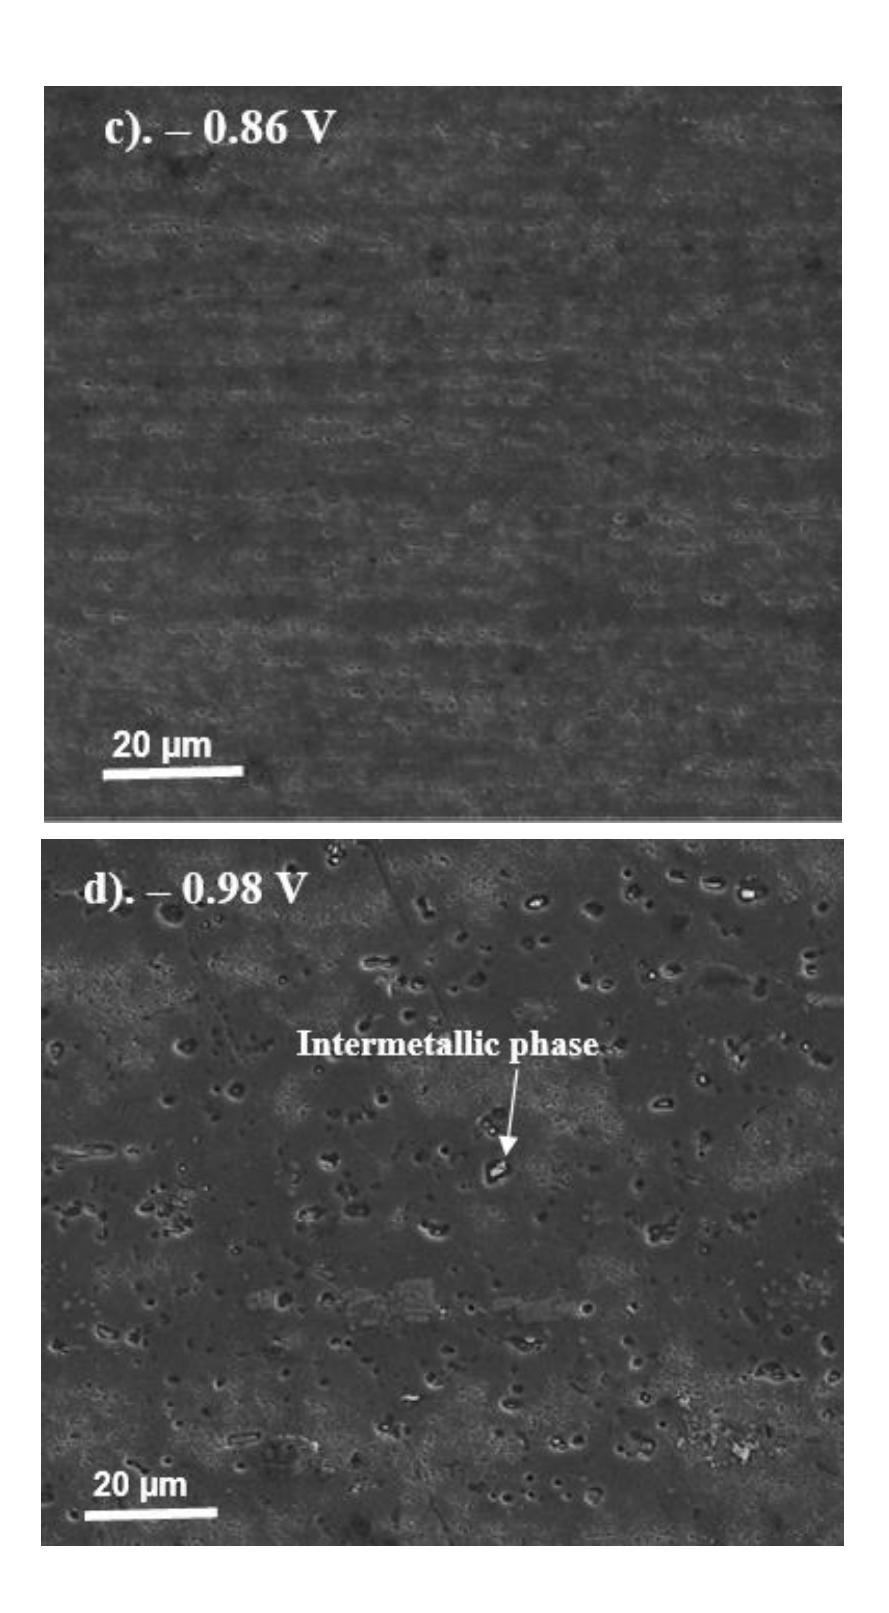
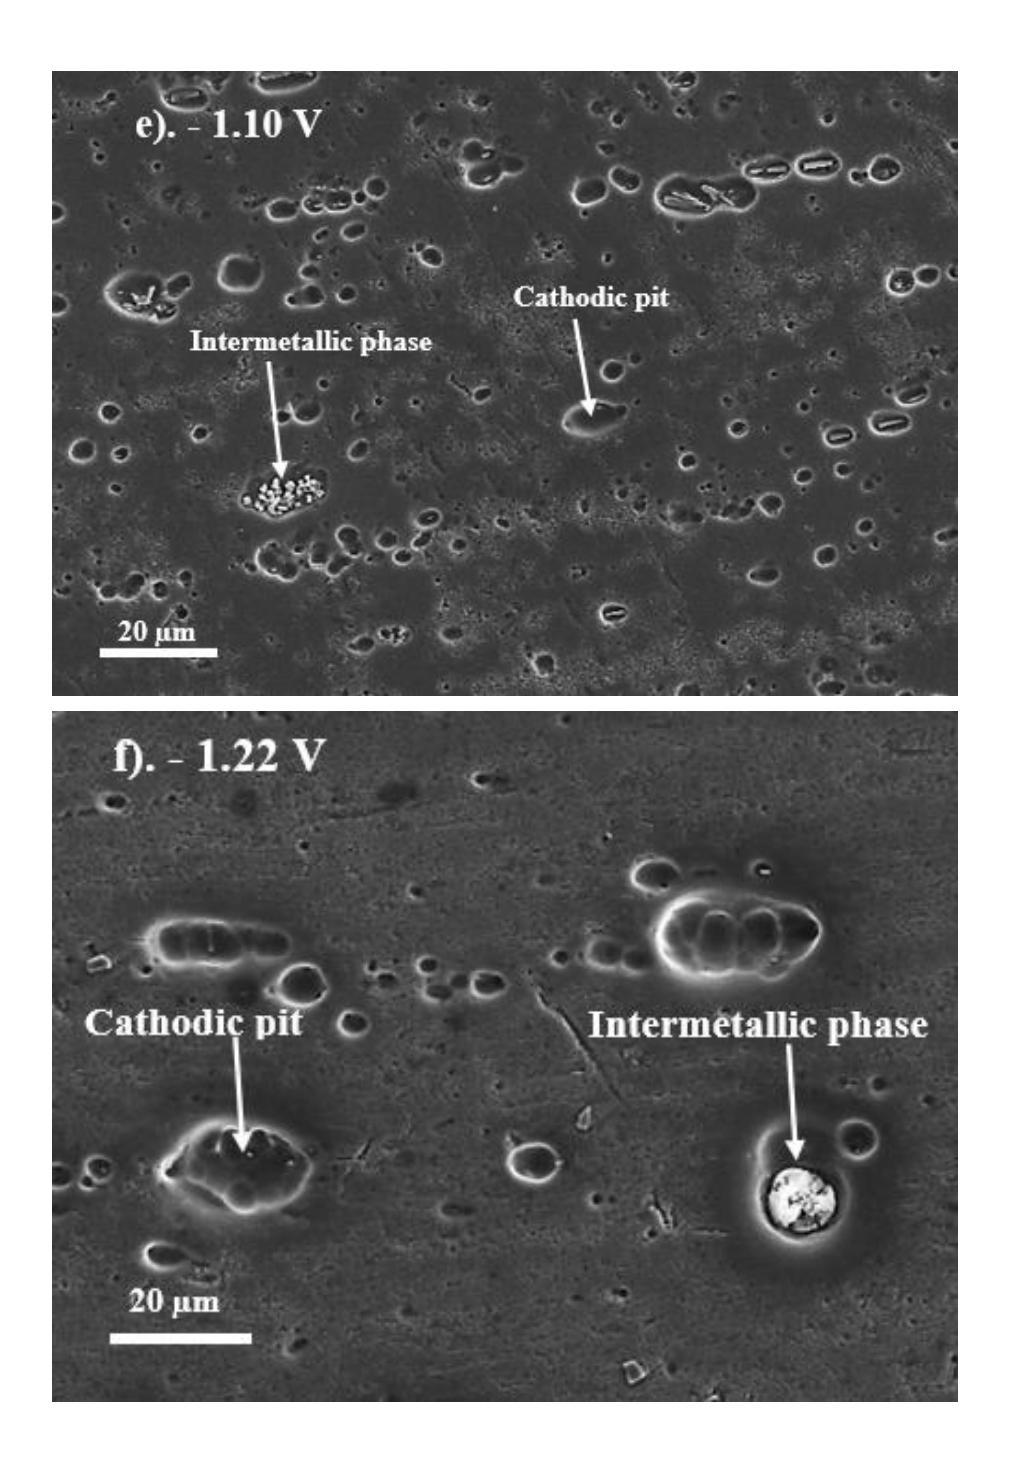
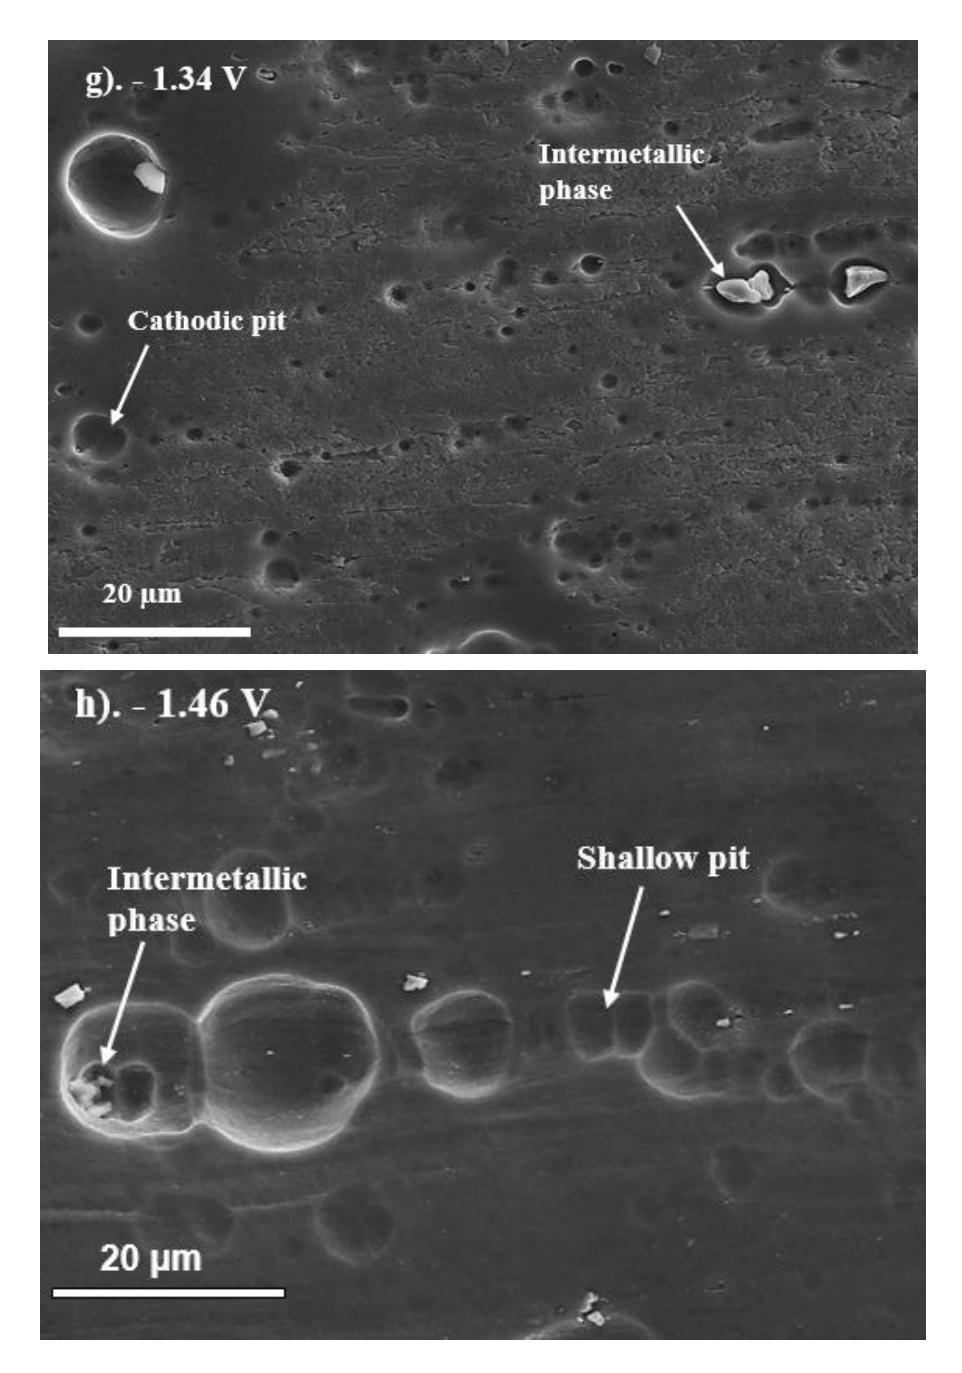
Fig. 4.17 Secondary electron SEM micrograph of surfaces outside the wear track after polarization at the potentials (SCE) specified in the figure, according to the test sequence presented in §4.3.2 and Figs. 4.8 and 4.9 after stripping the corrosion products. The sliding test was conducted at a normal force of 2 N, frequency of 1 Hz, and 5 mm displacement in 3.5% NaCl solution.

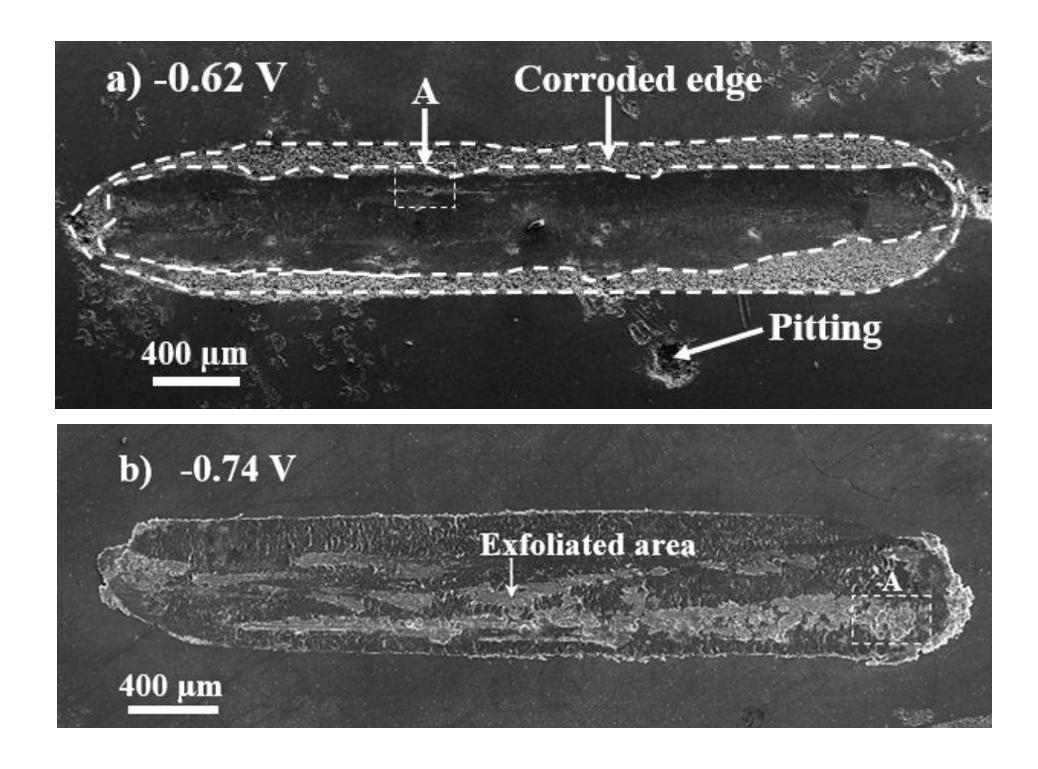
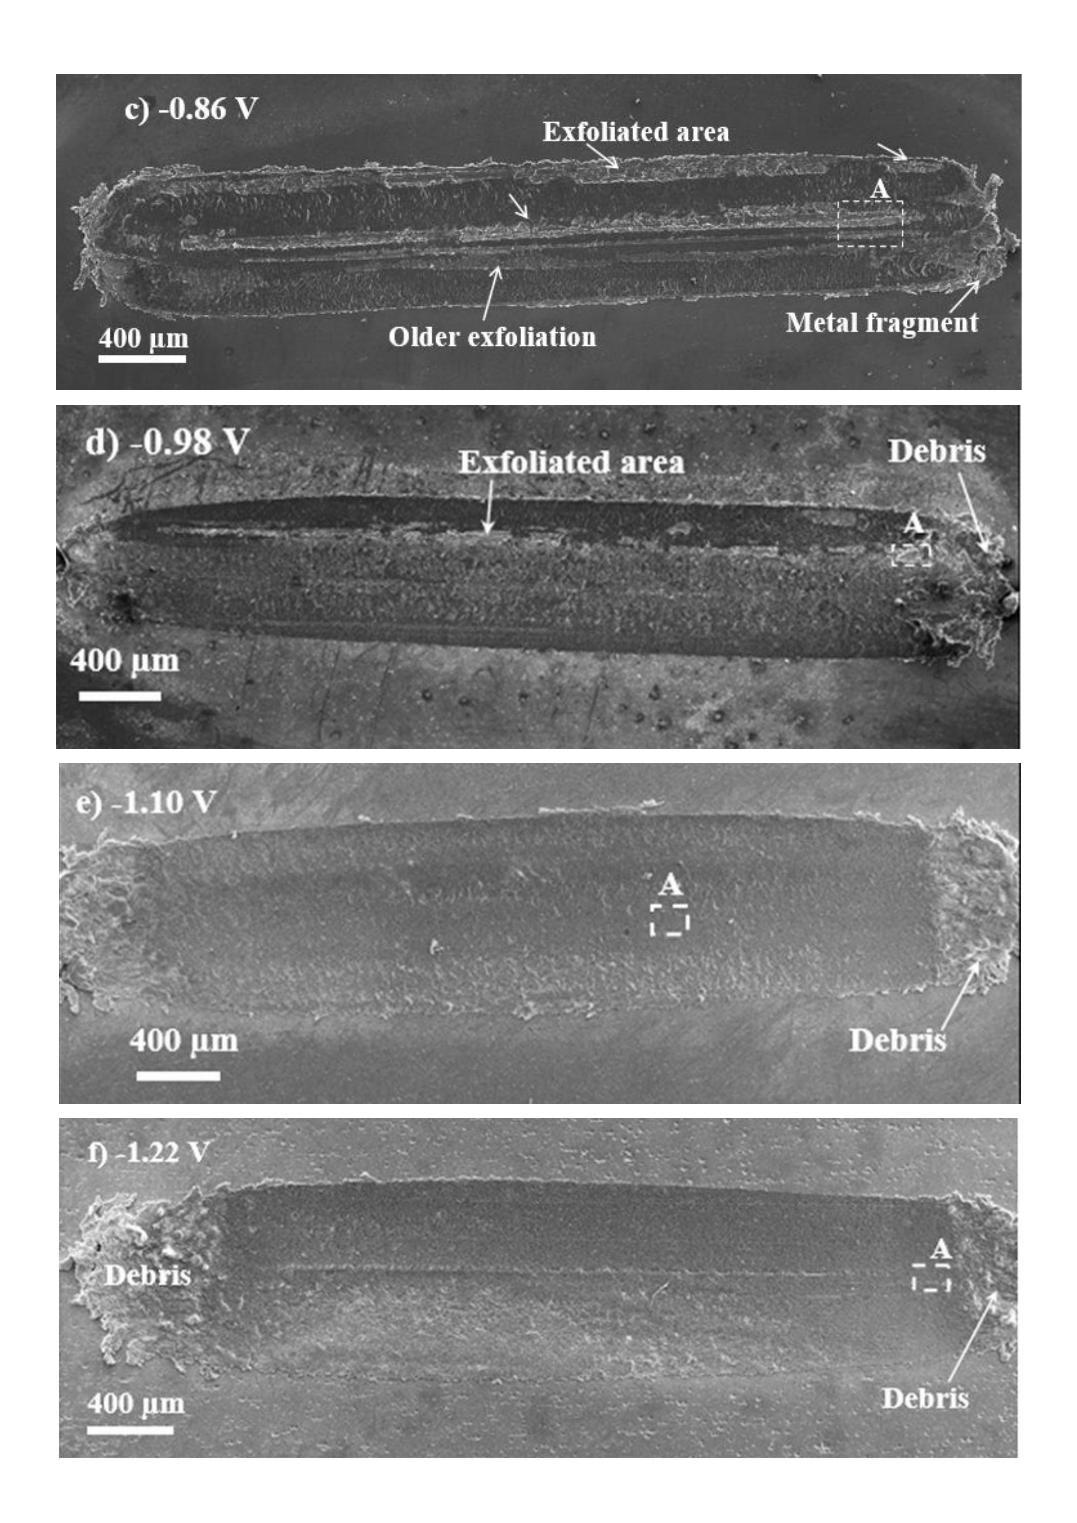
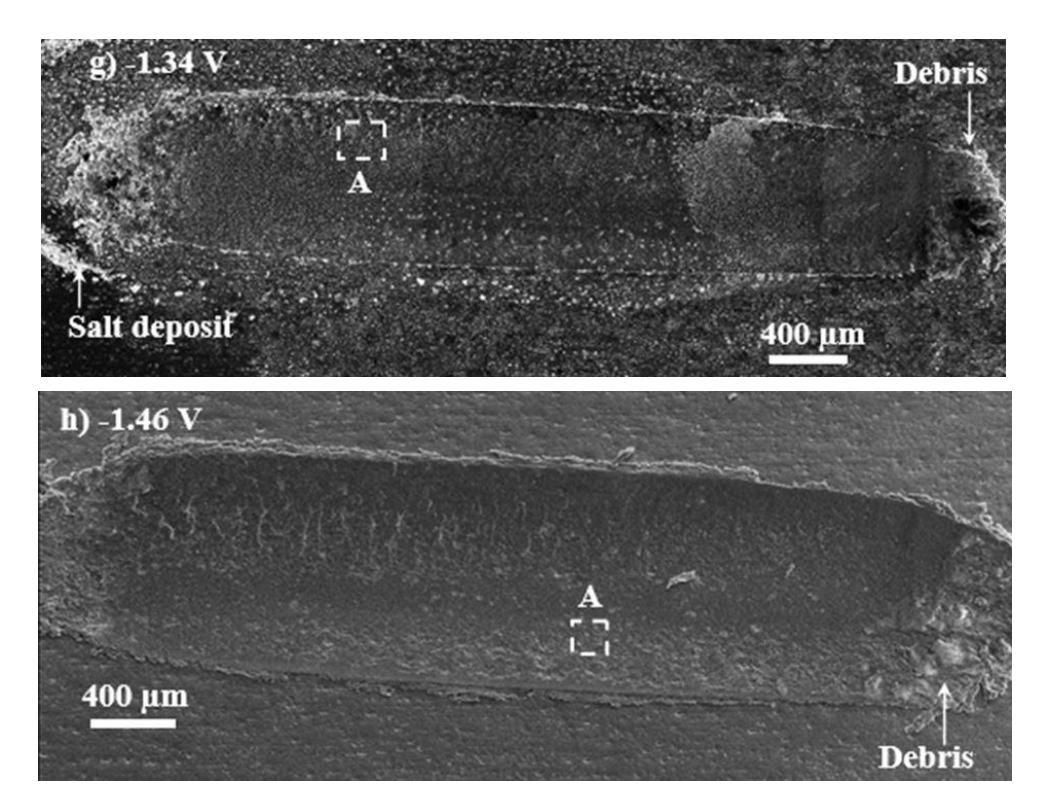
Fig. 4.18 Low magnification secondary electron SEM images of wear tracks tested at the potentials (SCE) specified in the figure according to the procedures described in §4.3.3 and presented in Figs. 4.8 and 4.9. The areas marked A were examined at higher magnification.

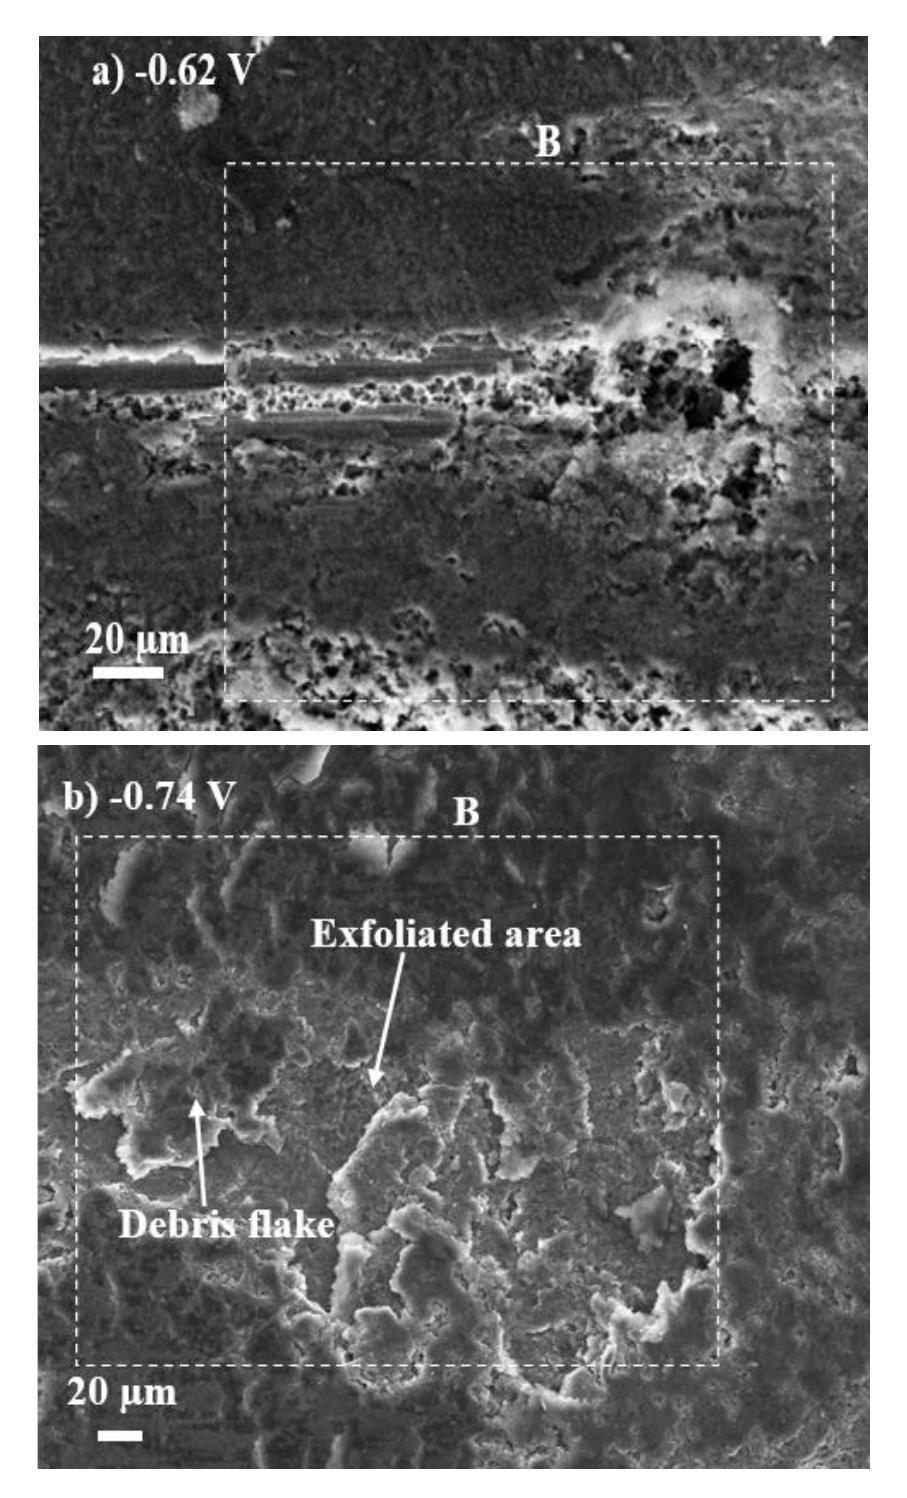
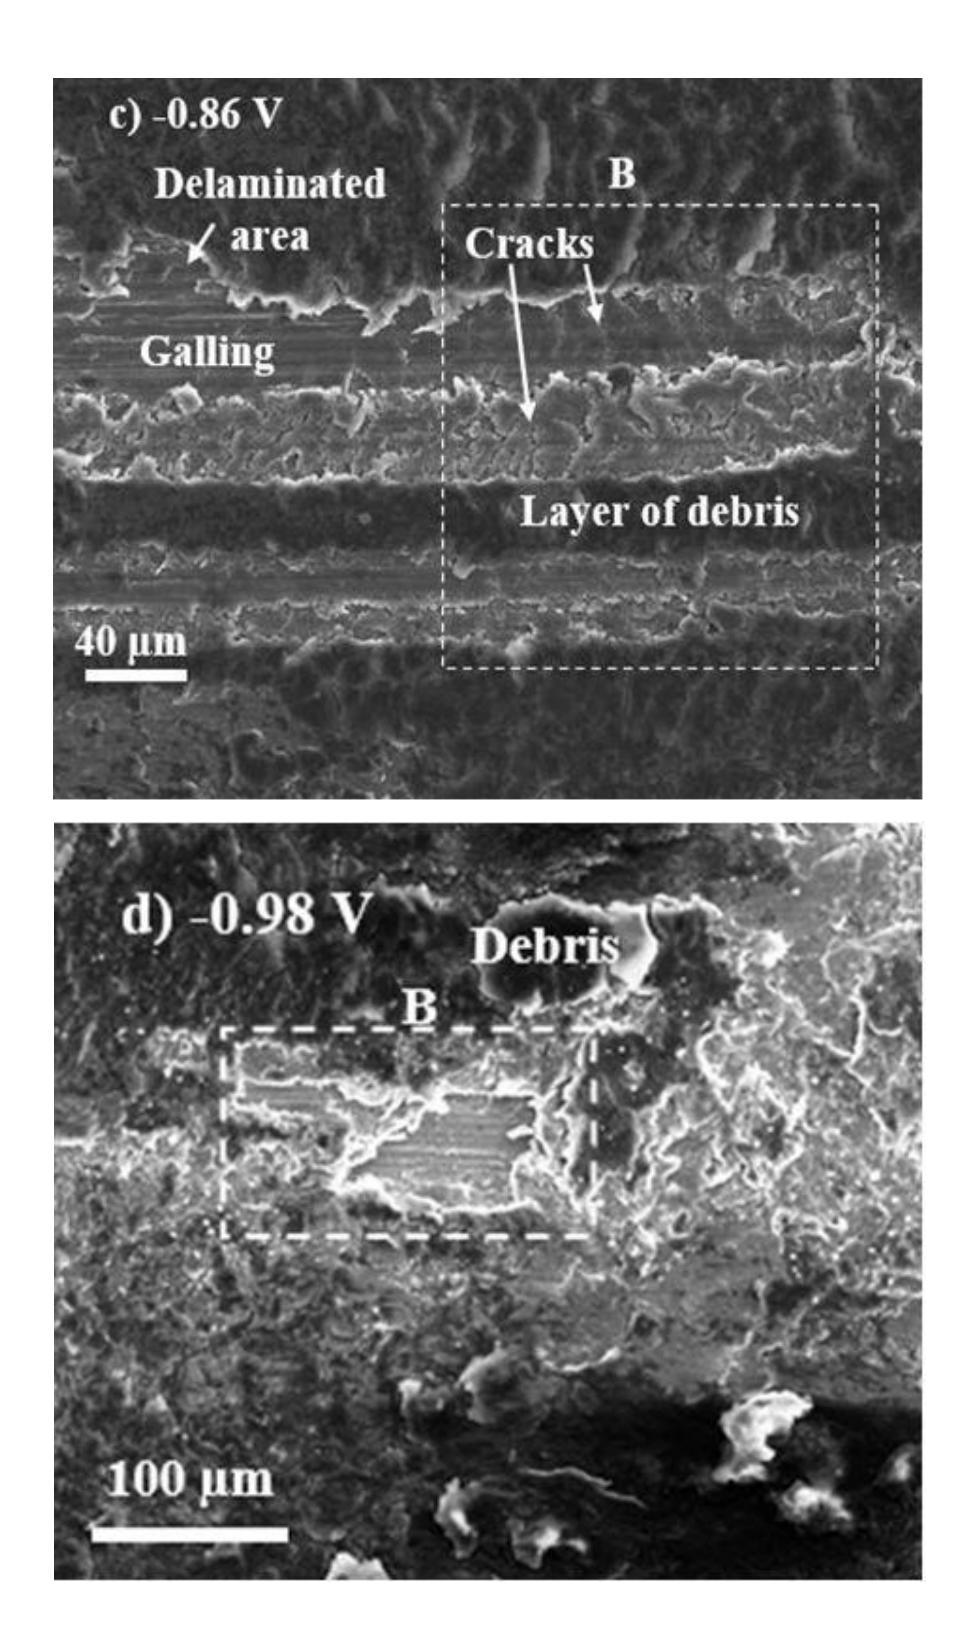
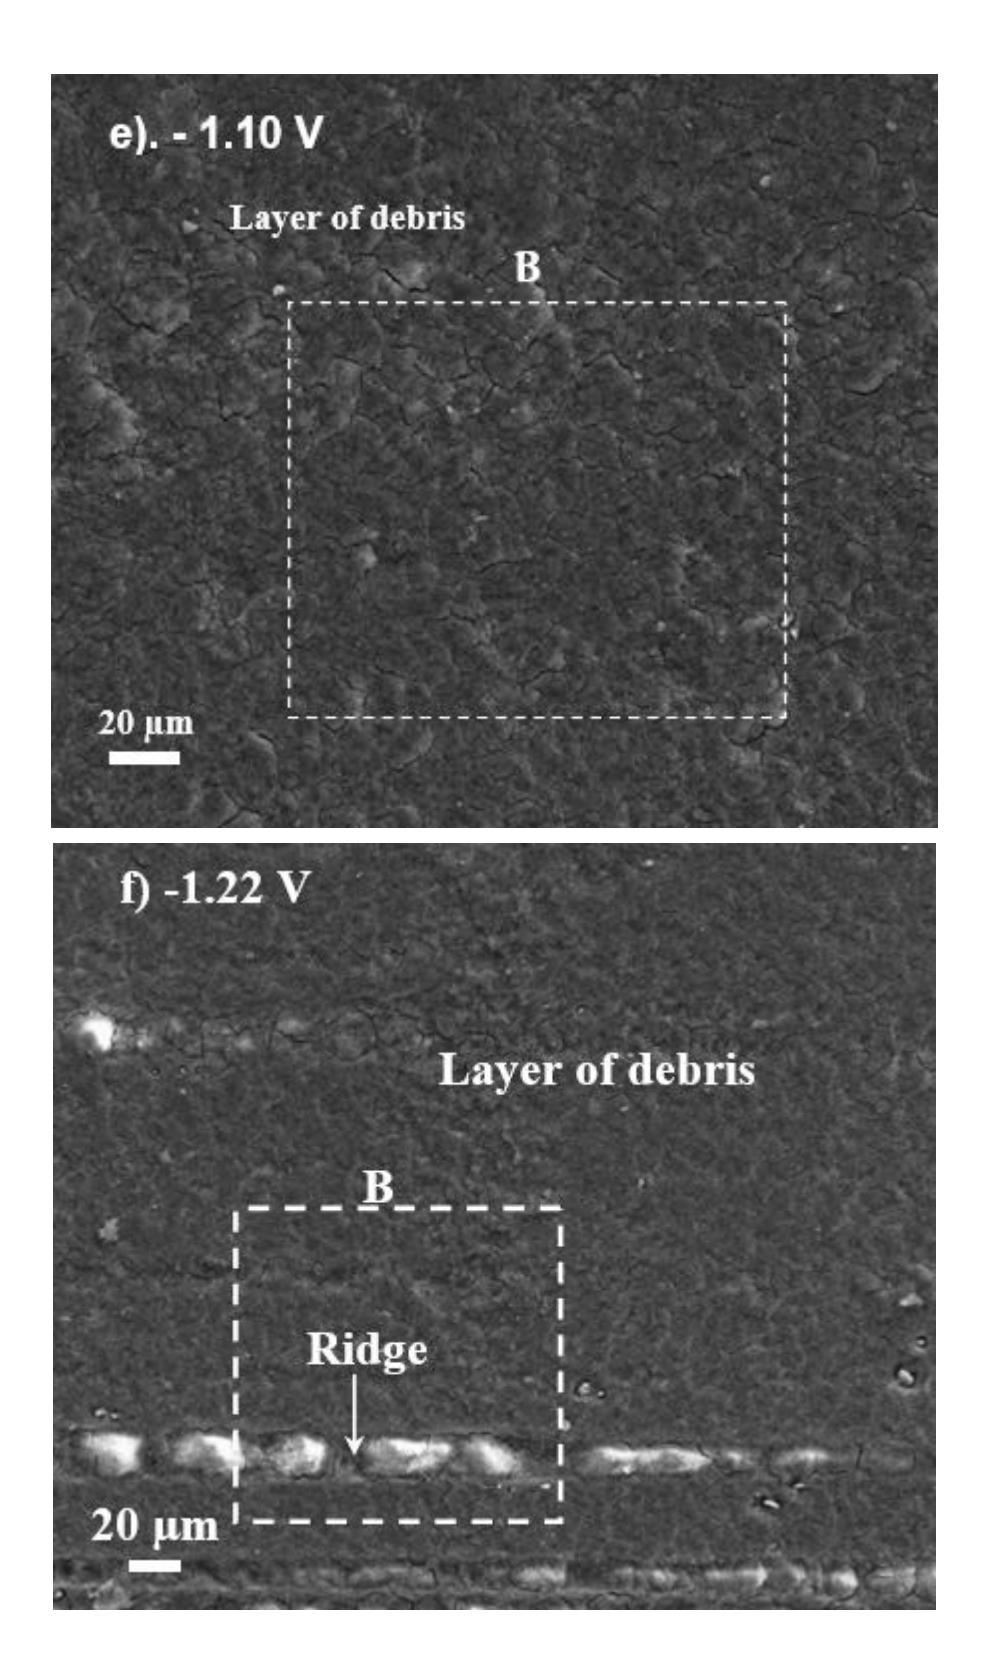
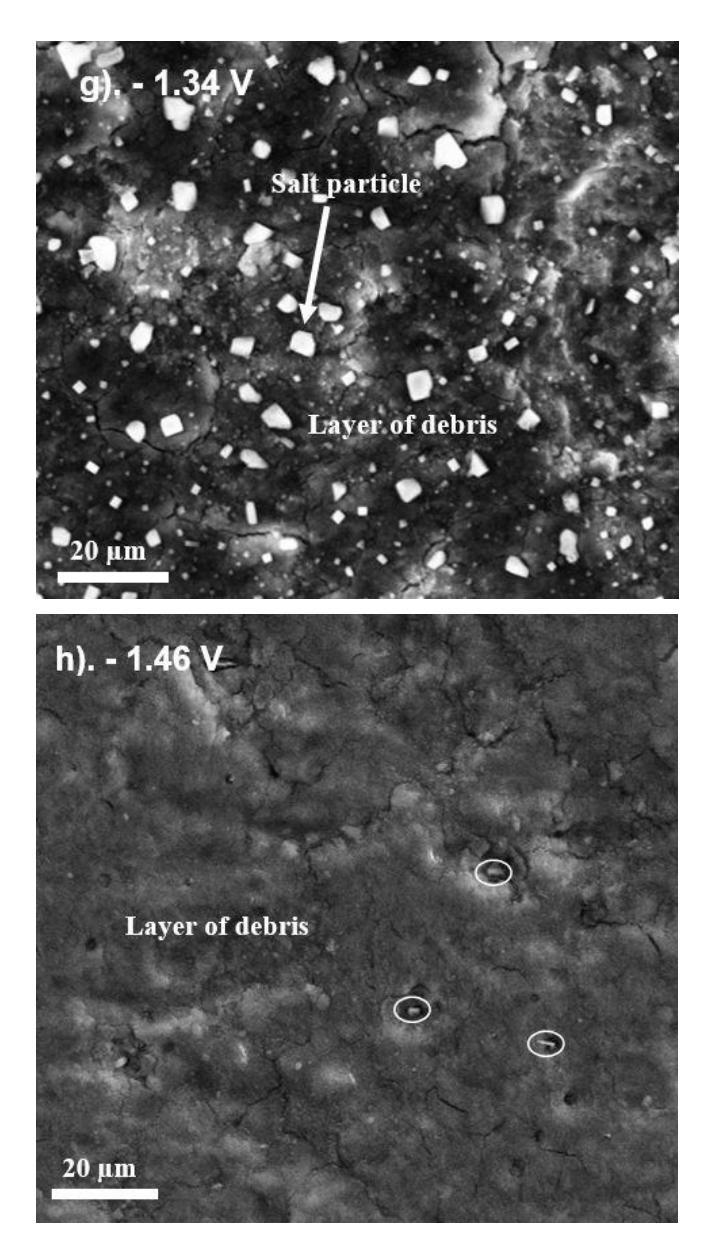
Fig. 4.19 Secondary electron SEM images of as tested wear tracks (Marked A in Fig. 4.18) of AA 1350 4200 s at various applied potentials (SCE) in 3.5% NaCl solution (see §4.3.3 for more detailed description of the electrochemical test sequence) at 2 N normal load, 5 mm displacement amplitude and 1 Hz frequency. The areas marked B in figures a to f (slightly magnified) and the whole area of figures g and h are presented in Fig. 4.20 after cleaning in hot chromic-phosphoric acid bath.
