Degradation Mechanisms of AA 1350 Aluminium Alloy Conductor Strands in Air and Chloride Solution

Thesis for the Degree of Philosophiae Doctor

Trondheim, May 2020

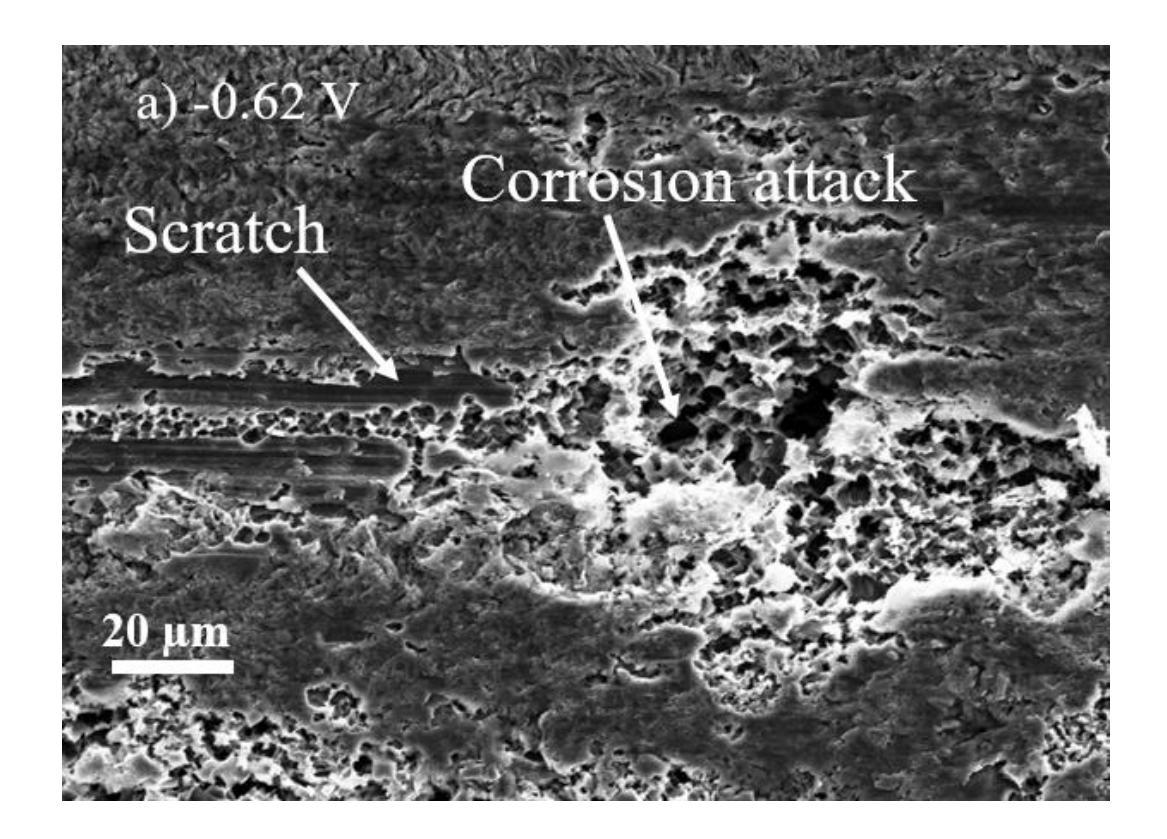
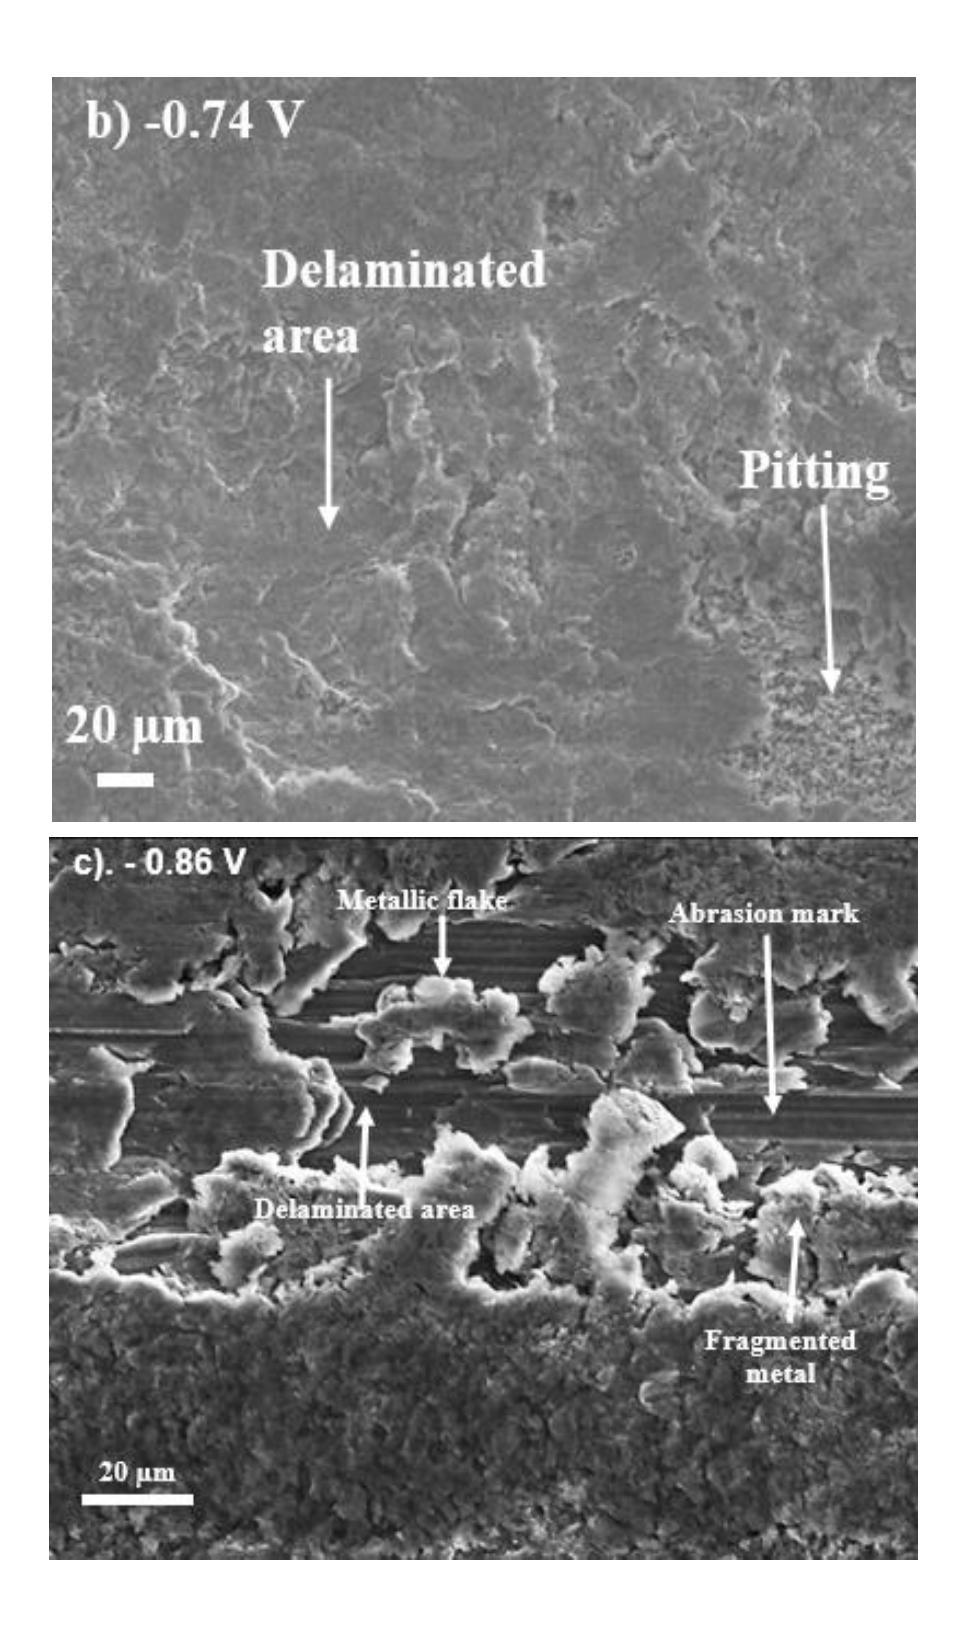
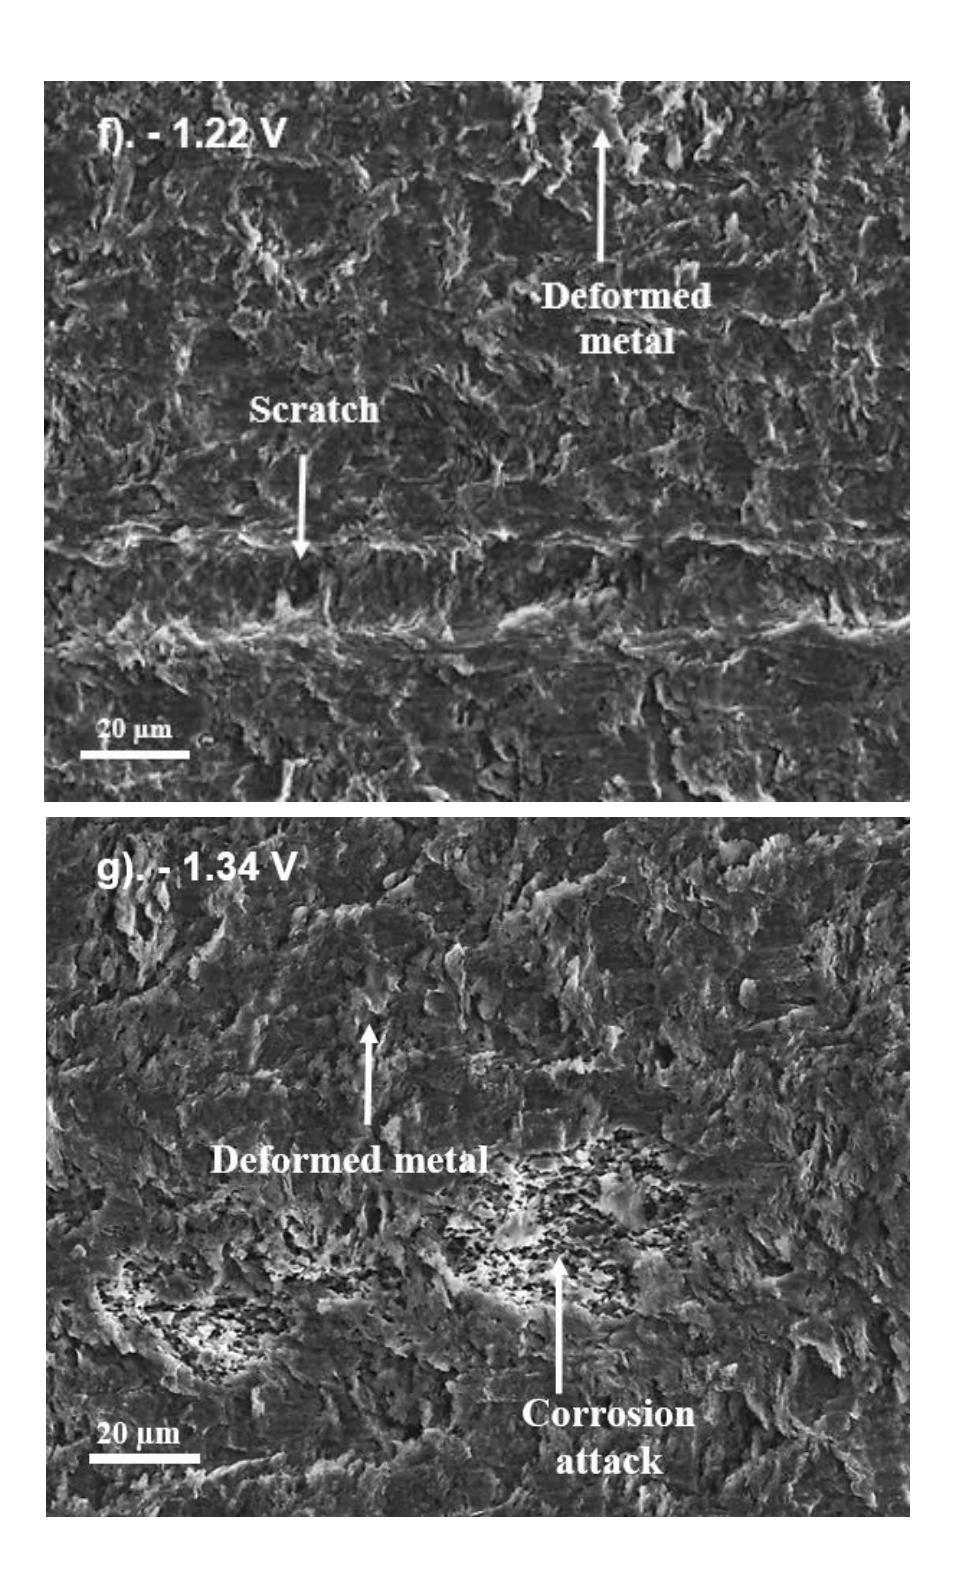
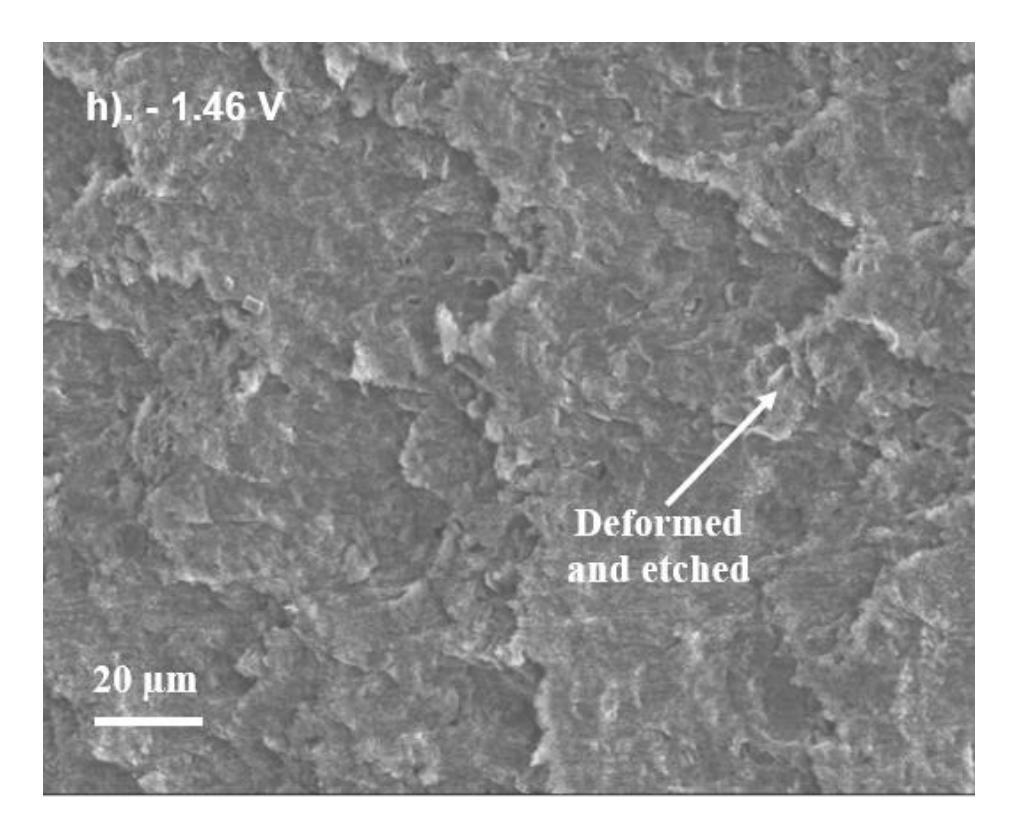
Fig. 4.20 Secondary electron SEM images of stripped wear tracks of AA 1350 tested as described in Fig. 4.19. a) Crystallographic corrosion attack on the worn surface, especially the scratched sites. b) Light pitting attack on a surface which was deformed and ridged. c) and d) Mechanically deformed, sheared and fragmented surface in the wear track without indication of corrosion attack. e) and f) Mechanically worn surface morphology with ridged and deformed metal without indication of significant corrosion attack. g) Wear track morphology showing metallic deformation and ridges of metal caused by wear with some localized corrosion attack. h) Micrograph showing mechanically ridged and deformed surface with uniform corrosion attack (etching).

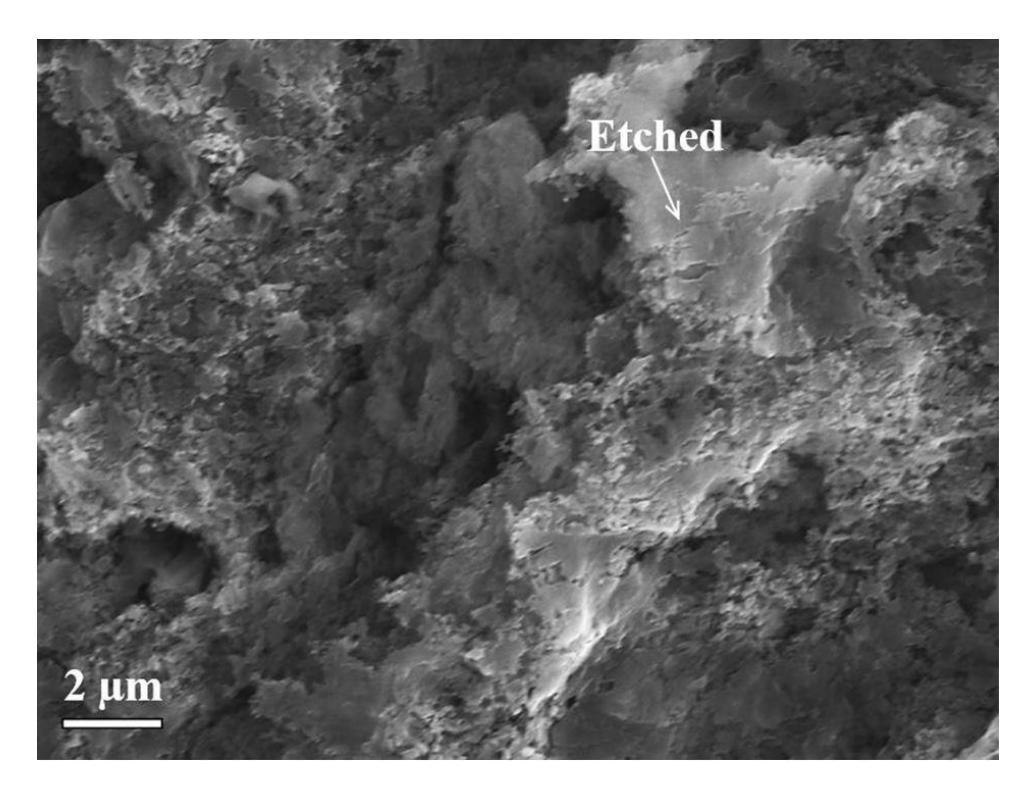
Fig. 4.21 High magnification secondary electron SEM image of the worn surface shown in Fig. 4.20h tested as described in Fig. 4.17. The metal surface was etched by corrosion on microscale.

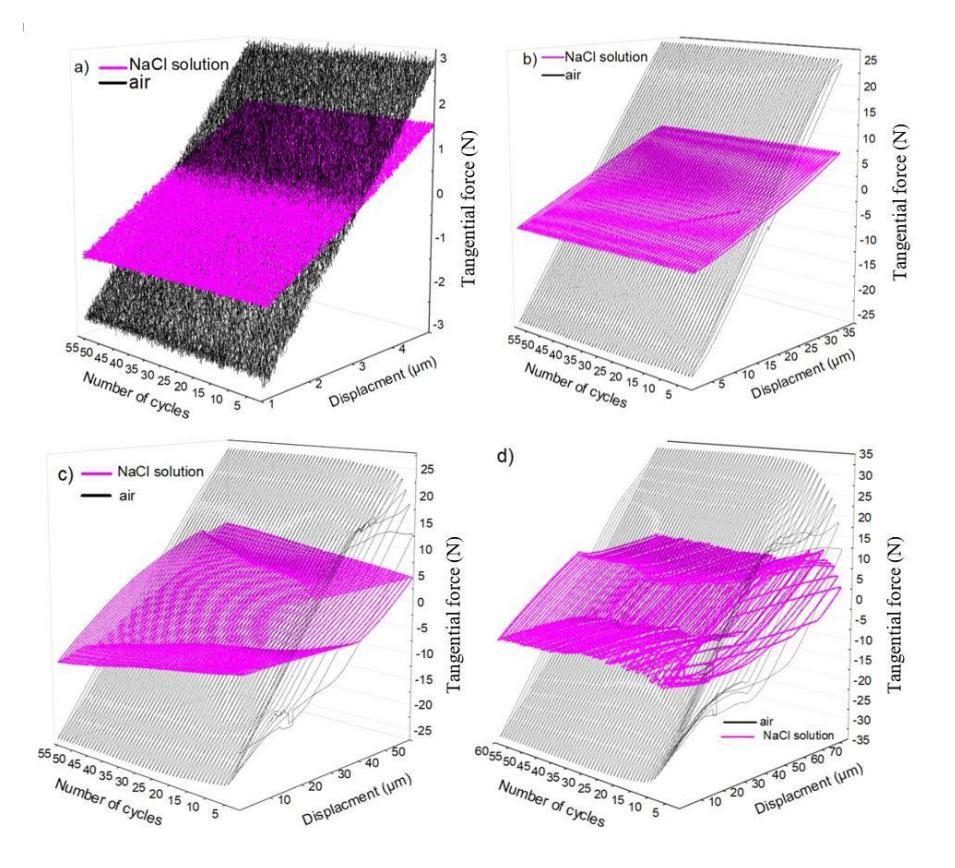
Fig. 5.1 Friction logs obtained from fretting in air and NaCl solution at the normal forcedisplacements of (a) $20 \text{ N} - 4 \mu \text{m}$, (b) $20 \text{ N} - 35 \mu \text{m}$, (c) $20 \text{ N} - 60 \mu \text{m}$, (d) 20 N - 80 at a frequency of 1 Hz for 3600 s. *Note*: The number of cycles axes factor is 60x.

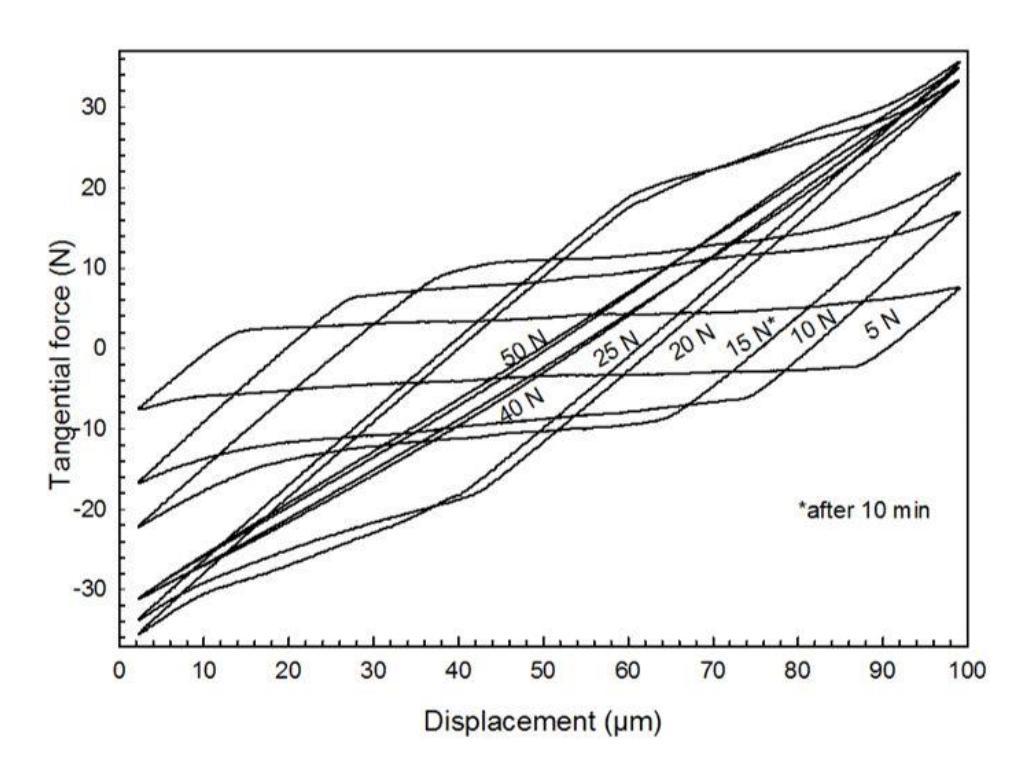
Fig. 5.3 Tangential force transients for different normal forces and constant displacement (100 μ m) recorded 30 min after the onset of fretting in air. The curve recorded after a relatively shorter duration is marked by *. The shape of the curves changed from parallelogram to elliptical hysteresis with increasing normal force, indicating change in the fretting regime from gross to partial slip between 15 and 20 N.

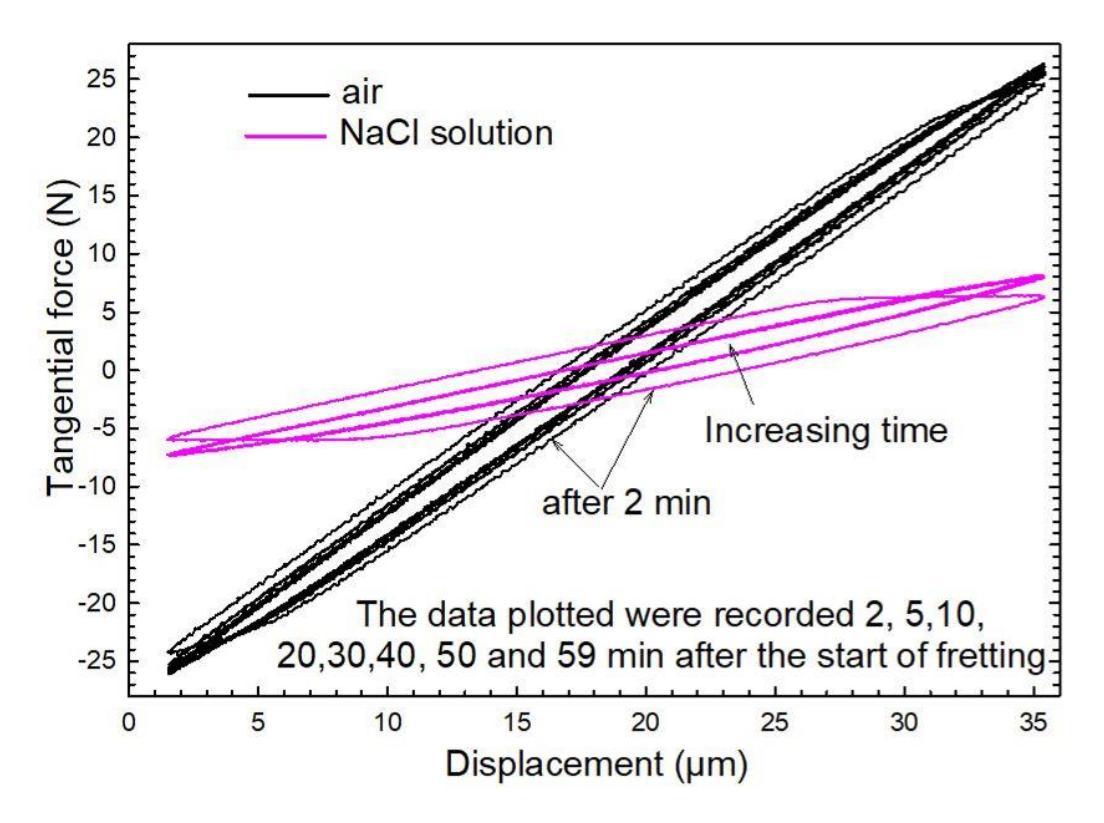
Fig. 5.5 Fretting curves obtained in air and NaCl solution at a normal force of 20 N, displacement of 35 μ m and frequency of 1 Hz, measured after the starting periods indicated in the figure.

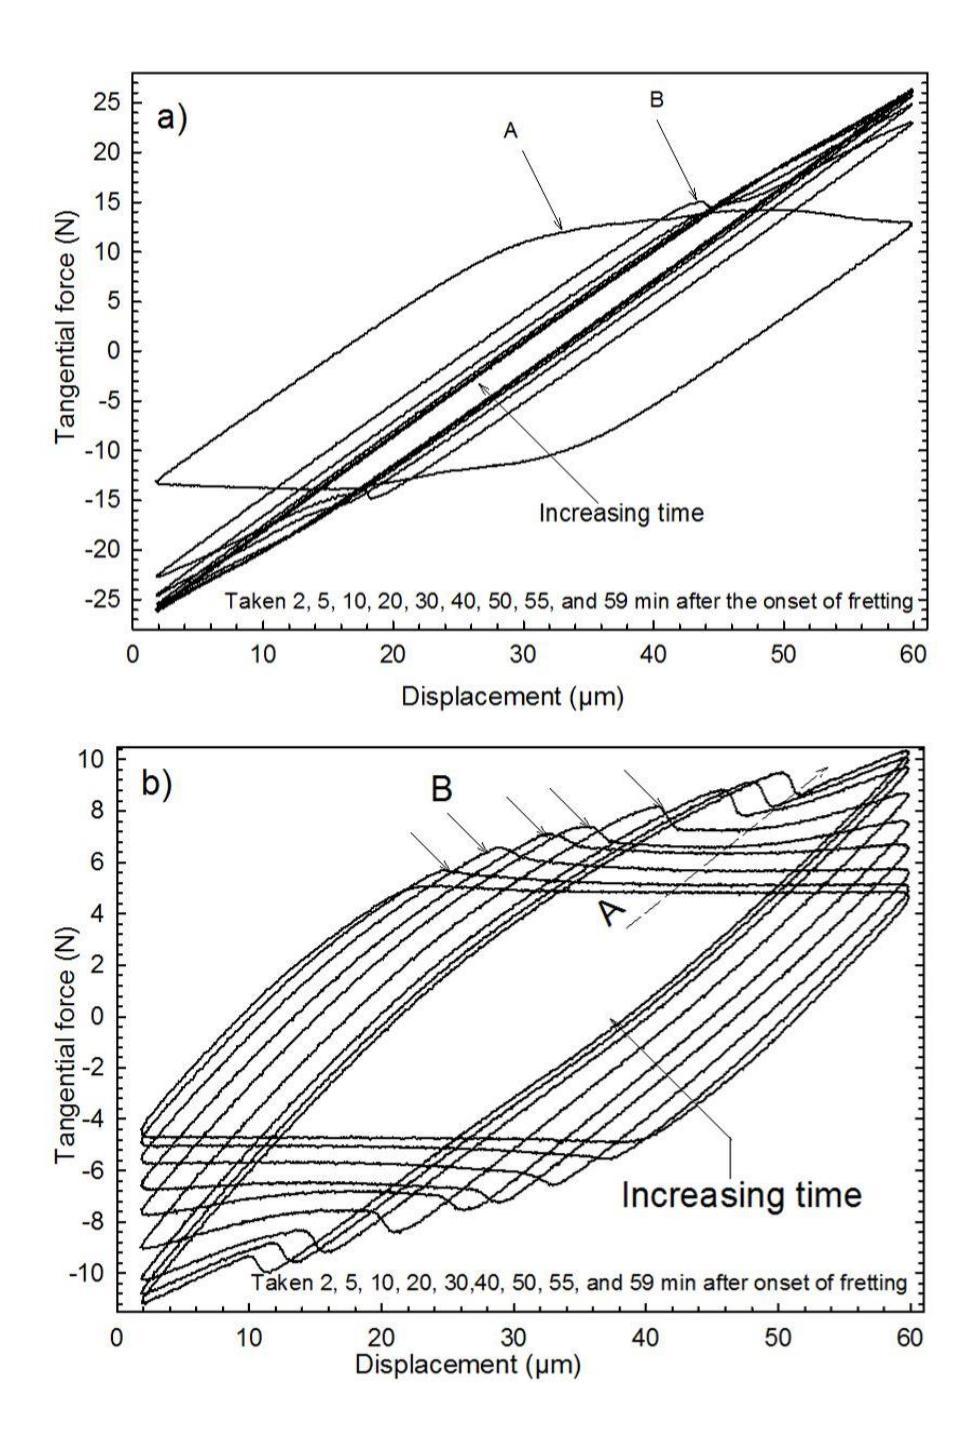
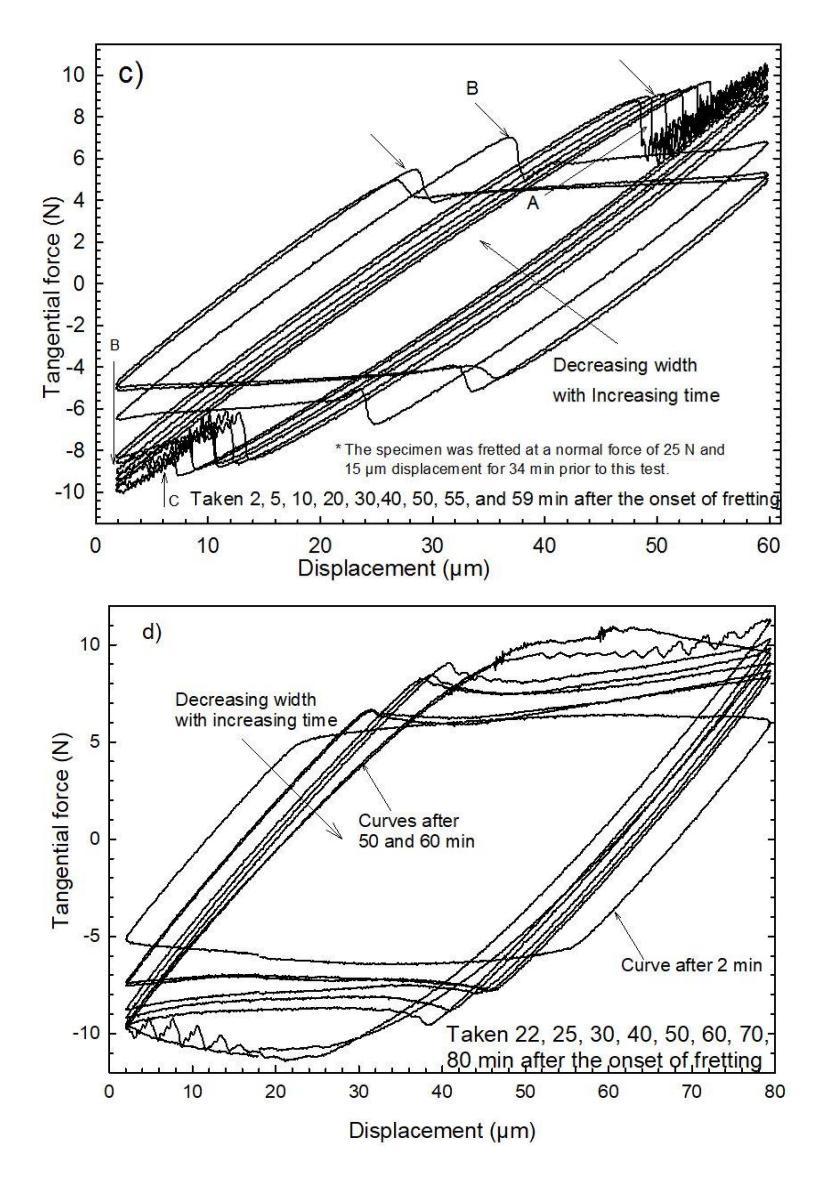
Fig. 5.6 Evolution of fretting curves with time obtained at a normal force of 20 N and 60 μ m displacement in (a) air and (b) NaCl solution. (c) Fretting curves obtained from tests in NaCl solution at increased normal force (25 N) and 60 μ m displacement. (d) Fretting curves obtained at increased displacement (80 μ m) and 20 N normal force. The plotted data were taken after the time intervals indicated in the figures (see the arrow) on flat and polished specimen fretted against 10 mm diameter alumina ball.

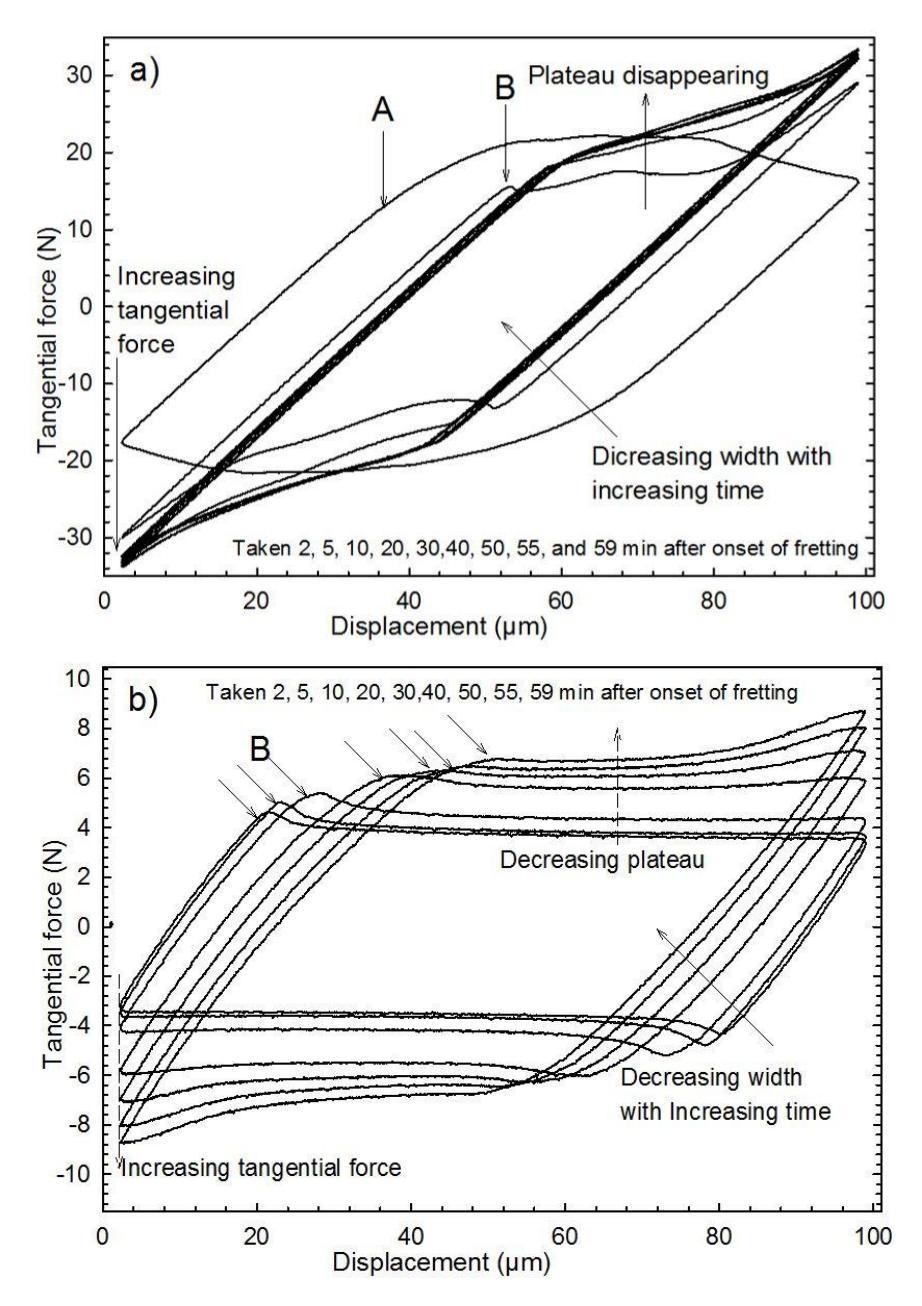
Fig. 5.7 Evolution of fretting curves with time, obtained from fretting of flat AA1350 alloy against 10 diameter alumina ball at frequency of 1 Hz, normal force of 20 N and displacement of 100 μ m. Test environments were air (a) and 3.5% NaCl solution (b).

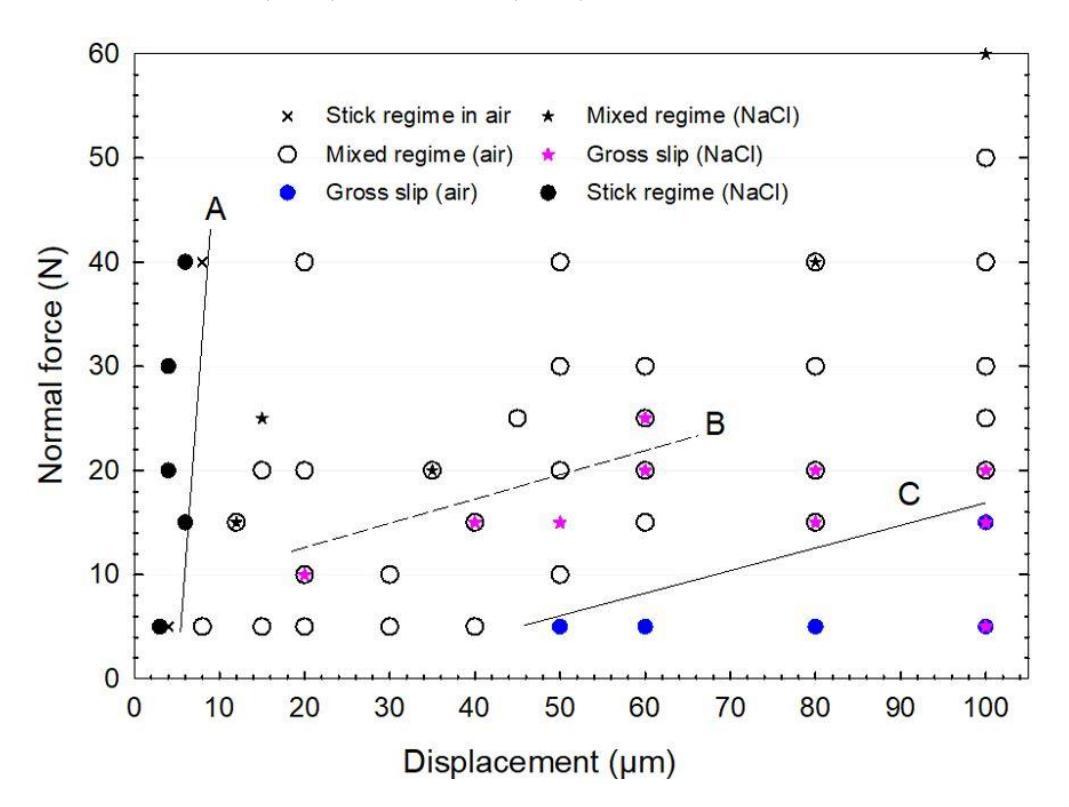
Fig. 5.8 Fretting map of flat and polished AA 1350 alloy fretted against 10 mm diameter alumina ball in air and 3.5% NaCl solution. The stick, mixed stick slip, and gross slip regimes are indicated. Line A represents the boundary between stick and mixed stick slip regimes in air and NaCl solution, whereas B and C approximate the boundaries between the mixed stick slip regime and gross slip regime in NaCl solution and air, respectively.

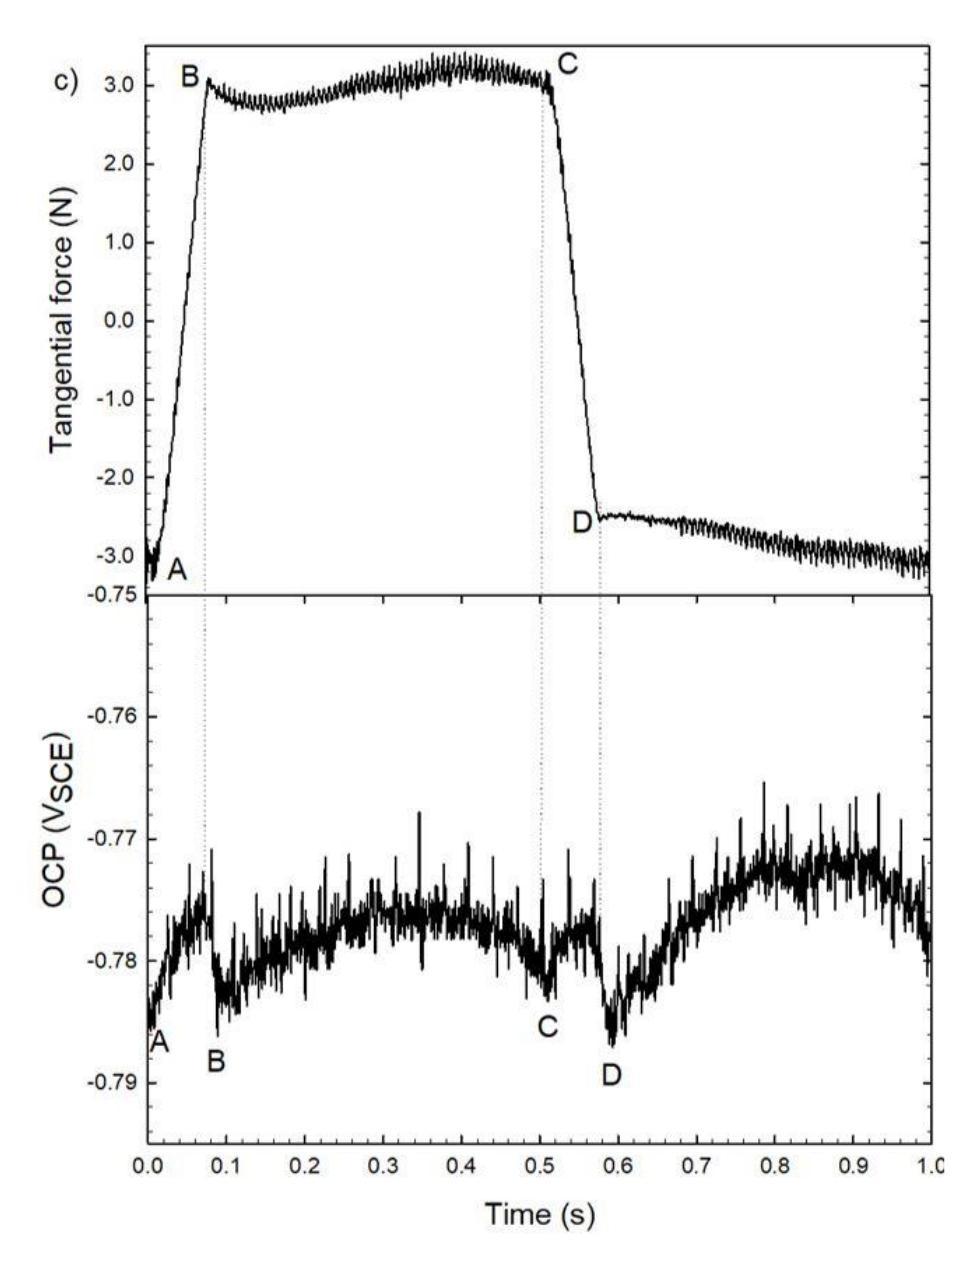
Fig. 5.11 Evolution of transient OCP, tangential force and displacement in a single fretting cycle in 3.5% NaCl solution at 15 N normal force and 1 Hz frequency at displacements of (a) $6 \mu m$ (the stick regime), (b) 40 μm (mixed stick slip regime), and (c) 5 N - 100 μm (gross slip regime).

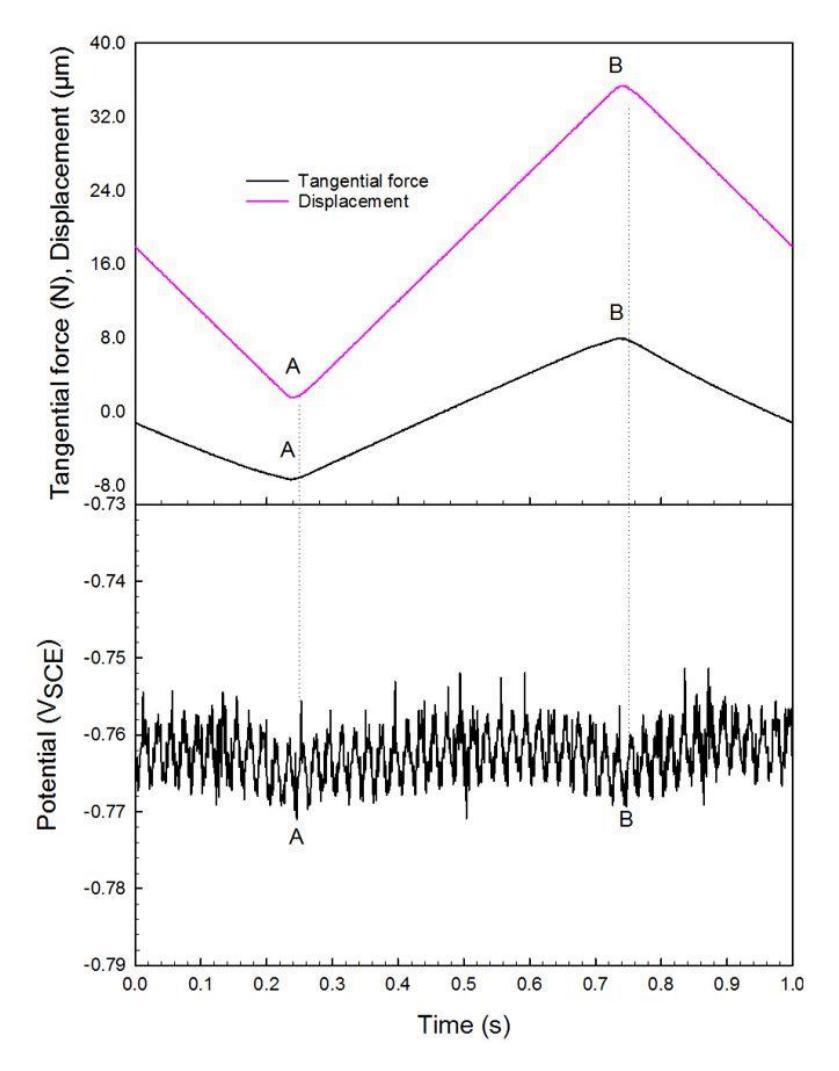
Fig. 5.13 Evolution of transient OCP, tangential force and displacement in a single cycle of fretting taken 25 min after the start of fretting at normal force and displacement combination of 20 N - 35 μ m (mixed stick slip regime) in a 3.5% NaCl solution.

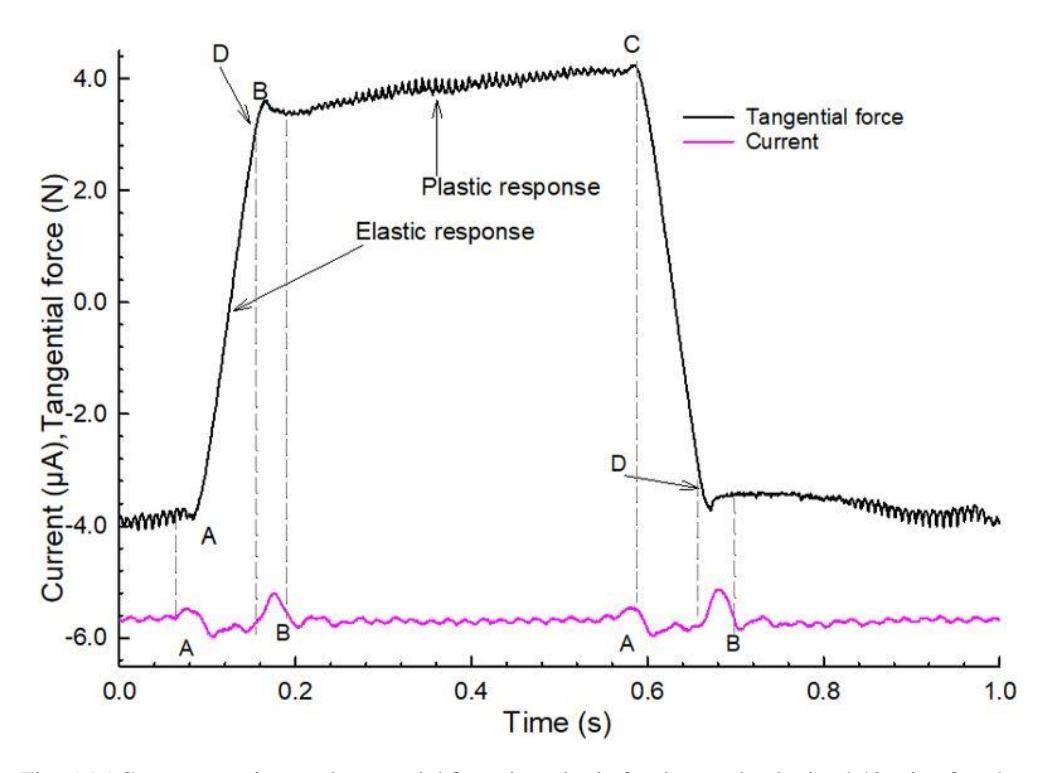
Fig. 5.15 Current transient and tangential force in a single fretting cycle obtained 40 min after the onset of fretting in Fig. 5.14 under fretting at potentiostatic condition in 3.5% NaCl solution (gross slip fretting regime) at a normal force of 5 N, displacement of 100 μ m, frequency of 1 Hz and applied potential of -1.10 V_{SCE}.

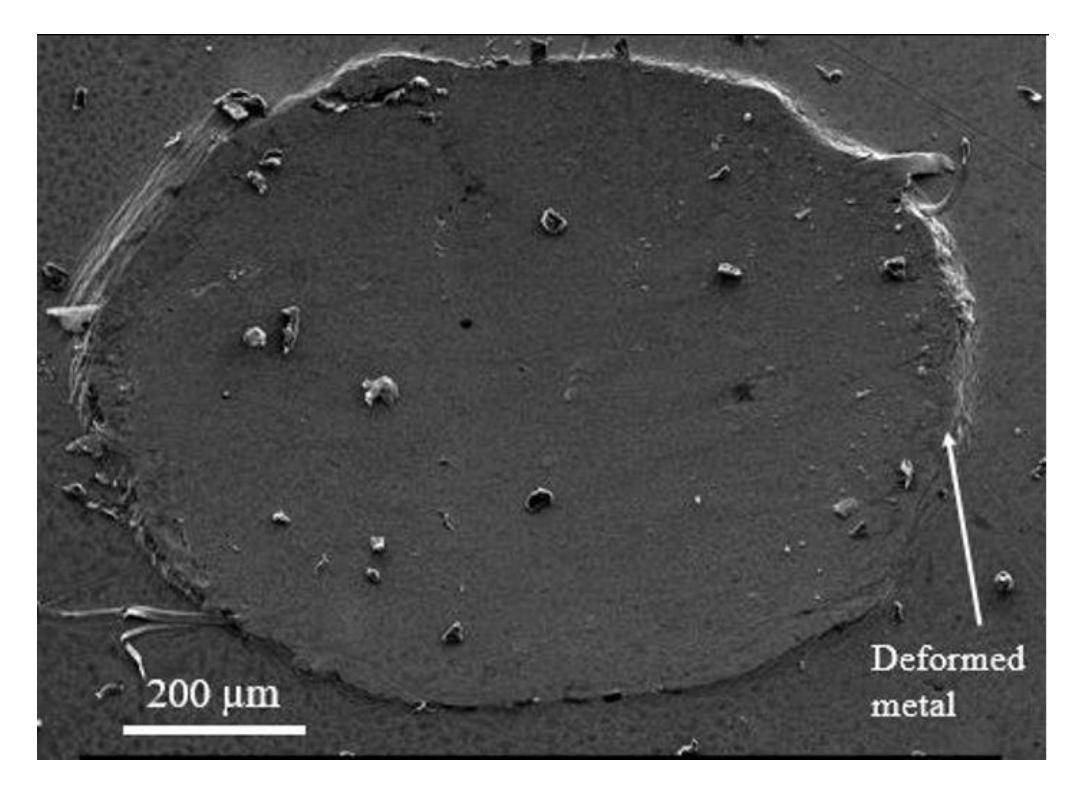
Fig. 5.17 Secondary electron SEM micrograph showing surface morphology of a surface fretted in the stick contact condition for 3600 s. Test parameters: F = 20 N, $D = 4 \mu m$, f = 1 Hz. Flat AA1350 fretted against 10 mm diameter alumina ball in air.

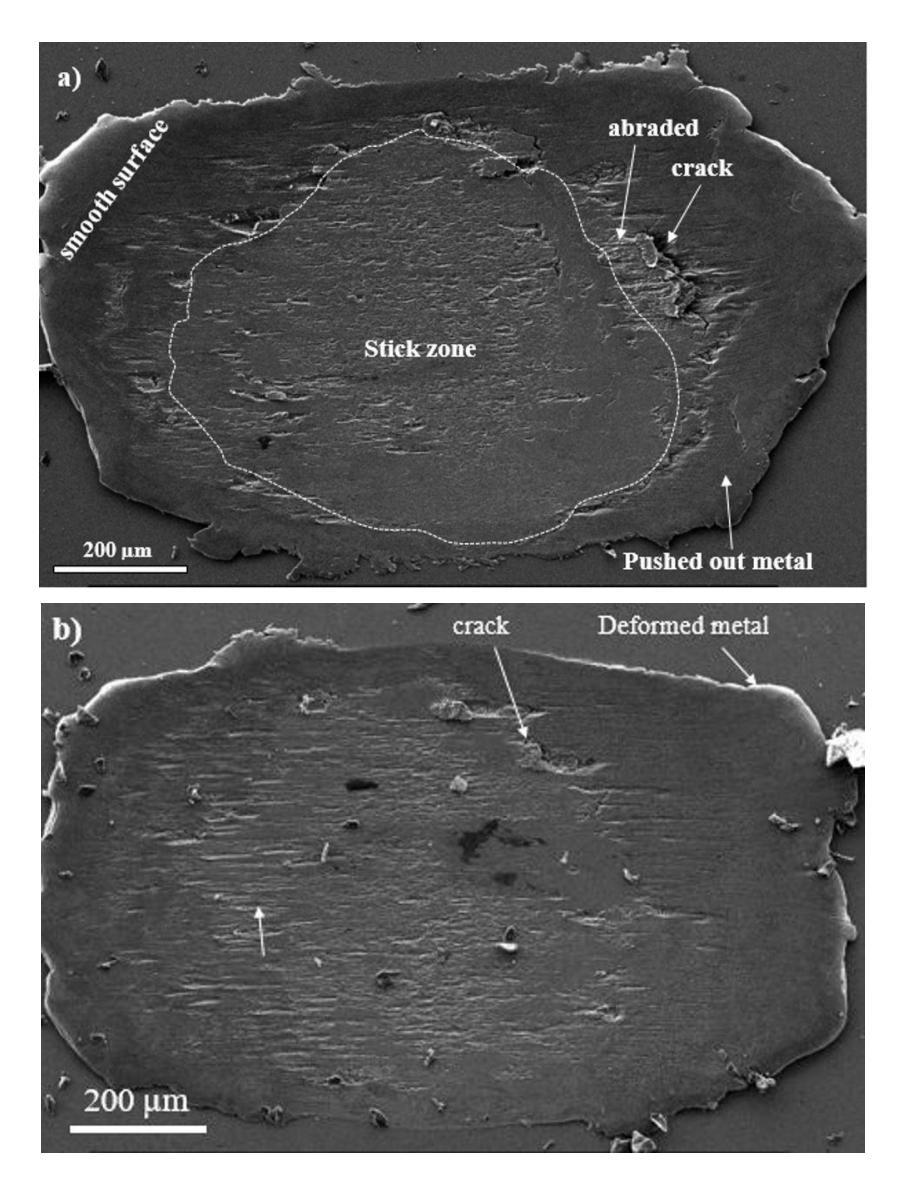
Fig. 5.22 Secondary electron SEM images obtained from fretted surface in a mixed stick slip contact condition after 3600 cycles in air. In both cases, the surface was plastically deformed, and metal was pushed out of the wear track. Moreover, the central areas of the contacts were in stick contact and the surrounding areas (outside the initiated cracks) were in a slip. F = 40 N, f = 1 Hz. (a) $D = 80 \text{ }\mu\text{m}$. (b) $D = 100 \text{ }\mu\text{m}$.

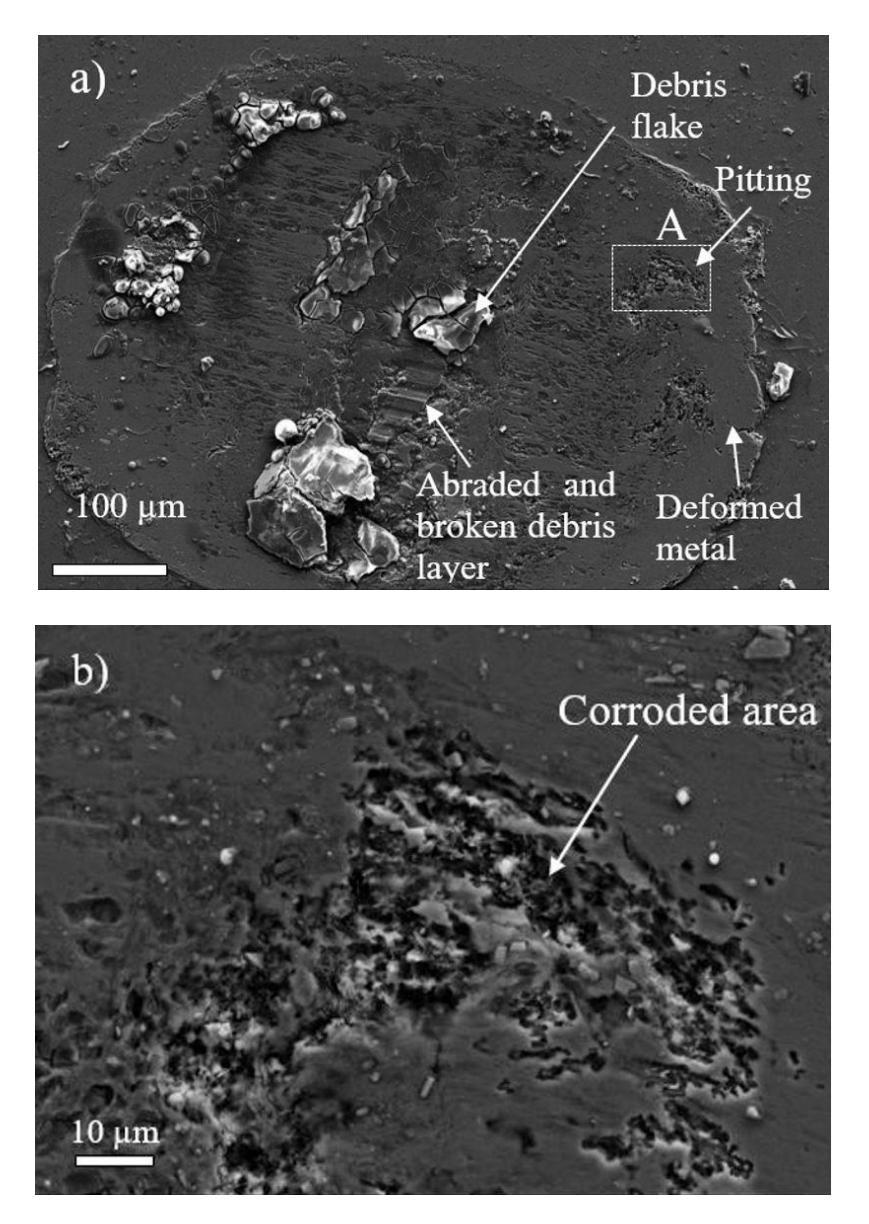
Fig. 5.25 a) Secondary electron SEM images of typical surface morphology obtained from fretting in gross slip contact condition in 3.5% NaCl solution at a normal force of 20 N and displacement of 80 μ m. Metal was plastically deformed and pushed to the edges of the stroke and covered with debris layer. The contact area was also covered with debris. b) Detail of A showing an area affected by corrosion etching on the worn surface.

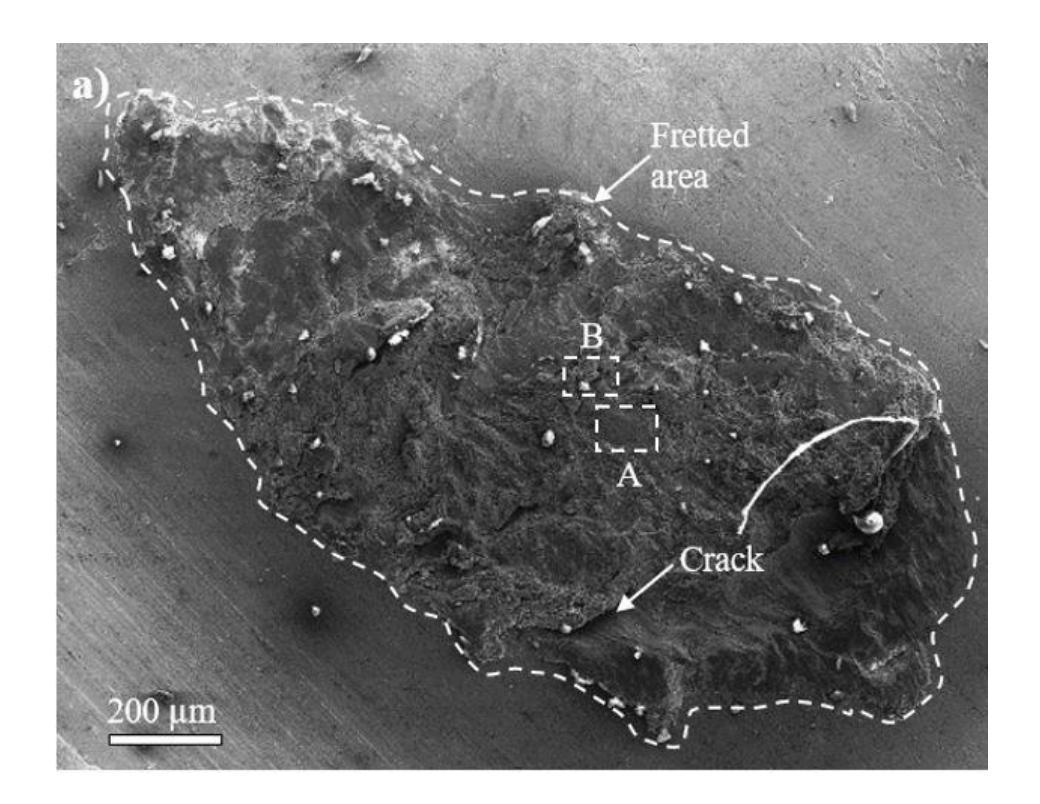
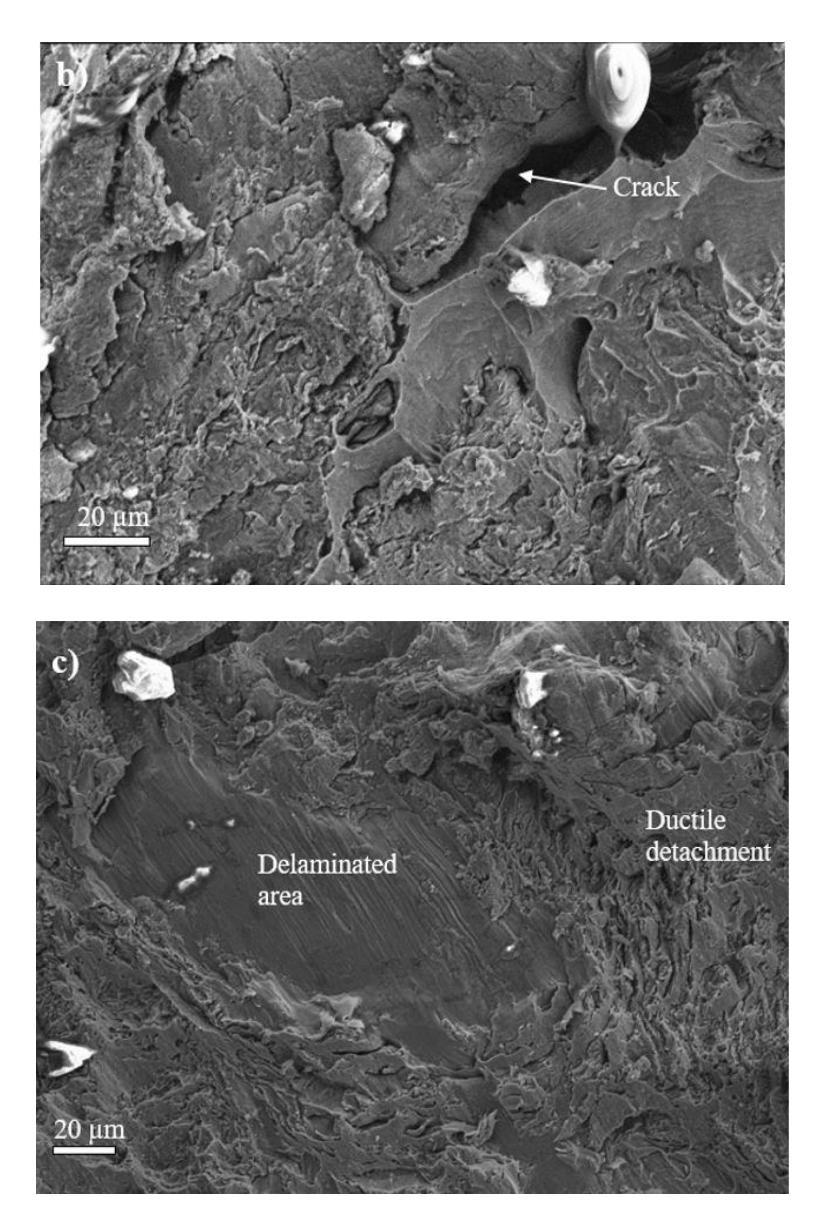
Fig. 5.28 Secondary electron SEM micrograph showing wear morphology of a cylindrical strand after 5 hr fretting with identical strand at a normal force of 40 N, displacement amplitude of 100 μ m, frequency of 1 Hz in air and angle about 45 ° between the axes of the strands. (a) The contact surface (marked area) was plastically deformed and fragmented. (b). Magnified view of area marked B in Fig. 5.27a, illustrating metallic fragmentation and cracking on the surface. (c)
