Soapstone in the North Quarries, Products and People 7000 BC – AD 1700

Gitte Hansen and Per Storemyr (eds)

From Soapstone Quarries to Churches: Control, Ownership and Transport Along the Helgeland Coast in North Norway

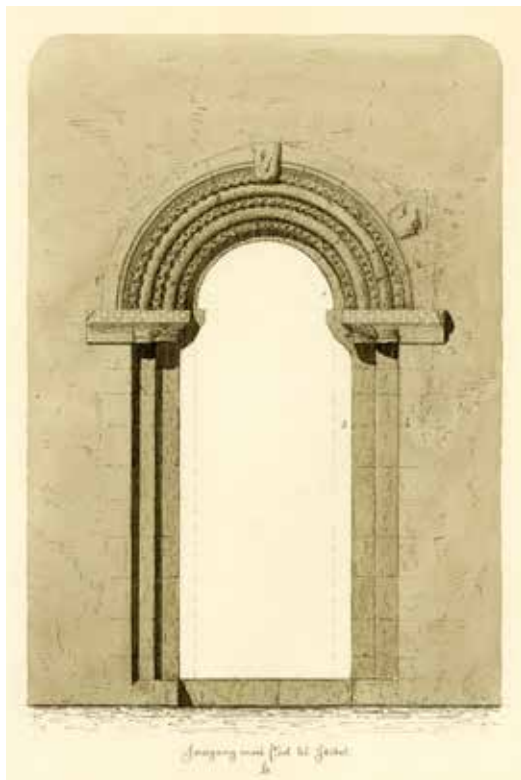
Figure 2. The old west portal in the nave of Dønnes church as it was drawn in 1860 by C. Christie before the church was rebuilt in 1866. The frame of the portal with its ornamentation is made of soapstone. (©The Directorate for Cultural Heritage, The Archive).

the Dønnes estate around 1690 (Coldevin 1980:46, 83). Then part of the chancel wall was demolished. When the church was rebuilt in 1866, half of the nave was removed. The rest became the new chancel (Coldevin 1980:49). The richly decorated soapstone frame forming the west portal was unfortunately removed at that time, but a drawing of it made by Christie six years before the rebuilding in 1866 still exists (Figure 2).

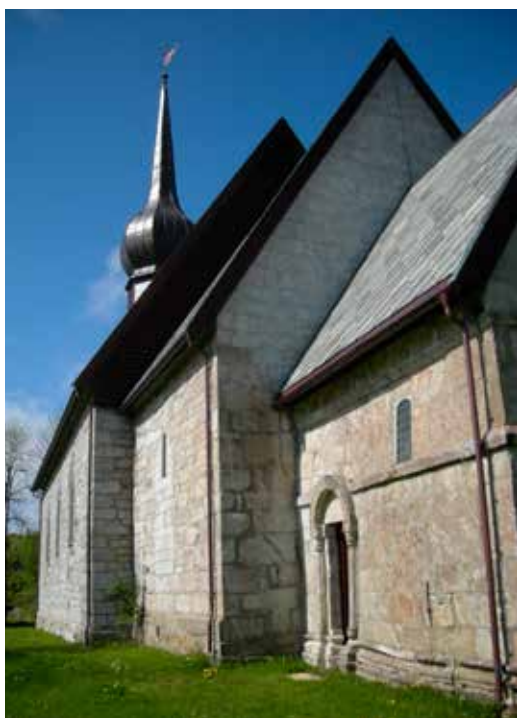
Figure 4. The medieval church at Alstahaug as it appears today after the rebuilding in the 20th century. To the right are the south walls of the old chancel and nave, built of soapstone. (Photo: B. Berglund).

The oldest chancel and nave (Figure 4) were built between 1150 and 1250 according to art history dating (H. Christie 1973:19). They were planned at the same time, but the chancel was built first (H. Christie 1973:11–12). The inner and outer walls of the chancel were made of soapstone ashlars (H. Christie 1973:9) and fine stonework. The south wall of the chancel has a round-headed portal flanked by columns. The arch is decorated with a sunken star motif (Figure 5) made using a chip-carving technique originating in wood carving. This motif was used in both Nidaros Cathedral in Trondheim and St Mary's church in Bergen in the 12th century. It originates from the Norman area in northern France and England (Ekroll 1994:99). Both the chancel and the nave have a moulded

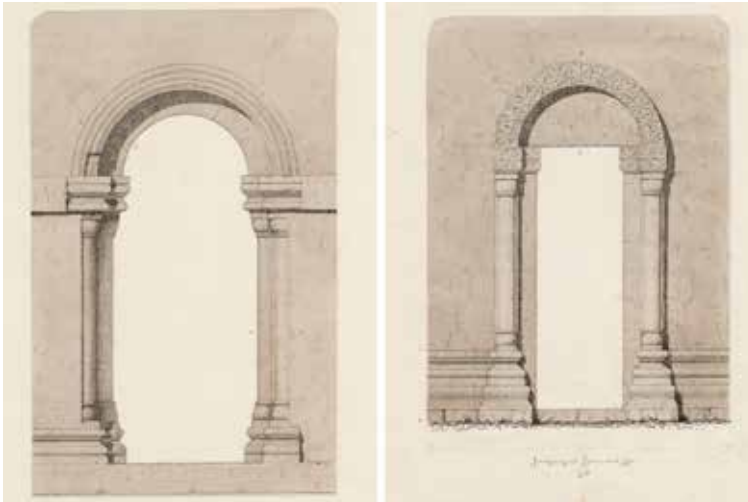
Figure 5. Right: The south portal of the medieval chancel of Alstahaug church with the round-headed arch with the sunken star pattern carved in soapstone. Left: The opening between the medieval chancel and nave. Drawings by C. Christie in 1860 before the church was rebuilt in 1863–65. (©The Directorate for Cultural Heritage, The Archive).

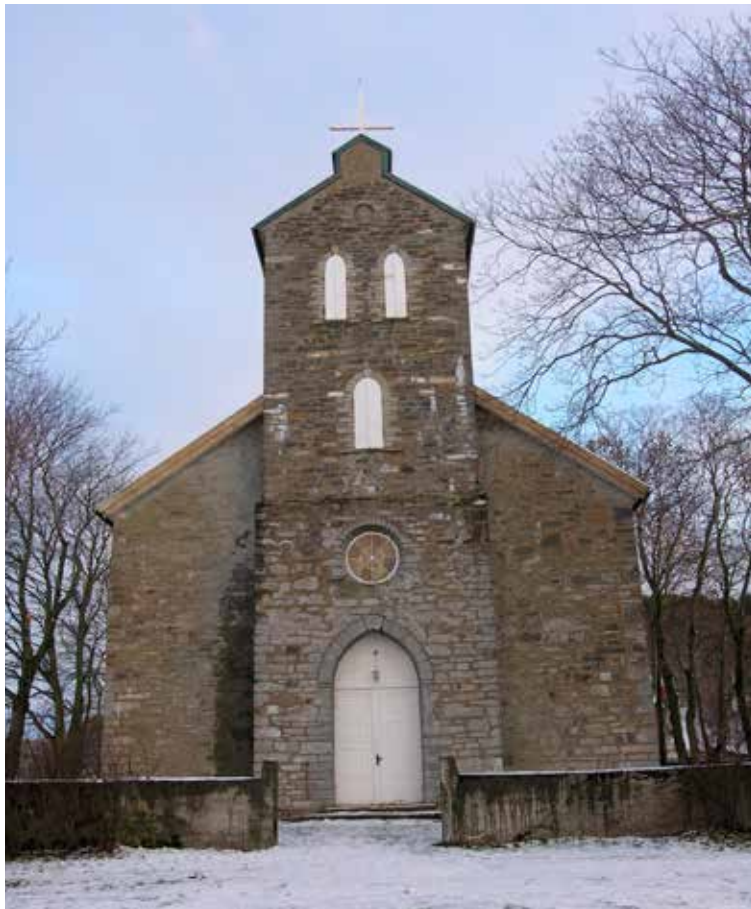
Figure 6. The west front of Tjøtta church as it appears today after the last rebuilding finished in 1851. Soapstone ashlars from the medieval church are visible in the wall together with rubble stone. (Photo: B. Berglund).

This church was struck by lightning in 1843 (Åsvang 2000:90), and its rebuilding was finished in 1851. The stone walls had survived this time, too, and they were taken down during the rebuilding process and good stones were again re-used. Some soapstone was quarried on Haltøya, while rubble stone was quarried in Kalberghaugen in Tjøtta (Åsvang 2000:90–93). Ashlars from the medieval church are still visible in the walls, especially the west front (Figure 6).

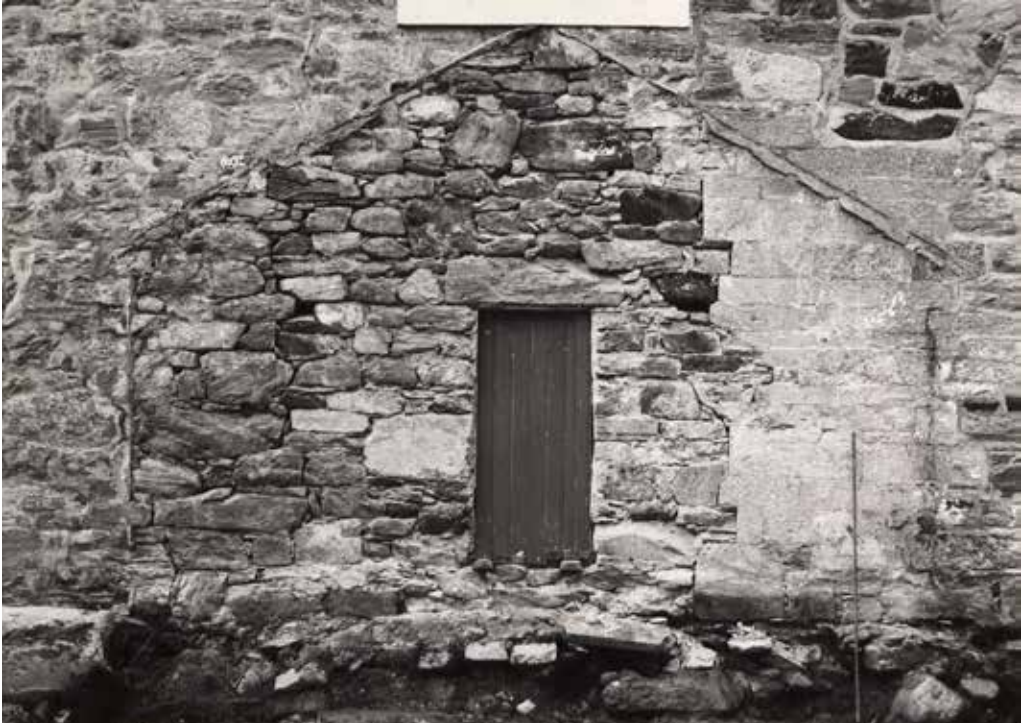
Figure 8. *The outer east wall of the chancel in Brønnøy church. The photograph from 1960 shows that a section of the medieval wall with soapstone ashlars is preserved. (Photo: E. Høvding. ©The Directorate for Cultural Heritage, The Archive).*

Bishop Nannestad stated in 1750 that Brønnøy church was a stone church (Wolff 1942:3). The church was struck by lightning in 1772 and all the wood inside the church burnt, except for some church ornaments (Nordhuus 1977:59–62 [1848]). Nordhuus wrote that the walls also suffered from the fire. Most of the walls were, nevertheless, left as in Tjøtta church. A photograph (Figure 8) from 1960 shows a section of soapstone ashlar masonry in the east wall of the old chancel.

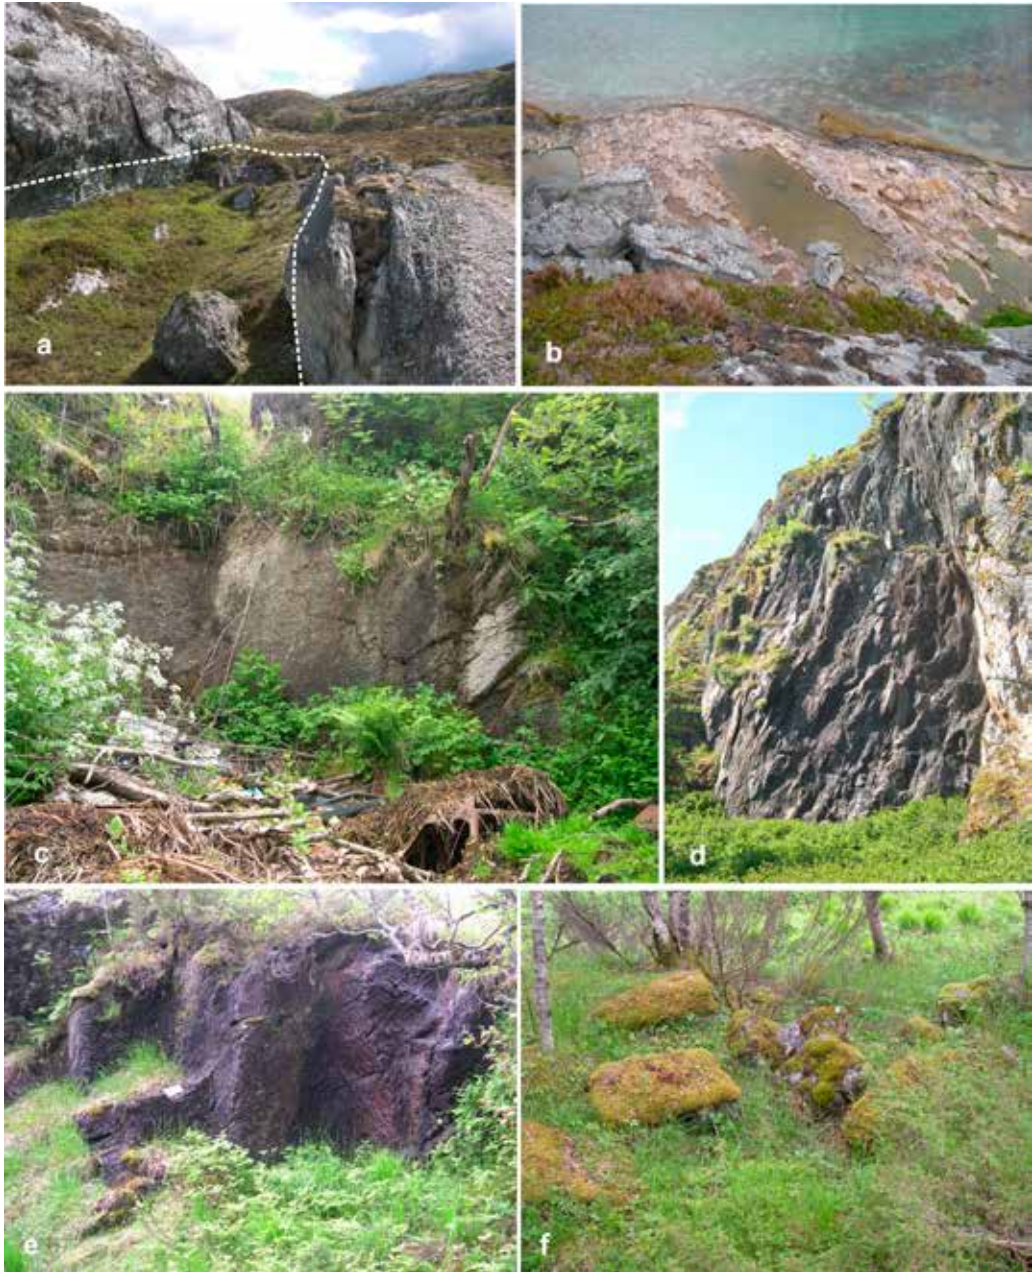
Figure 9. Features from the soapstone quarries. a) quarry at Esøya (dotted line shows extent of extraction), b) quarry floor close to sea level at Esøya, c) small ashlar quarry at Tro, d) vessel and ashlar quarry face at Storesjøya, e) ashlar quarry at Haltøya, f) leftover ashlar blocks at Haltøya. (Photos: T. Heldal).

The visual features of the soapstone found in the churches have been described using the same criteria as the quarries (Figures 9, 14). Figure 15 summarises the observations from the churches. Figures 16, 17 show the correspondence between churches and quarries, indicating the most likely provenance.

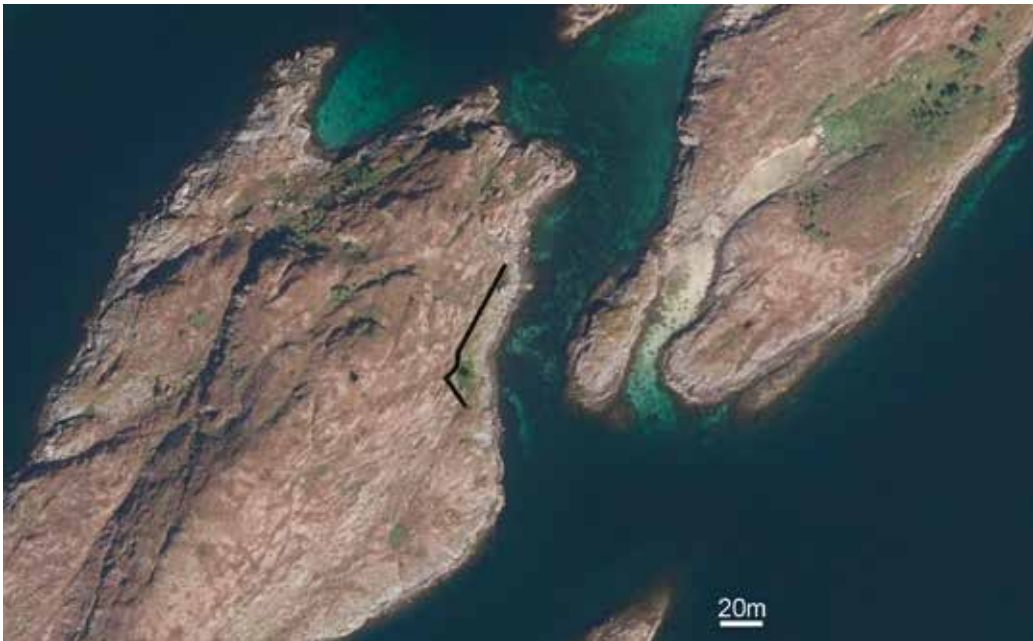
Figure 10. Location of the Storesjøya quarry. Black line indicates quarry face.

The islet of Storesjøya is far west in Brønnøy. Most of it consists of gabbroic bedrock, but a lens-shaped body of soapstone, about 8 m at its thickest, occurs within the gabbro in the northeast. A steep quarry face is seen at the southwest end of the quarry (Figure 10), and it displays traces and marks from the extraction of soapstone vessels and ashlar blocks. The quarry floor in front of the steep face also has extraction marks, and a rough estimate of the extracted volume is 500 m³. Most of the quarrying spoil is assumed to have ended in the sea beside the quarry, but one ashlar block is found by the far northeast end.

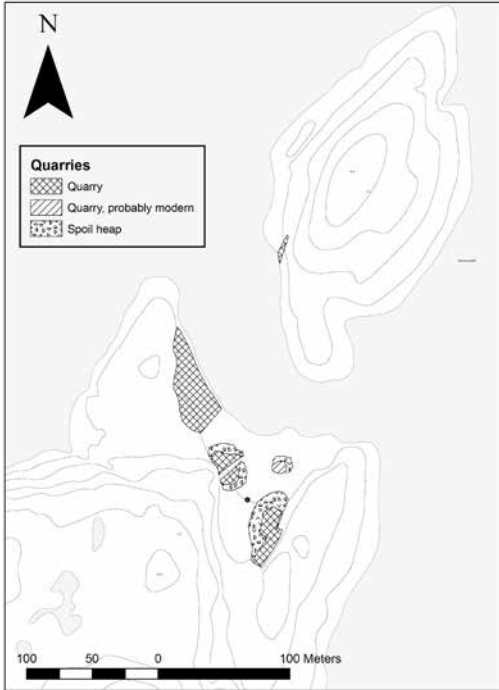
Figure 11. The location of quarries at Esøya.

A large quarry where at least hundreds of cubic metres of rock have been extracted is found on the island of Esøya in Vevelstad (Figure 11). Soapstone appears to have been quarried here for cooking vessels, fishing weights and building stone. There are no indications of fairly recent soapstone production, but a small deposit of actinolite seems to have been exploited by mineral collectors in recent times. The western part of the quarry displays evidence of the extraction of vessels and probably fishing weights on the quarry floor. However, a significant amount of rock has been quarried and the schist behind has been partly undermined so that large blocks have fallen onto the quarry floor. It is therefore difficult to tell whether building stone was extracted before the last phase of quarrying.
