Article

Bondline Thickness Effects on Damage Tolerance of Adhesive Joints Subjected to Localized Impact Damages: Application to Leading Edge of Wind Turbine Blades

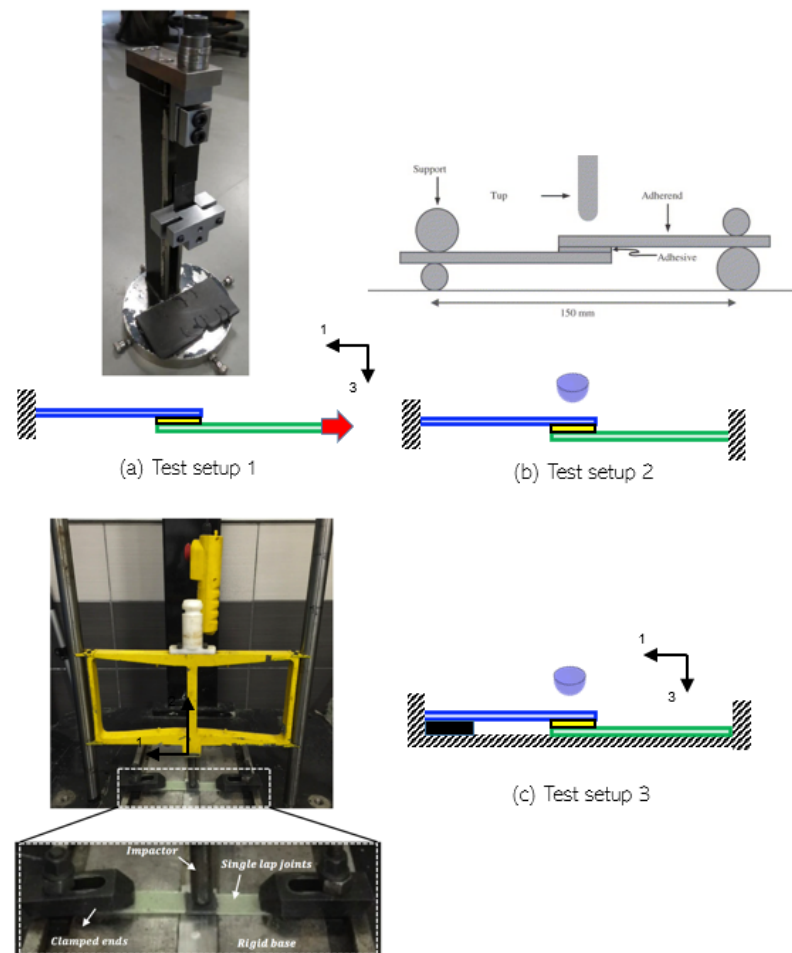
Figure 4. Different test setups used for testing adhesive joints under impact loads [51,56,59].

(1) Test setup 1: Under this test setup, boundary conditions include one end of the joint being rigidly fixed, whereas the other end is unconstrained in the direction of force (F) (see Figure 4a). An impactor is allowed to drop in such a way that it impacts the lower end of the fixture attached to the sample [44,45] (see Figure 4a). In other words, impact forces are imposed in the in-plane direction of the single lap joints in order to break the adhesive bond. This test setup is also referred to as in-plane dynamic testing with high strain rate, where the substrates of the joints are dominantly exposed to membrane forces. The test setup has been used extensively in the literature sources by [44,46–50] to investigate impact assessment on single lap joint. However, this test setup is contrary to the global impact scenario in our study applied to the leading edge of a wind turbine blade. Hence, this test setup was not considered suitable for the current study.

(2) Test setup 2: This test setup includes both ends of the sample being rigidly fixed, and a drop weight impact machine is used to apply impact energy in through the thickness direction of the sample (see Figure 4b). This configuration of loads is explicitly referred to as the transverse impact loading condition in the literature (perpendicular to the reinforcement direction) and has been utilized in [51–55]. The dominant mode of failure is governed by the membrane effects in the substrates, global deflection of the sample under impact-induced bending, as well as localized deformations. Hence, mixed loading and failure modes will likely cause a severe inconsistency when comparing three different bondline thicknesses. Therefore, this test setup was not considered suitable for the study.

(3) Test setup 3: The configuration of loads and BCs for this test setup is similar to Test setup 2, however, a rigid support base is present below the samples along with rigidly clamped ends (Figure 4c). In this way, the local impact damage on the adhesive joint is isolated by eliminating any significant membrane forces and global bending deformation. Furthermore, the flat rigid plate also satisfies the geometric stiffness inherently present in the blade system due to the curvature of the leading edge section. Hence, this test setup enables a consistent comparison of localized impact-induced effects on adhesive joints between different bondline thicknesses. The test setup has also been explored in the literature [56–58] for impact testing on adhesive joint, and was judged as the most suitable configuration for the present study.

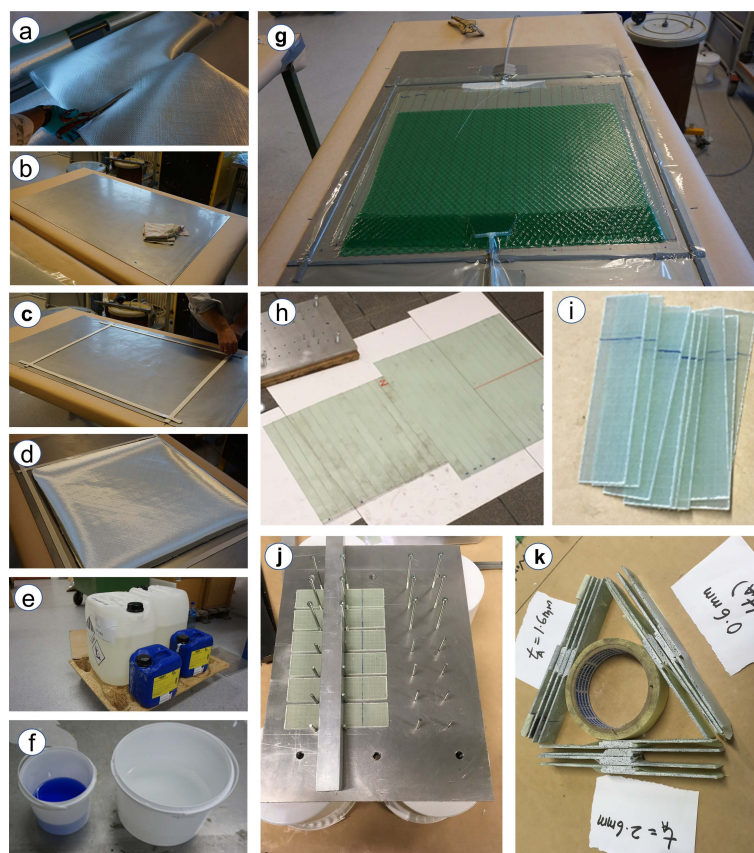
Figure 6. Step-by-step procedure (a–k) followed in experiment for preparing laminates and adhesive joints.

stacking the reinforcements, the stacking mould is unstained with acetone and a release agent is used (Figure 6b). Then, the sealing tapes are applied on the mould (Figure 6c), and the desired sequence of reinforcement along with peel ply and flow meshes are stacked (Figure 6d). Momentive EPIKOTE-MGS135 epoxy resin and EPIKURE-MGS137 curing agent are mixed in a 3:1 ratio, and the mixture is used as the resin (Figure 6e,f). The mixed resin is then kept in the degassing chamber for removing any trapped air bubbles. Furthermore, the whole system is vacuum infused at a pressure of 0.8 bar (Figure 6g) and the prepared laminate has a final thickness of $2.2 \pm 2\%$ mm. The curing cycle of the laminate included keeping the prepared laminates at room temperature for 24 h followed by their post curing in the oven at $80\text{ }^{\circ}\text{C}$ for another 15 h. The prepared laminates are further cut into desired dimensions of size $100\text{ mm} \times 25\text{ mm}$ for their use as substrates in the SLJs (Figure 6h,i).

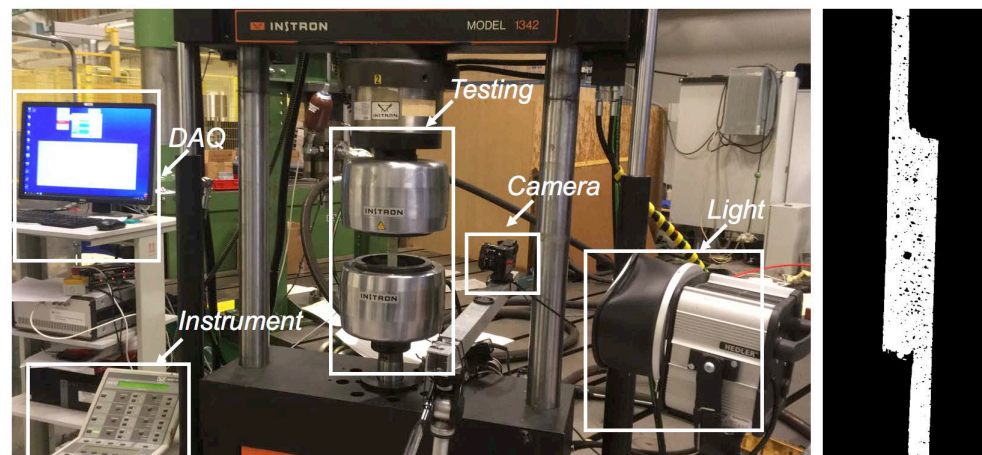
Figure 8. Setup for testing adhesive joints under lap shear (left) and through the thickness surface prepared for failure analysis (right).

The prepared single lap joints are tested in a universal testing machine (UTM) Instron model 1342, at a displacement rate of 1 mm/min. Figure 8a presents the test setup, where components such as data acquisition system (DAQ), operating instrument, camera, light, and samples are shown. In addition, the initial configuration of the joint along the thickness direction, which is used as a surface for image analysis of the failure process is shown in Figure 8b. The maximum force observed by the UTM machine is considered as the failure load of the intact samples. Note that all tests are carried out at room temperature ranging between 23 °C to 25 °C.

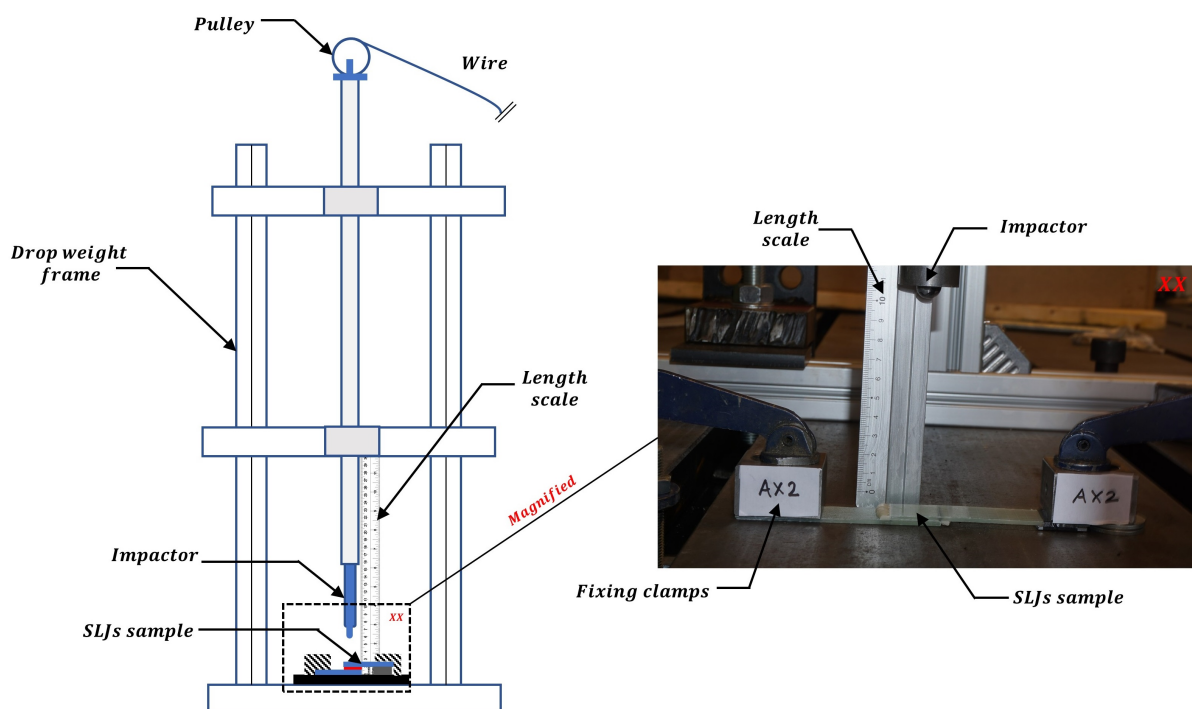
Figure 9. Test setup constructed for impact testing on single lap adhesive joints.

A special dedicated fixture for testing joints under impact loads is constructed for this study to replicate the boundary condition (see Figure 9). The test setup frame is assembled using strut profiles and connections from Bosch Rexroth AG [64], and the base of the setup is rigidly fixed to a steel base. A high-grade hollow steel cylinder is rigidly connected to the center of the frame (Figure 9), which acts as the guiding chamber for the impactor to fall on the sample. The impactor is a rigid steel cylinder having a mass of 5.1 kg and has an impactor diameter (ϕ_d) of 12.7 mm. One end of the impactor is attached with the fibre rope which runs through the pulley attached to the top of the hollow cylinder, and the rope is connected with the winch which controls the height of the impactor. A length scale is also attached with the setup which measures the release height and the rebound height of the impactor. In this way, the impact energies in the test are controlled.

A rigid base is used to hold the samples for impact, and the samples are clamped at the ends along with suitable tabs placed on one end. A camera capable of capturing the entire impact event is used during the test, and the recorded video is further utilized to analyze the impact kinematics as discussed in the next section. A magnified image of the sample is shown in Figure 9, which corresponds to impact energy of 5 J and release height of approximately 10 cm. Furthermore, for applying impact energy of 10 J and 15 J, the height of the impactor corresponds to approximately 20 cm and 30 cm, respectively (see Figure 5d). Note that the samples are properly numbered in a unique nomenclature. For example, in Figure 9, the sample is numbered as 'AX2'. Here, the first letter of the nomenclature 'A' corresponds to an impact energy of 5 J (B will correspond to impact energy of 10 J, and C will correspond to impact energy of 15 J), the second letter 'X' of the nomenclature corresponds to bondline thickness of 0.6 mm ('Y' will correspond to bondline thickness of 1.6 mm, 'Z' will correspond to bondline thickness of 2.6 mm), and the third letter of the nomenclature corresponds to the sample number.

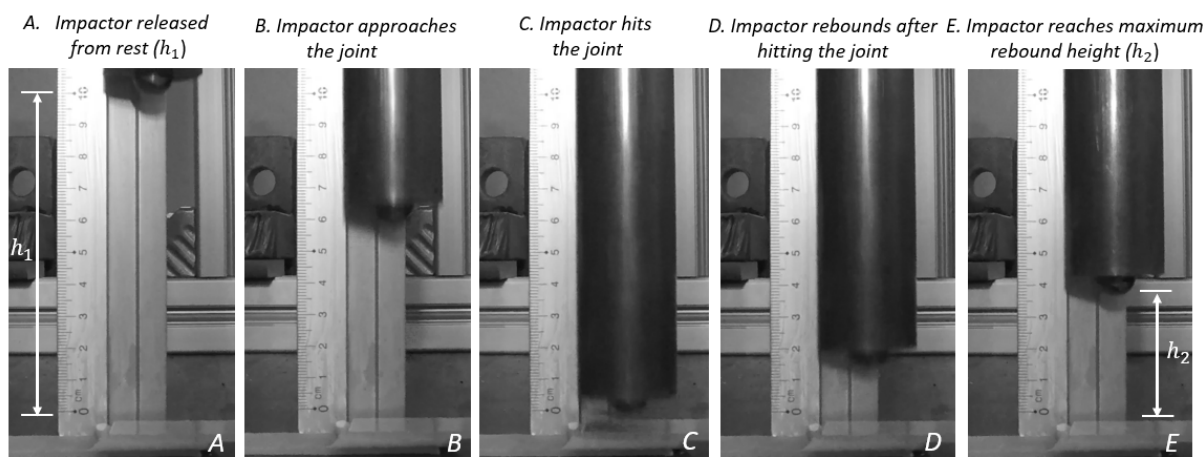
Figure 10. Different stages of impact event recorded by camera.

- Stage (A) Impactor released from rest at height (h_1);
- Stage (B) Impactor approaches the joint;
- Stage (C) Impactor hits the joint with velocity ($V_{I,1}$);
- Stage (D) Impactor rebounds after hitting the joint with rebound velocity ($V_{I,2}$);
- Stage (E) Impactor reaches the maximum rebound height (h_2).

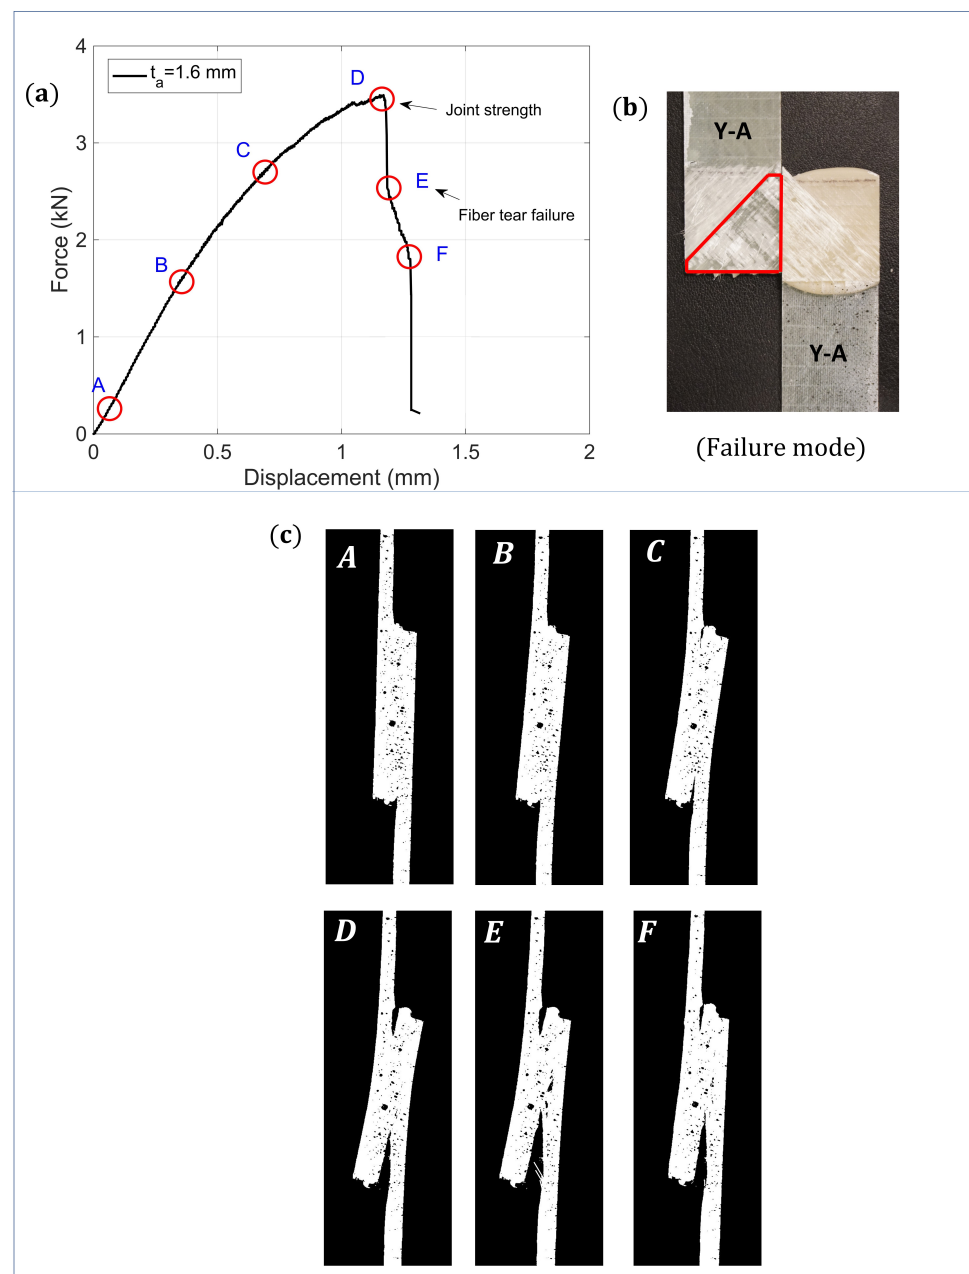
Figure 12. Tensile lap shear test results for intact joints: (a) Force-displacement history, (b) dominant failure mode, and (c) state of joint at different points A-H along the force-displacement history.

Figure 12a,b present the intact load displacement history and failure mode respectively for Type-Y samples ($t_a = 1.6$ mm) subjected to tensile lap shear tests. The figure shows that

the failure load of the sample is close to 3.5 kN, whereas the maximum failure displacement is around 1.35 mm. The failure mode is obtained in the form of fiber tear failure and partial delamination of the first ply of the bottom-most adherend at the adhesive-adherend interface. This is generally due to the fact that composite adherend's interlaminar tensile strength is lower than the peel strength of the structural adhesive, thereby causing a delamination of the bottommost ply. This failure mode is also consistent with the results obtained in the literature for SLJs made with GFRP substrates.

Figure 12a is also marked with different label pointers on the force-displacement curves, where each labeled point represents the deformation state of the sample at different time frames captured using a camera and presented in Figure 12c. It can be seen that the load curve exhibits linear behavior with increased displacement till point B. Furthermore, due to increased bending moment at increased displacement, the joints are exposed to both

tensile as well as bending mode of deformation (see state C,D). At point D, the maximum load is reached, and at this point, partial delamination of the bottom most ply has completely occurred at the adhesive-adherend interface due to high peel forces. This partial delamination further progresses into fiber tear failure at E, finally causing complete failure of the joint at F. The response behavior and failure mode is consistent for all the joint-types and for all the tested samples under tensile lap shear. Figure 13 summarizes the failure mode obtained under tensile lap shear tests for all the three different bondline thicknesses ($t_a = 0.6$ mm, 1.6 mm, and 2.6 mm) and for one representative sample. As seen from the figure, the dominant failure modes for all the cases include fiber tear failure and partial delamination of the first ply of the bottom-most adherend at the adhesive-adherend interface.

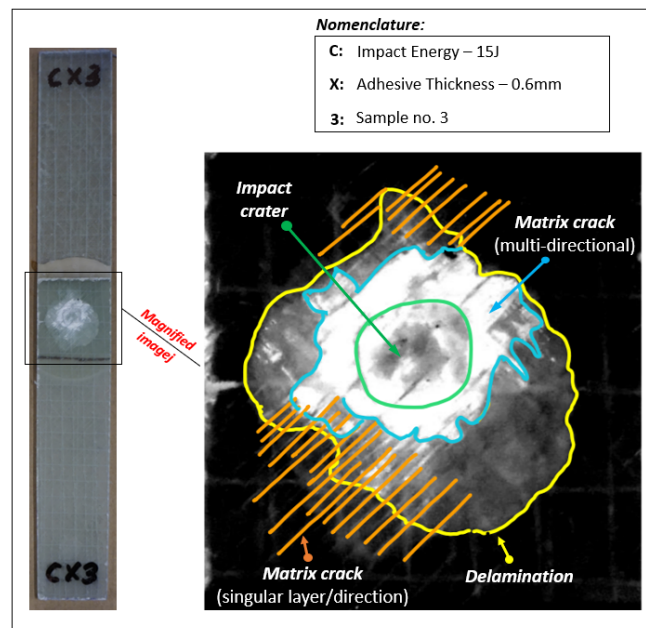
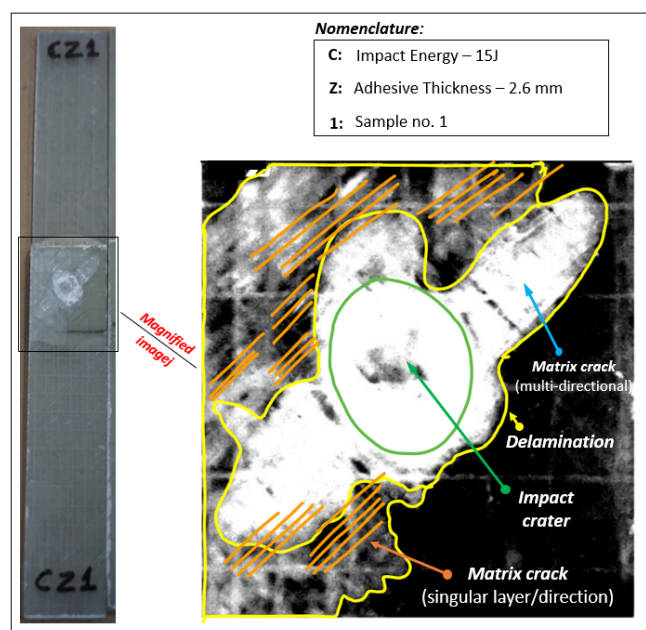
Figure 18. Different failure modes in the joints subjected to impact energy of 15 J for bondline thickness of (a) 0.6 mm and (b) 1.6 mm.

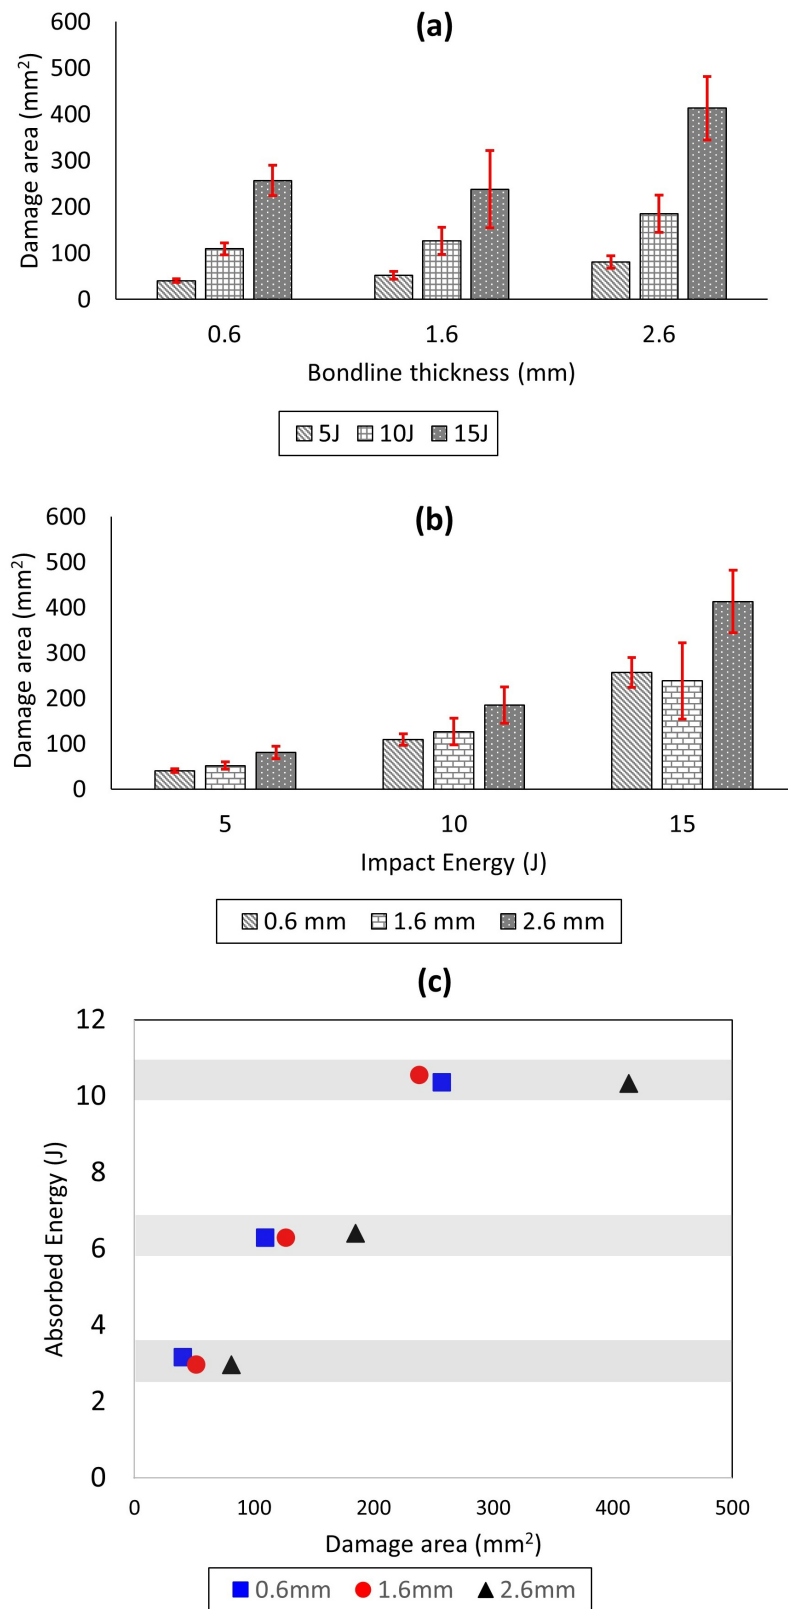
Figure 20. Comparison of impact-induced projected damage area in joints for different (a) bondline thicknesses, (b) impact energies, and (c) absorbed energies.

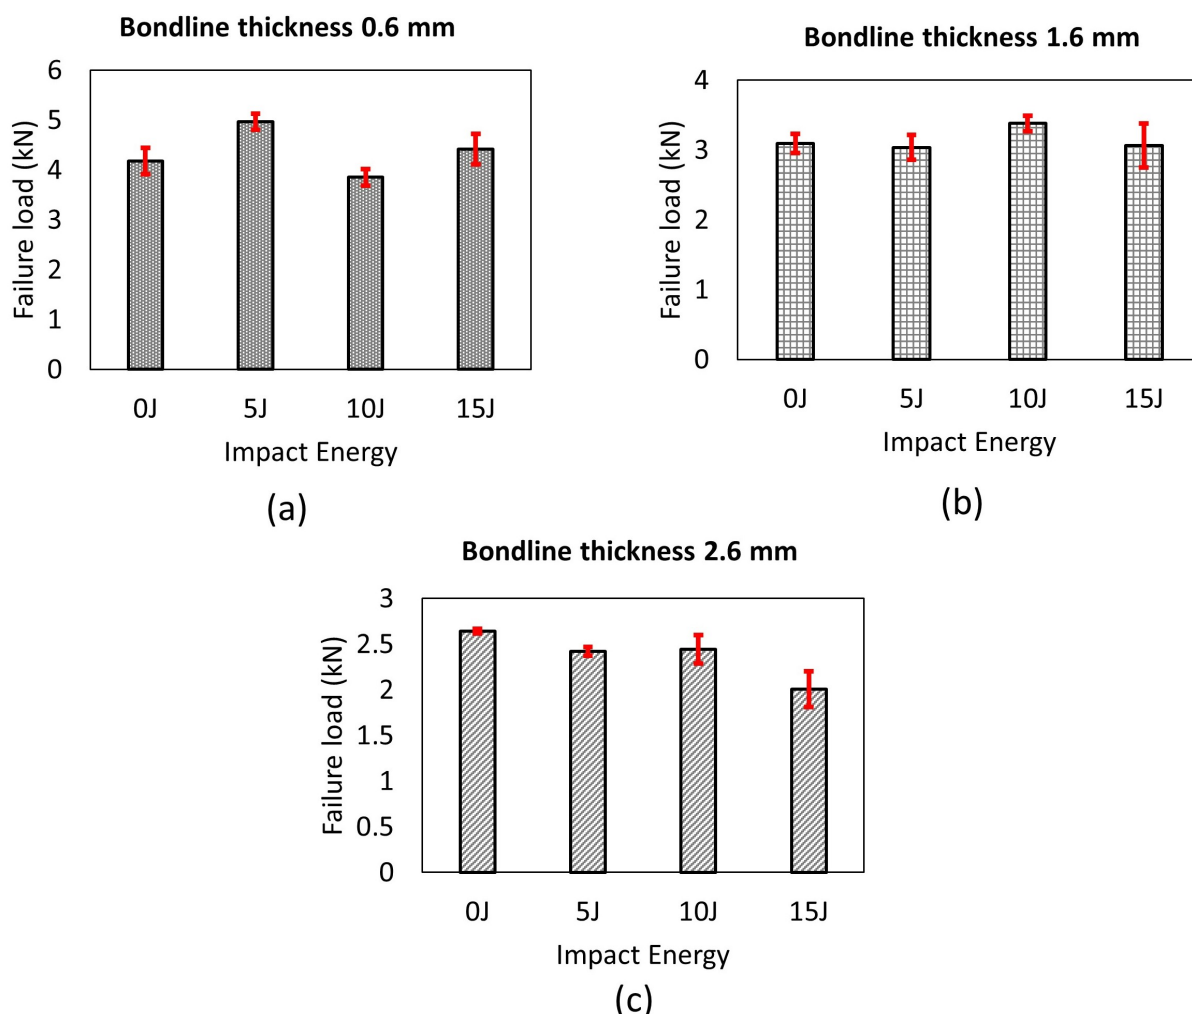
Figure 22. Comparison of post impact failure load of joints after being subjected to different impact energy: (a) Bondline thickness of 0.6 mm, (b) bondline thickness of 1.6 mm, and (c) bondline thickness of 2.6 mm.
